CITY OF BANGOR, MAINE

**PHASE 2 SEWER SYSTEM EVALUATION SURVEY
REPORT**

January 31, 2017

**AECOM
250 Apollo Drive
Chelmsford, Massachusetts 01824**

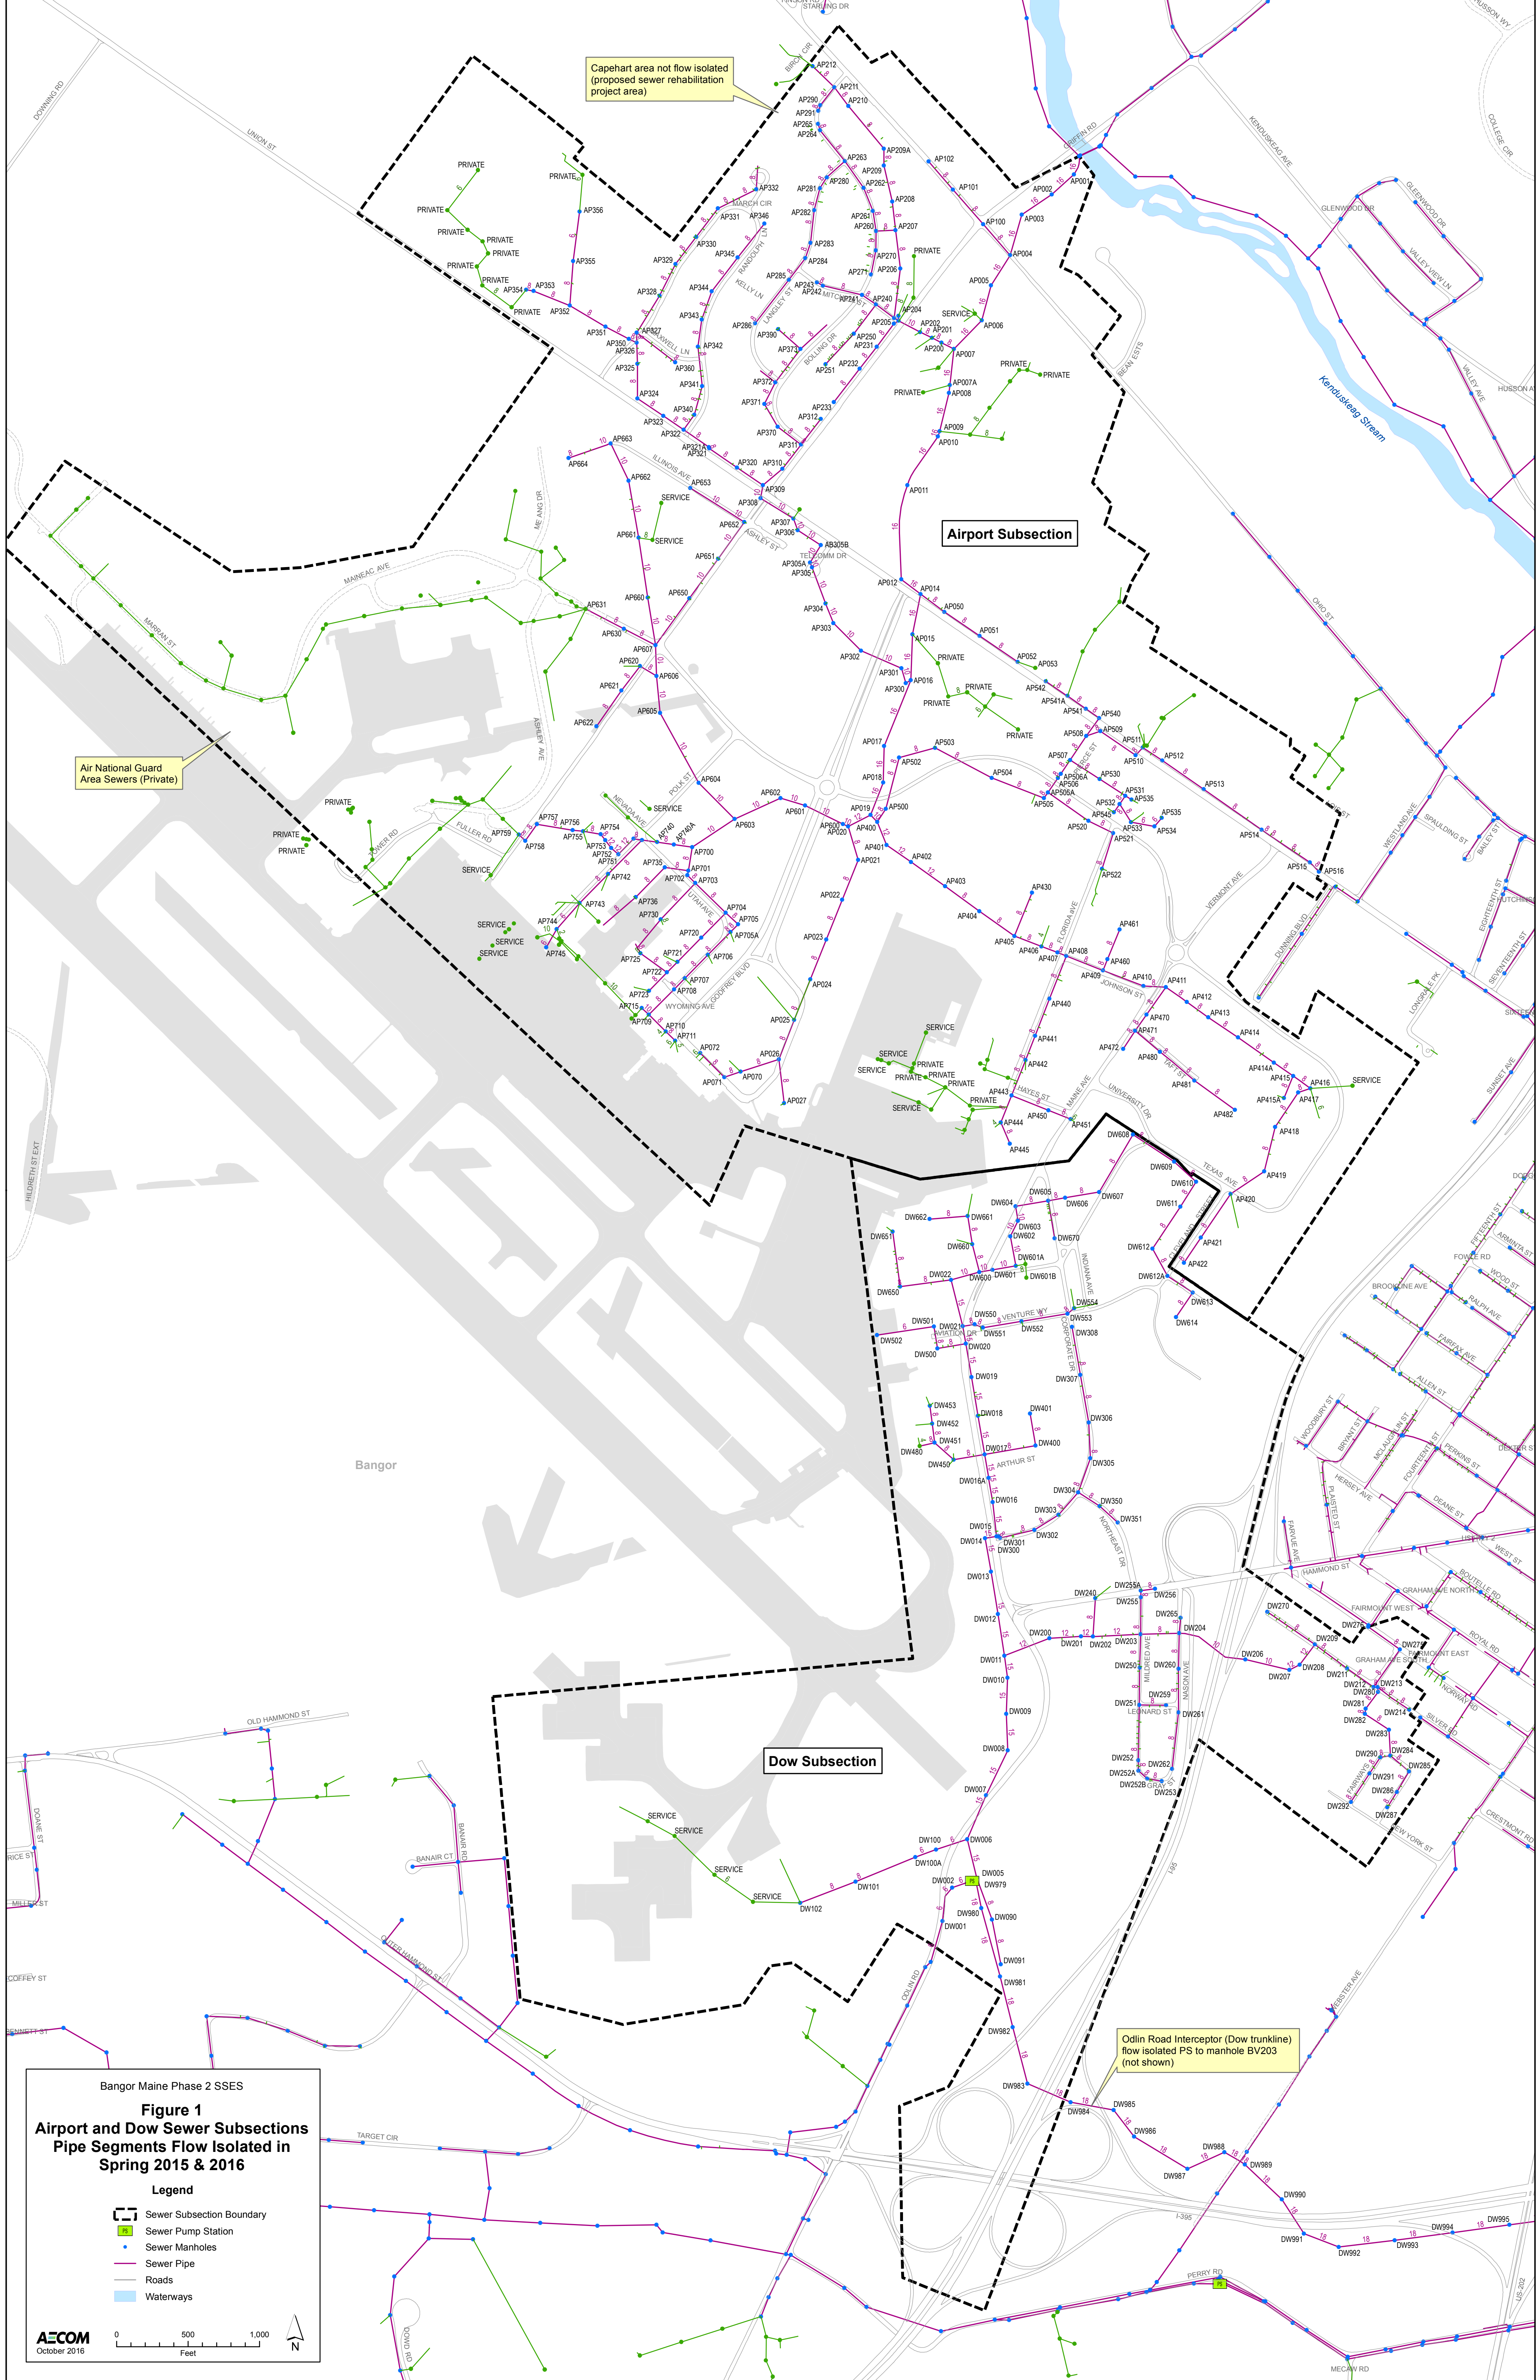
- Figure 1, Airport and Dow Sewer Subsections, Field Investigation Locations, Spring 2015 and 2016

Capehart area not flow isolated (proposed sewer rehabilitation project area)
