# Sucker Brook

## Stream Corridor and Watershed Survey

*Bangor and Hampden, Maine*

*October 2014*

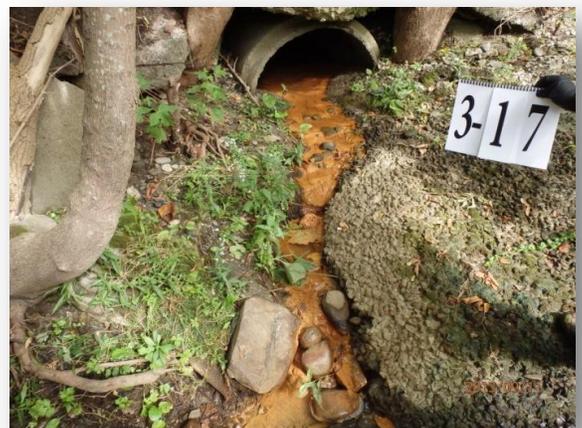
*Iron rich brown/orange discharge at Reach 3.*

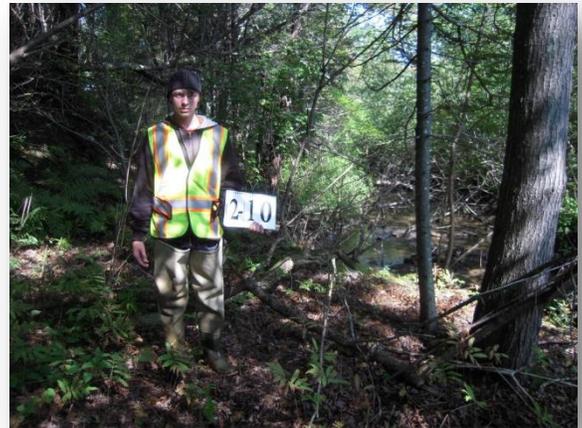
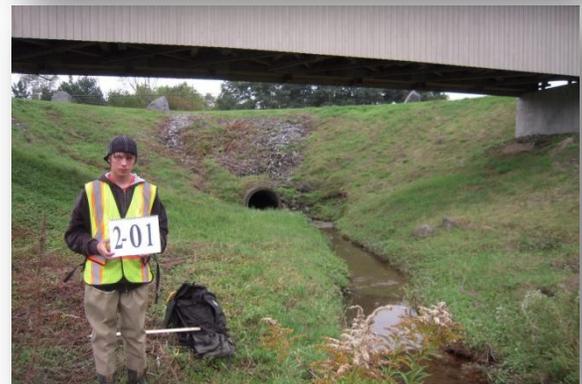
*Example of good (top) and poor (bottom) riparian shading in Reach 2. Bottom photo is near the Cole Land Transportation Museum in Reach 2.*

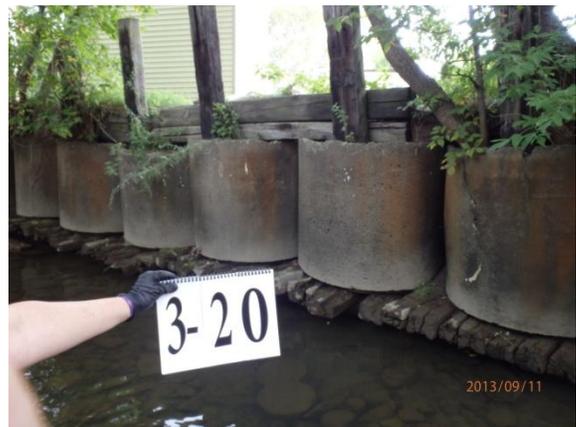
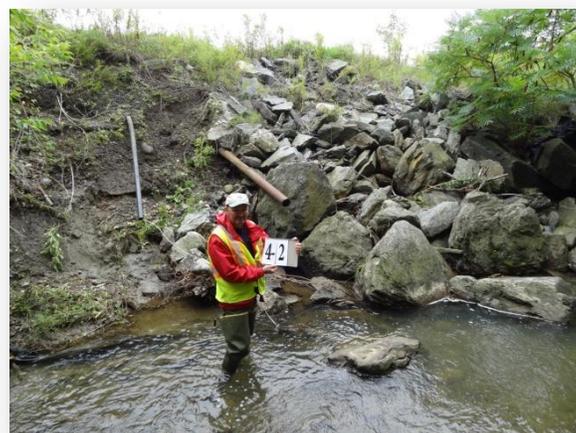
Examples of artificial bank modification in Reach 3 (top), and Reach 4 (bottom).

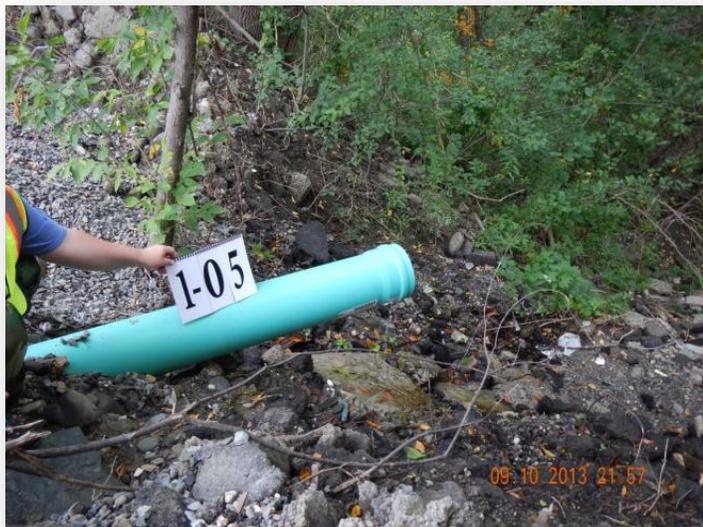
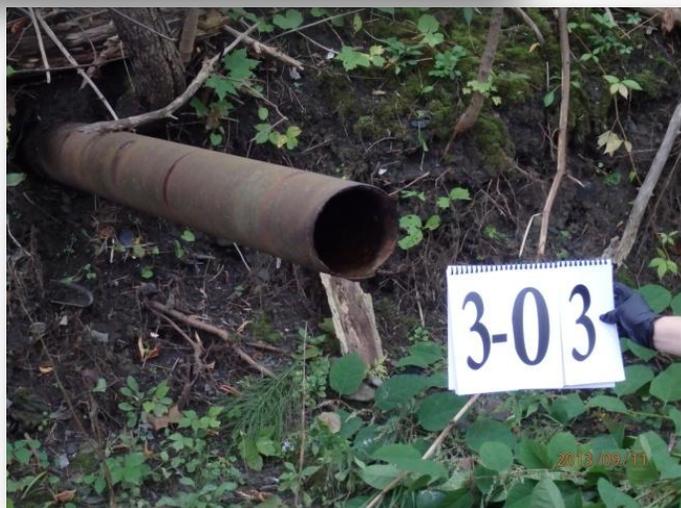
*Examples of discharging pipes or stormwater outfalls in Reaches 1, 3 and 4.*

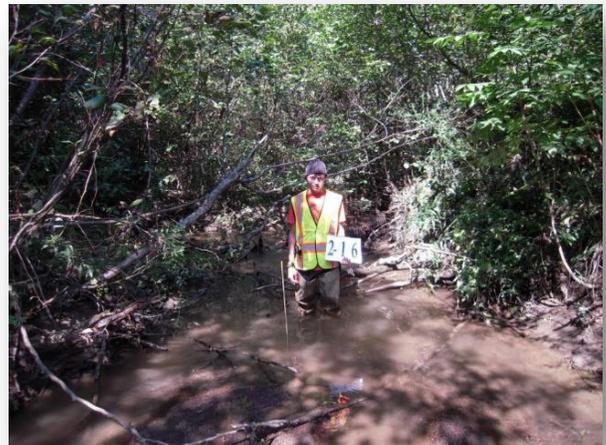
*Soft unconsolidated sediment (causing silty brown color in water), and formation of mid-channel bars was evident in Reach 2.*

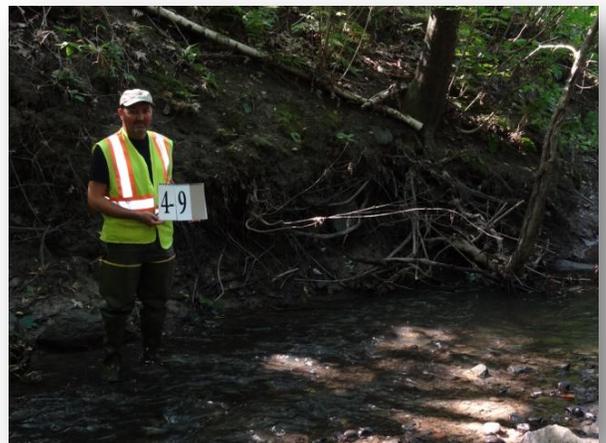
*Elevated tree roots and/or root fans, as seen above in Reach 4, are indicators of degradation.*

Evidence of degradation includes elevated tree roots, or root fans above the channel bed, bank height increases, and absence of depositional features such as bars. Degradation was most apparent at Reach 3-2 and Reach 4-1. All other reaches exhibited little to no evidence of degradation.

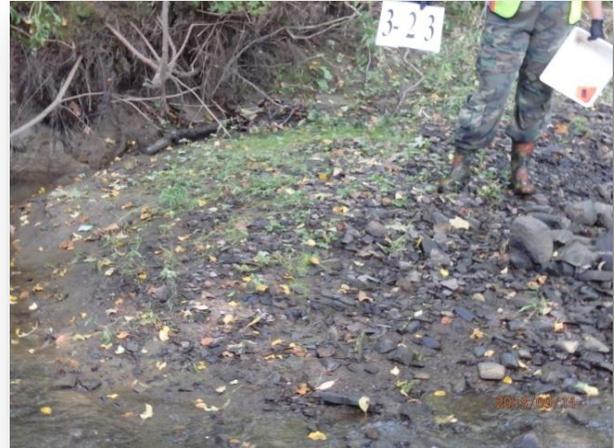
*Collapsed streambanks, and buildup of sediment in the stream channel has resulted in a wide, shallow stream in the upstream portion of Reach 3.*

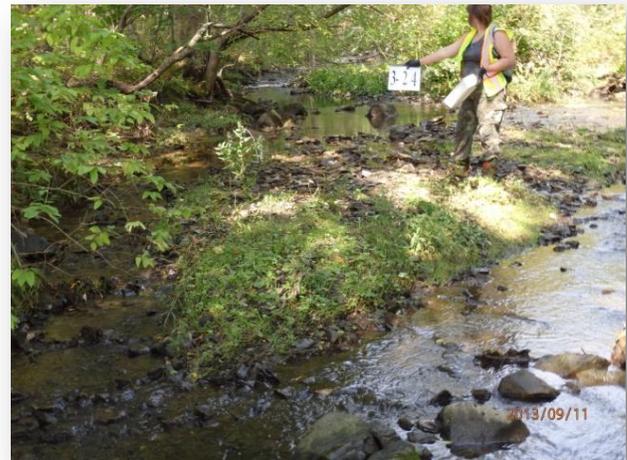
*Example of planimetric form adjustment in Reach 3 showing cut-off channels and mid-channel bars.*

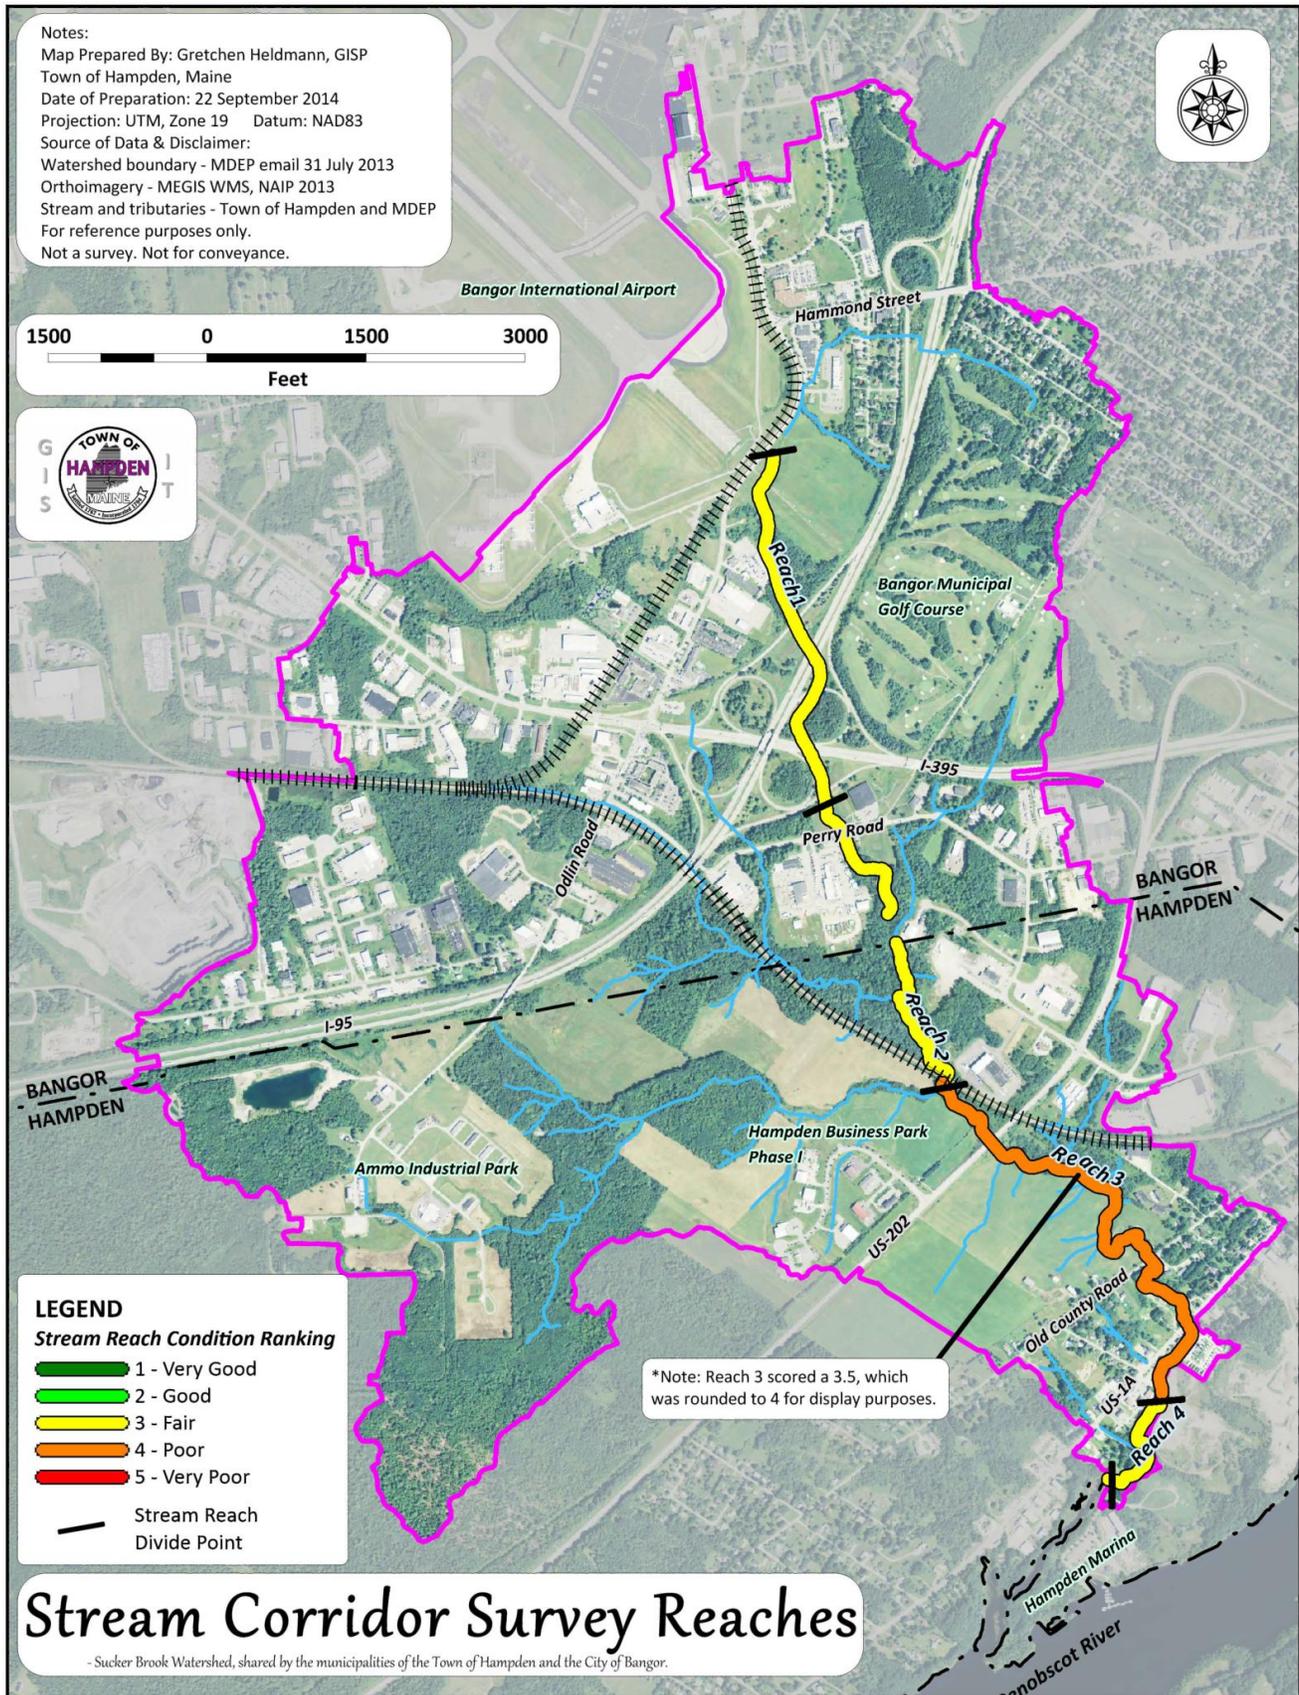
Figure 4. Stream conditions map.

Upon review of the findings from this screening-level survey of representative reaches of Sucker Brook, this water resource appears to be in Fair condition (Table 3). An overall score was assigned to each of the full reaches (1, 2, 3, 4) by averaging the scores for all subreaches within a given reach (Figure 4).

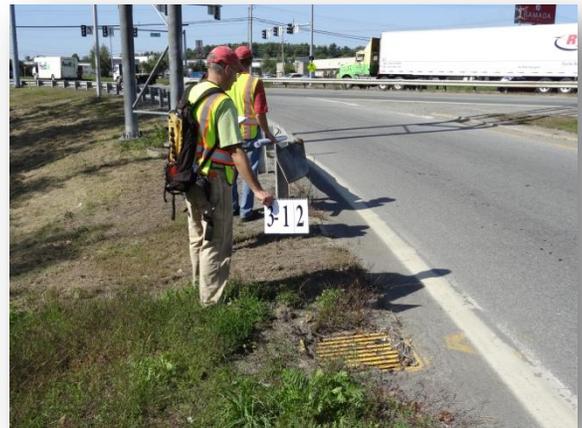
*Numerous catch basins in Sector 3 collect road runoff and redirect stormwater directly to Sucker Brook.*

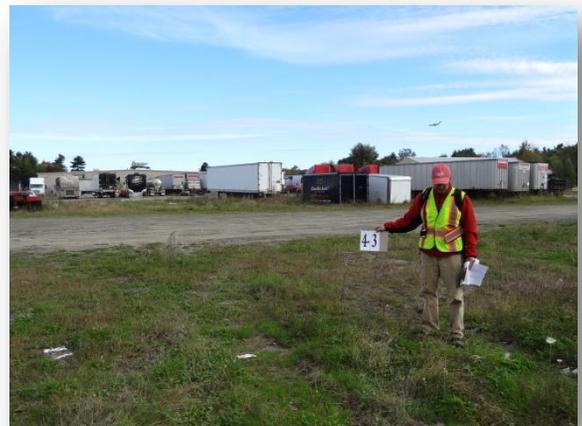
*Runoff resulting from compacted grass and gravel in Sector 4.*

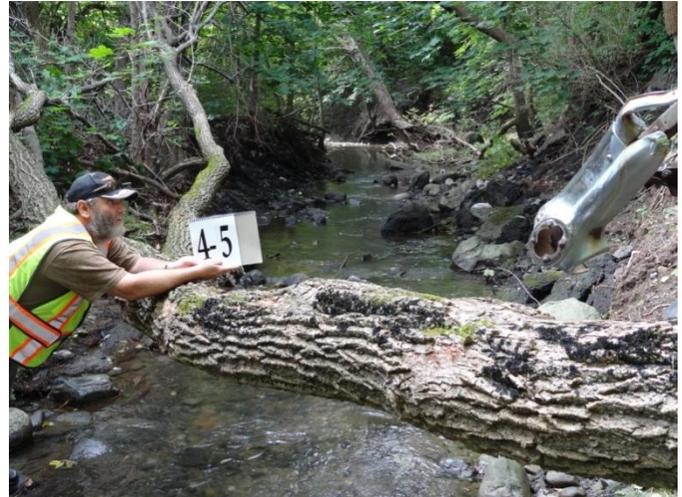
Steep, eroding banks within Reach 4 resulting in a fallen tree.

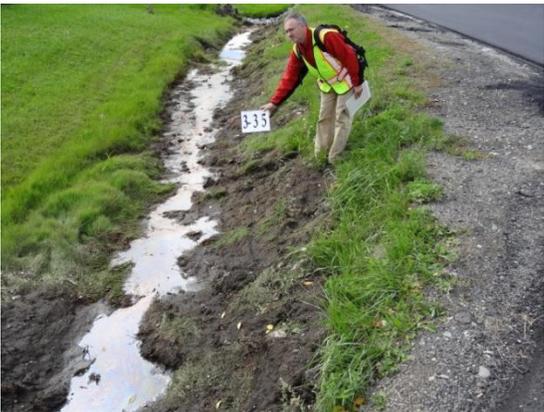
Eroding ditch along Odlin Road in Sector 3.

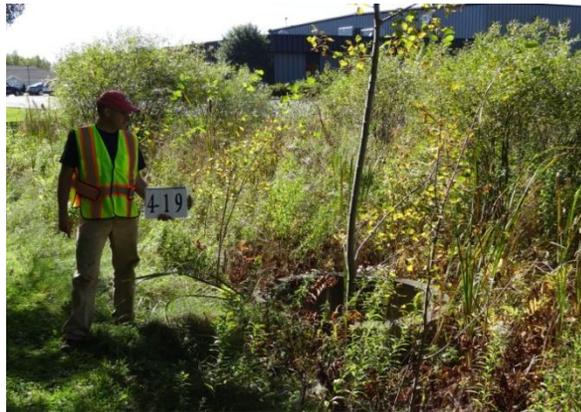
Slow moving area and overgrown well in Sector 4.

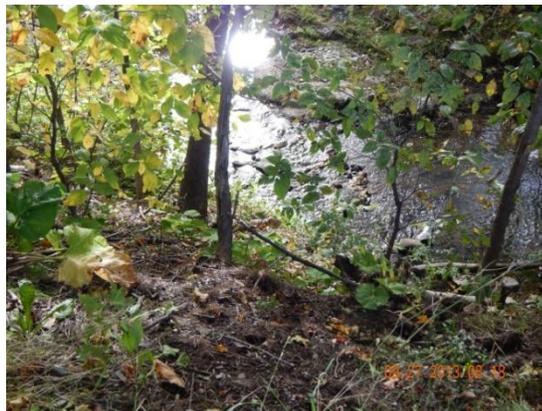
Steep bank above Sucker Brook in Sector 6.

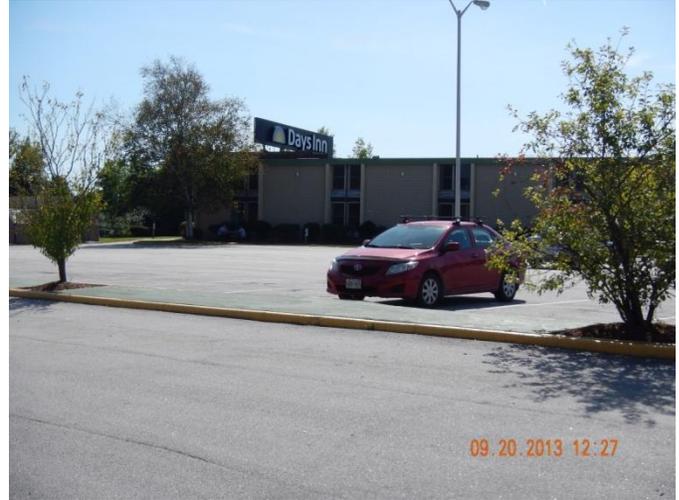
**Site 1-12.** Days Inn and Ground Round. Potential Pollutants: Hydrocarbons from idling vehicles and parked cars and trucks. Recommendations: Rain garden, detention pond.

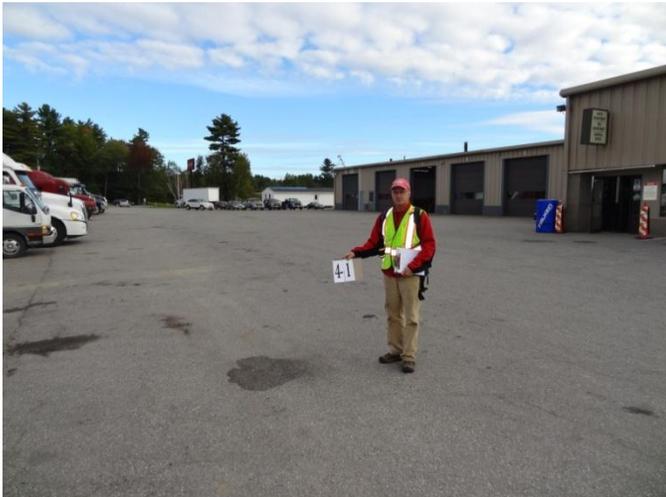
**Site 4-1.** Freightliner. Potential Pollutants: Hydrocarbons from parking lot. Recommendations: Hydrocarbon filter, stabilize vegetation.

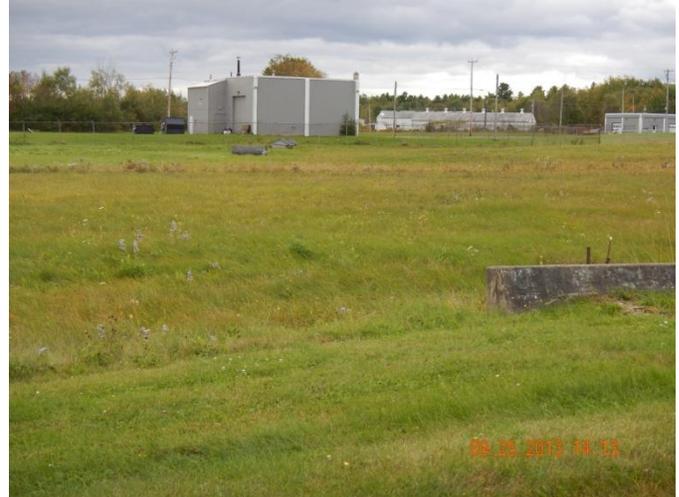
**Site 5-3.** Ammo Park and Associated Businesses. Potential Pollutants: Sediments, oils and metals from auto body shop, grass swale at BSP chlorotic. Recommendations: Stormwater controls when sites are developed.
