Broadway Corridor Study

Bangor, Maine

Existing Transportation Conditions Technical Memorandum

Prepared by:
TYLININTERNATIONAL

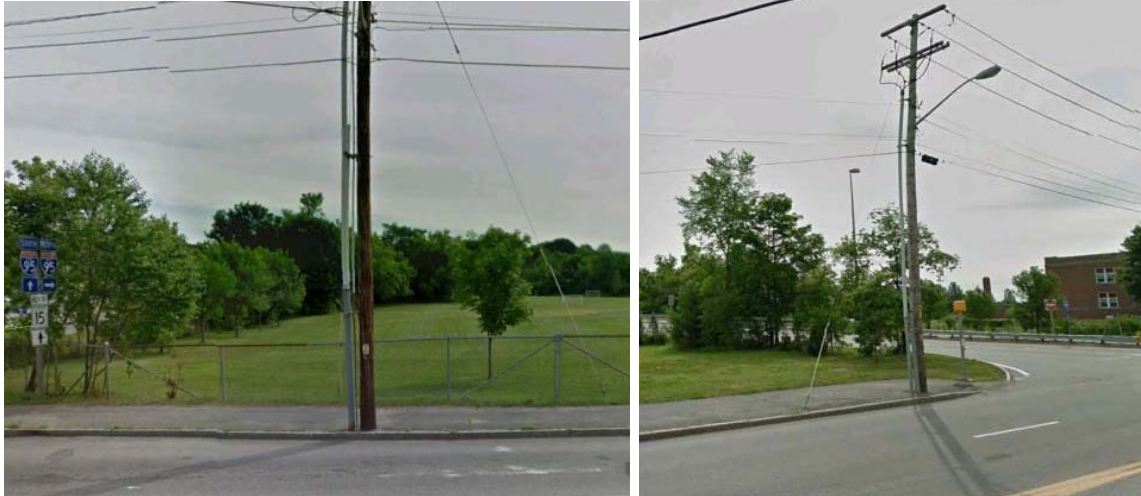
- **I-95 Northbound Intersection:** Sidewalks are found on all approaches to the intersection with the exception of the I-95 ramps. Sidewalks are bituminous concrete and are 5 feet in width. Obstructions such as utility poles are commonly found in the sidewalks. Connections to crosswalks (discussed further in the next section) do not meet ADA compliance and end with no connection to the north of the I-95 ramps.

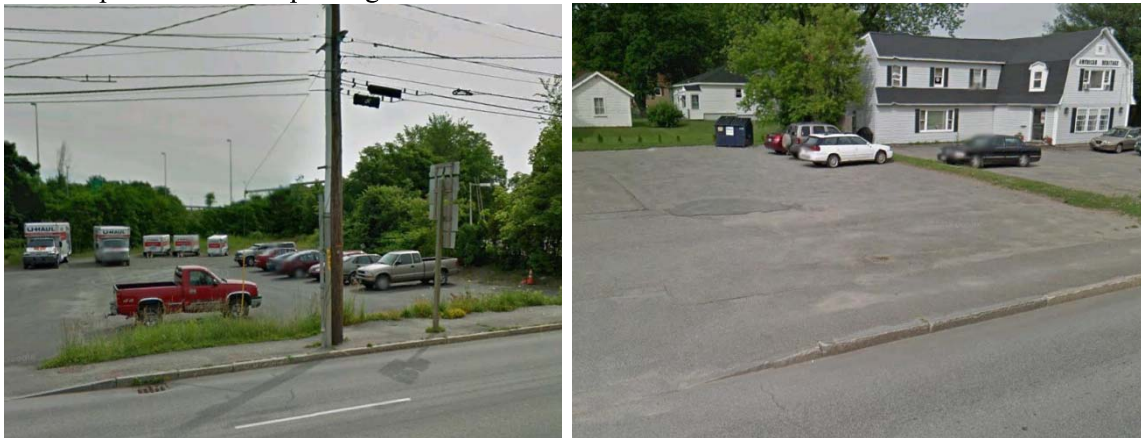
- **Earle Avenue Intersection:** Sidewalks pick up at the approach from Earle Avenue to the intersection and line both sides of Broadway. The sidewalk in front of Tri City Pizza turns into the parking lot/roadway and the sidewalk in front of the redemption center is at the same level at the roadway offering pedestrians no separation from vehicles.
- **From Earle Avenue to I-95 NB:** Sidewalks line both sides of Broadway along this stretch. They ramp down for drive through the corridor but suffer from obstructions in the sidewalk. Sidewalks have no protection from parking lots.

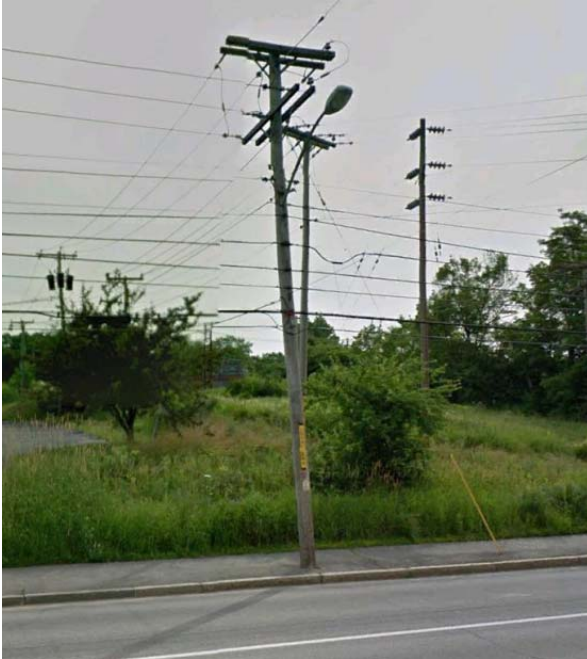
- **Falvey Street Intersection:** Sidewalks are on all approaches to the intersection. On Falvey Street, sidewalks line the residential street separated by esplanades that open into Broadway. There are sidewalks on both sides of Broadway. Ramps open to the two crosswalks that cross Broadway and Falvey Streets from the west but on the east, the sidewalk receives the Broadway crosswalks at the entrance to the Chinese restaurant. Ramps do not contain detectable warning tiles or updated pedestrian heads. Utility poles and signs continue to impede sidewalks.

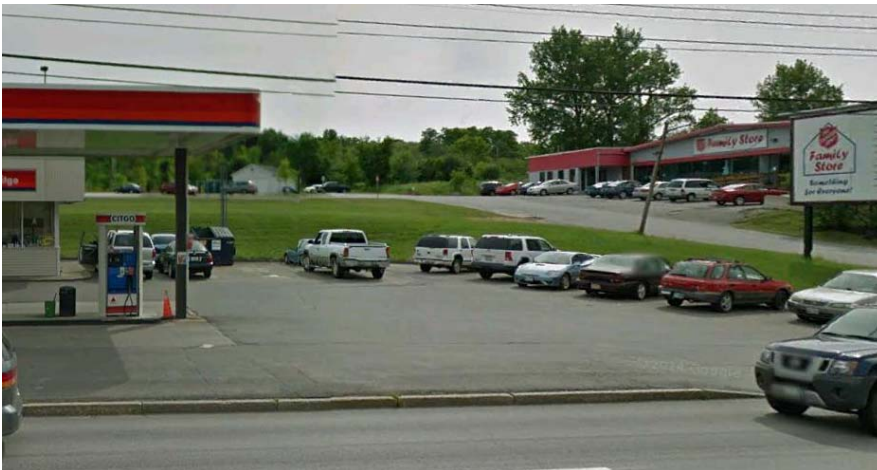
- **Between Falvey Street and the Shopping Center:** Sidewalks line Broadway and continue to be impeded by utility poles. Sidewalks are the same level as parking lots in some locations such as the picture below at the Citgo.

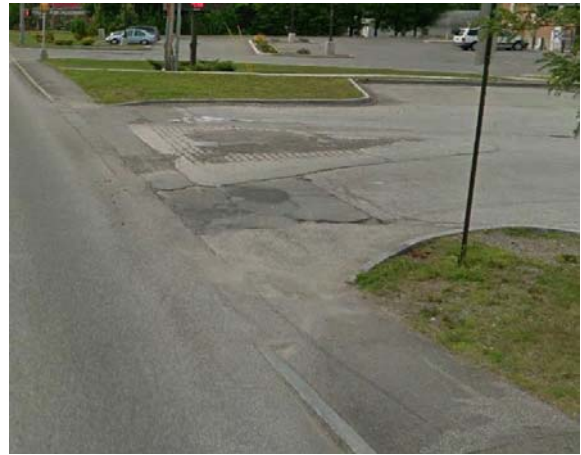
- **From School Street/Walgreens to Husson Avenue:** Sidewalks line Broadway and continue to be impeded by utility poles. Sidewalks crossing major drives with islands did not have pedestrian refuge.

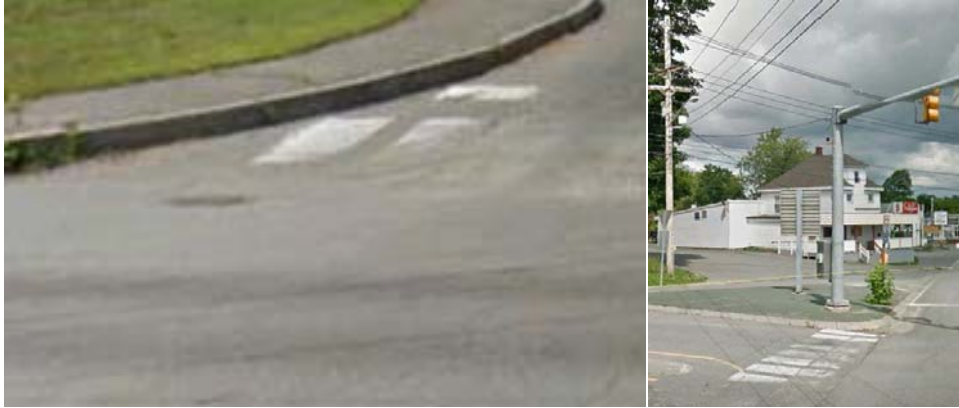
- **Broadway/Center Street/I-95 NB:** Block style crosswalk crosses the southerly side of Broadway and I-95 Northbound and Center Streets. There is no crosswalk across the Broadway southbound approach or from the raised island on Center Street to sidewalks north of the intersection. There are also no detectable warning panels and many connections with the sidewalks lack ramps and curb cuts. There is no connection from the island across Center Street to the existing sidewalk. Existing pedestrian signals are not countdown heads.

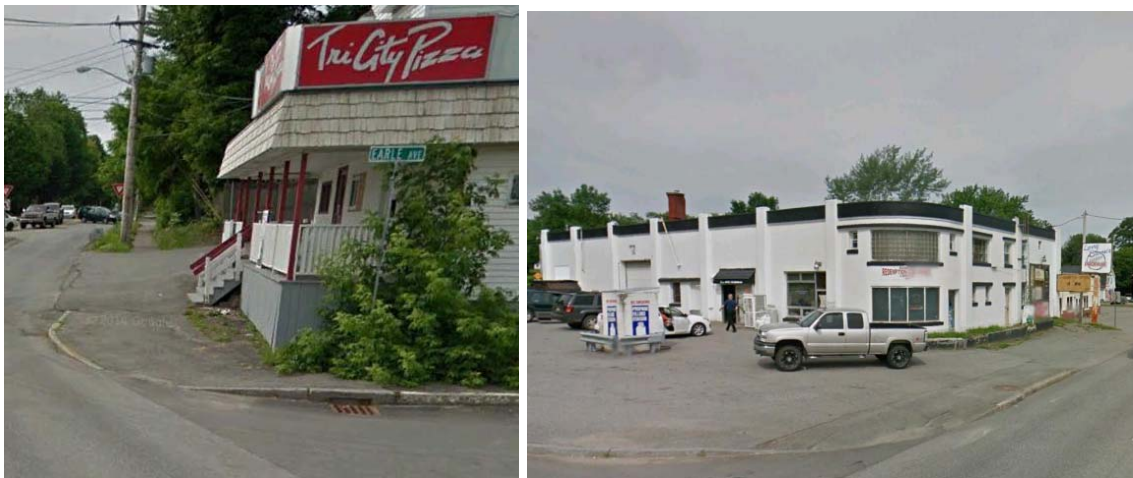
- **Broadway/Earle Avenue:** There is a block style crosswalk across Earle Avenue at this stop-controlled intersection. Ramps direct users into the intersection with Broadway rather than across Earle Avenue as shown in the picture below.

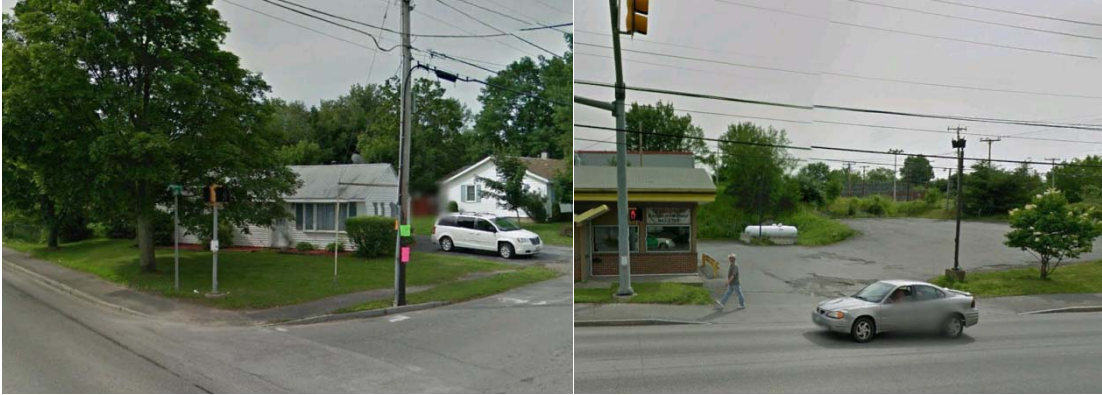
- **Broadway/I-95 SB/Alden Street:** There are block style crosswalks across I-95 SB separated by a small island. There are also block crosswalks across Alden Street and the I-95 SB On Ramp. Facilities have been updated however the push buttons for the I-95 SB Off Ramp and Alden Street were not working at the time of site evaluation.
- **Broadway/Falvey Street:** There are block style crosswalks across the southerly end of Broadway and across Falvey Street. The Broadway crosswalk is diagonal across the intersection increasing the amount of time needed for a pedestrian to cross the intersection. There are no detectable warning tiles present. Existing pedestrian signals are not countdown heads.

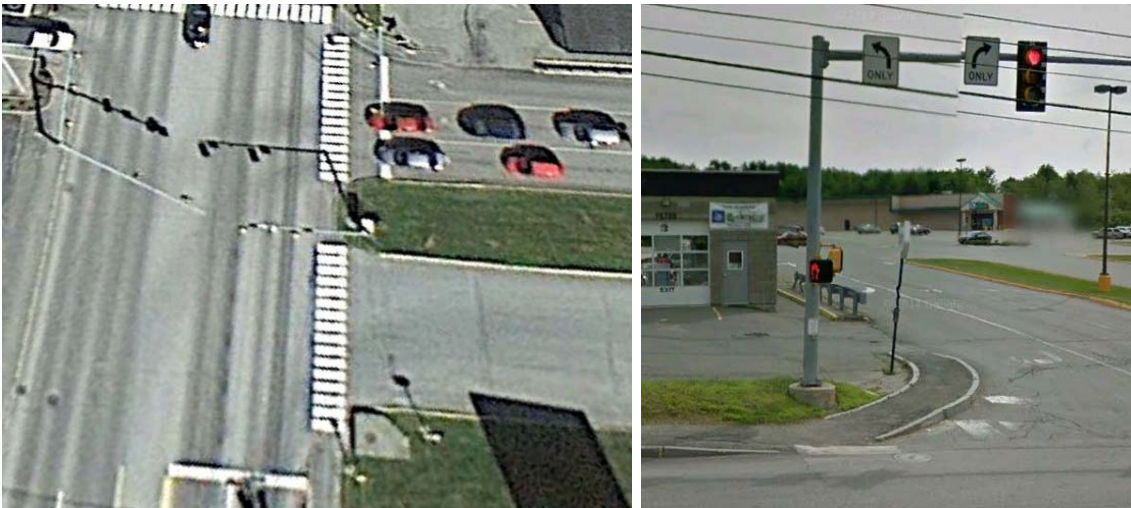
- **Broadway/Shopping Center Entrance/McDonald's Exit:** There are block style crosswalks across the shopping center and the northerly side of Broadway. The crosswalk breaks at the shopping center but does not have a pedestrian refuge or full 5 foot sidewalk at the island location. Ramps, particularly at the intersection are awkward and do not have updated countdown pedestrian heads or detectable warning tiles.

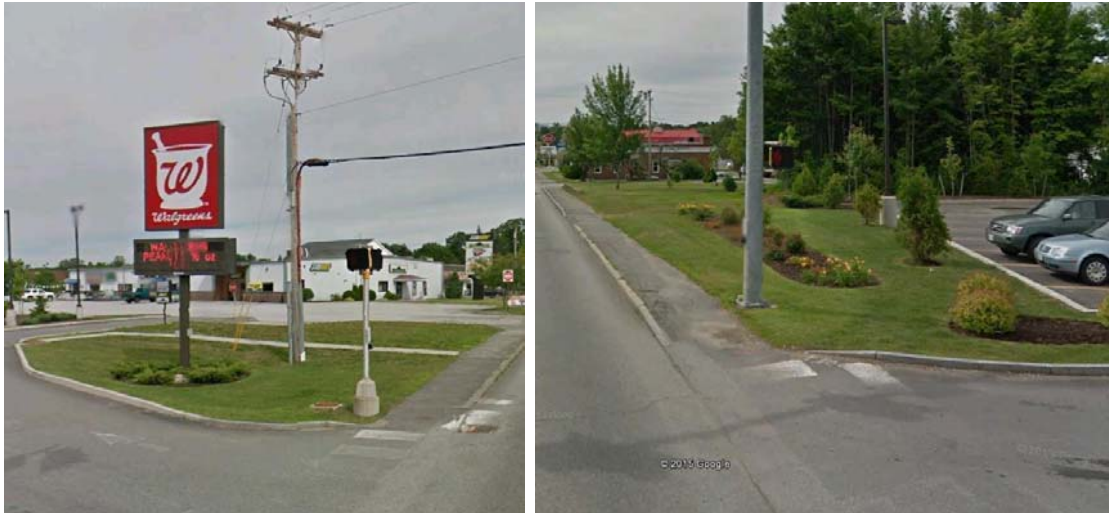
- **Broadway/ School Street/Walgreens:** There are block crosswalks across School Street, Walgreens, and the northerly side of Broadway. There are no detectable warning tiles at this crossing and pedestrian signals are not countdown type.

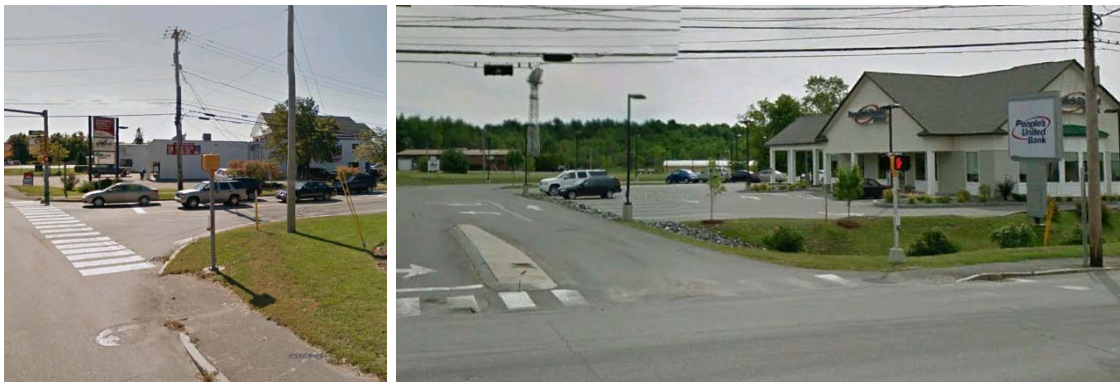
- **Broadway/Husson Avenue:** There are block style crosswalks across the Husson Avenue, the entrance to the bank, and across the southern side of Broadway. There are no detectable warning tiles at this location.

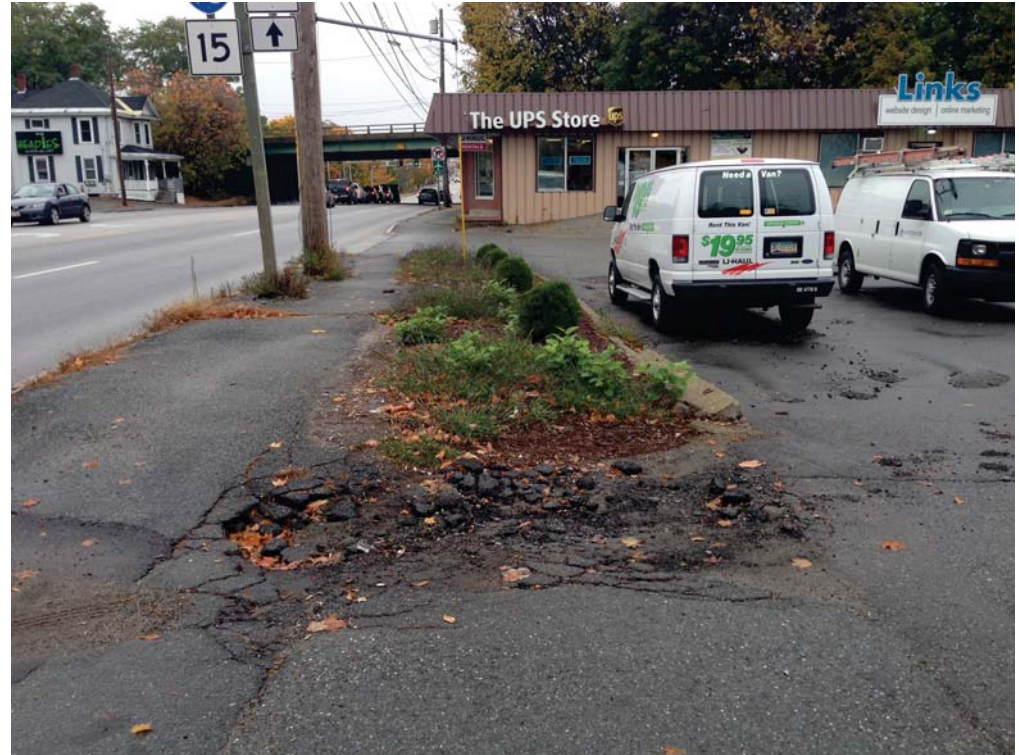
Figure: Poor Entrance

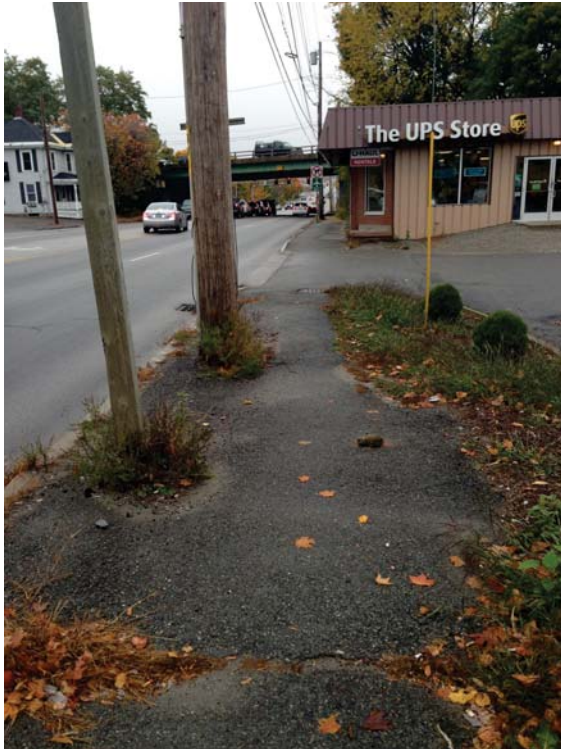
Figure: Narrowed Crosswalk

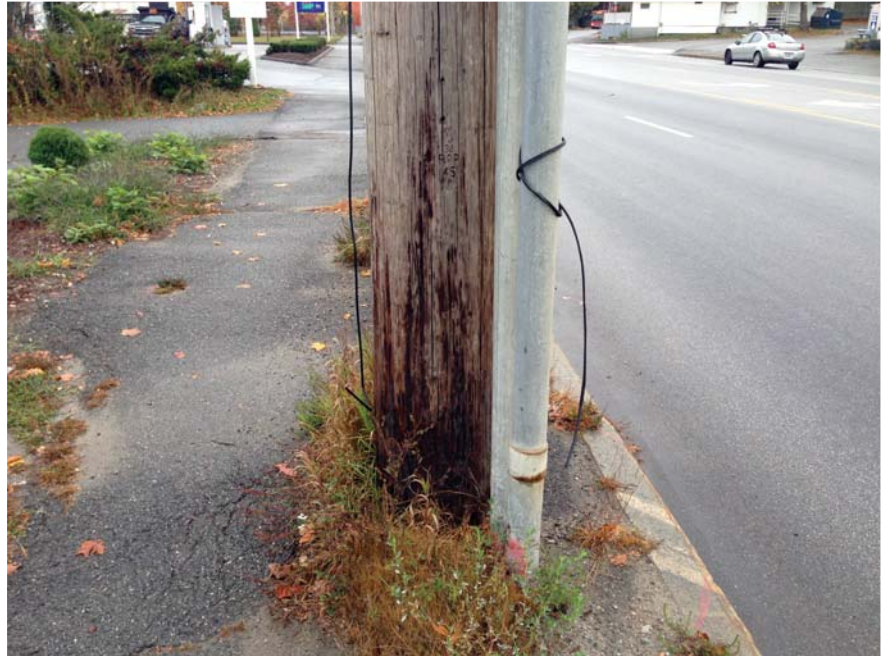
Figure: Loose Wires

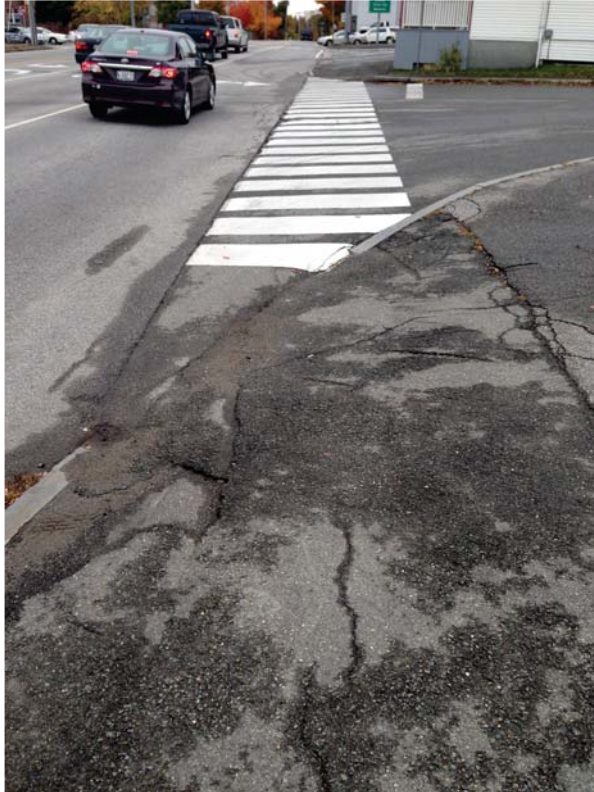
Figure: Poor Crosswalk Alignment

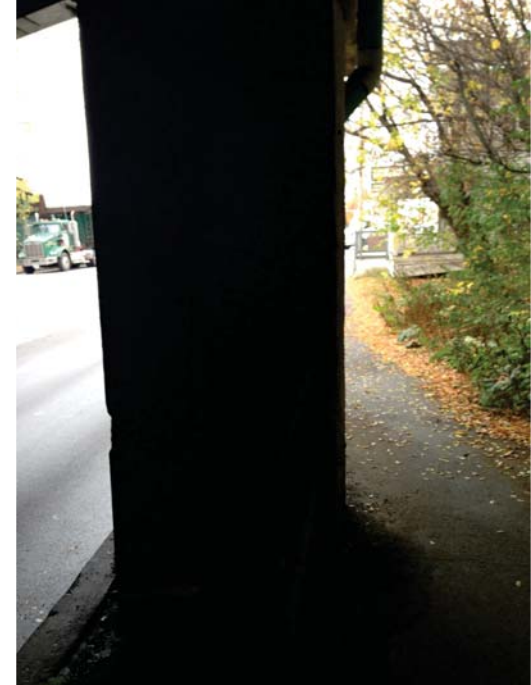
Figure: No Lighting

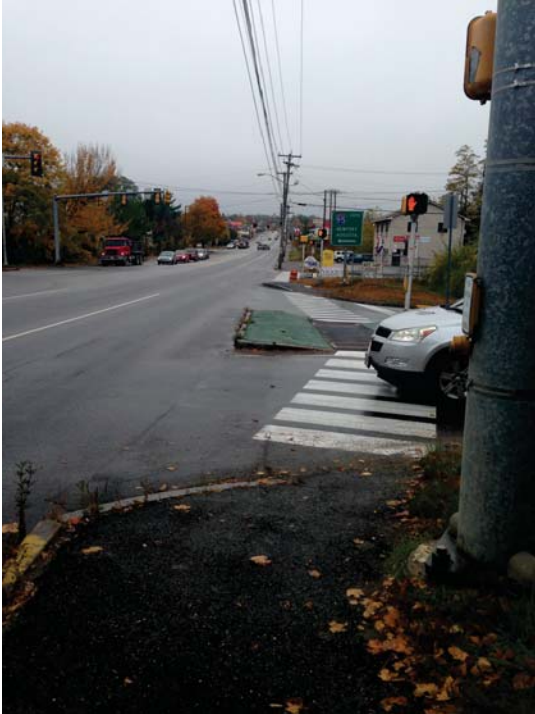
Figure: Some updates;
Lights not cycling properly

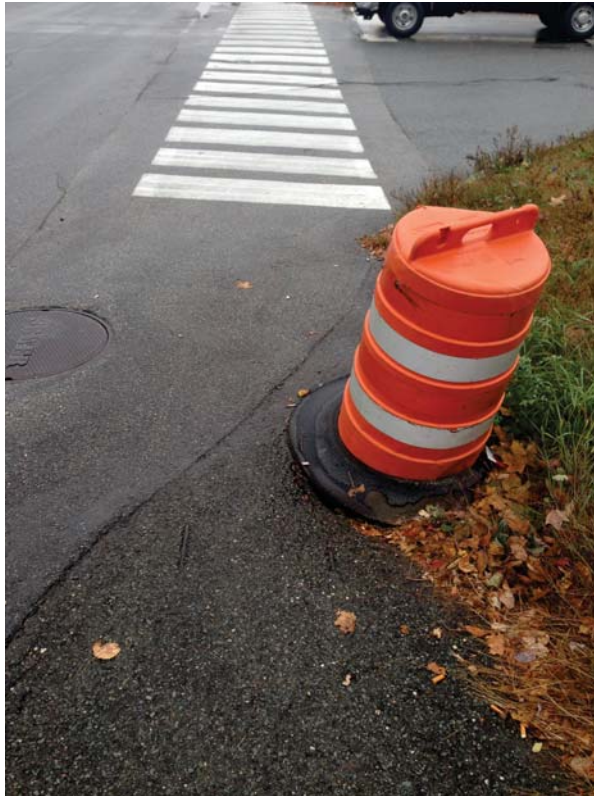
Figure: Pothole

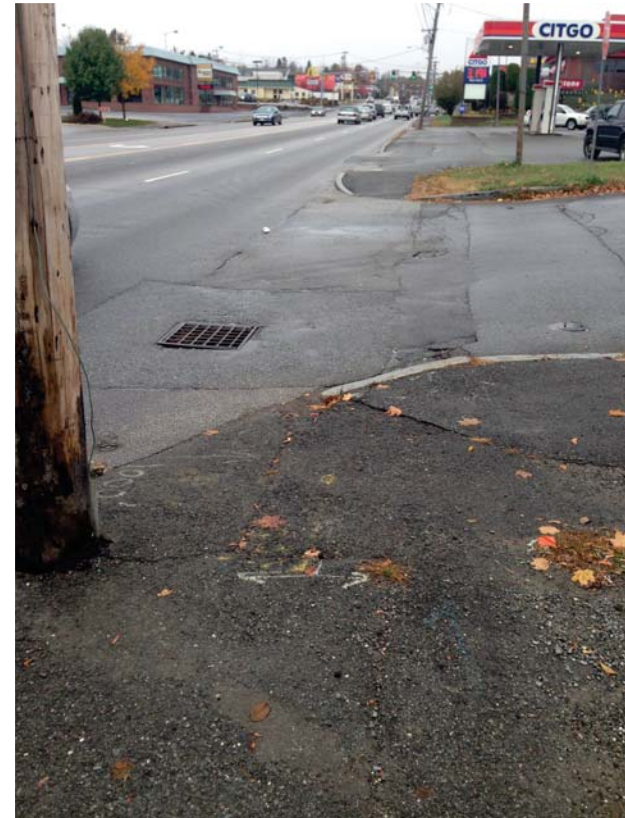
Figure: Poor curb cut, obstruction, restriping needed

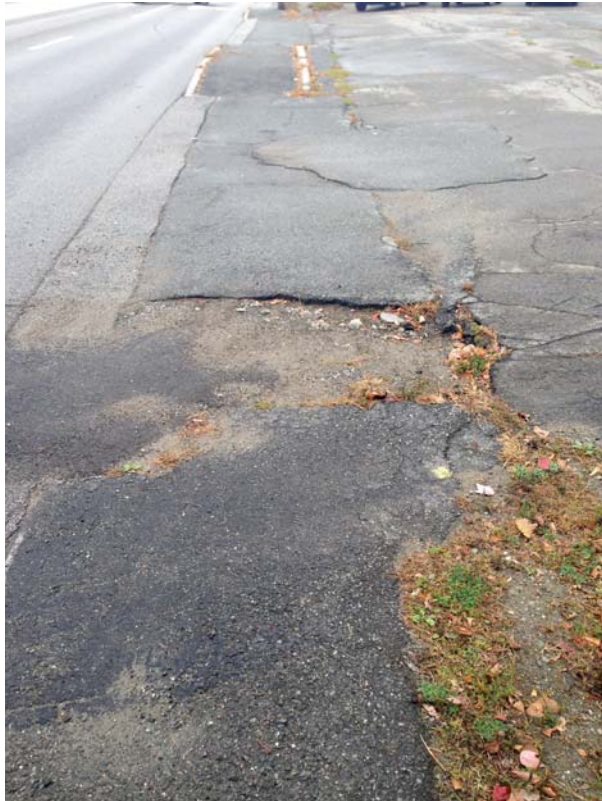
Figure: Concrete disrepair

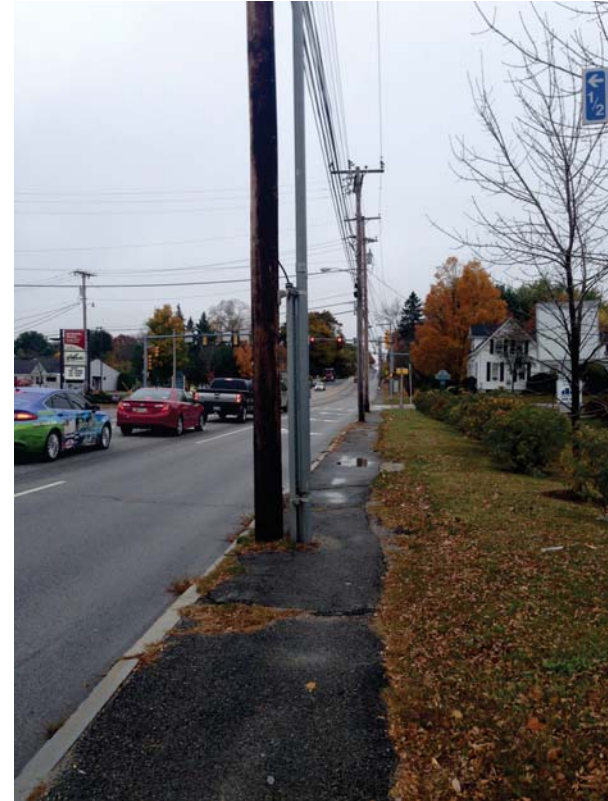
Figure: Sidewalk Obstructions

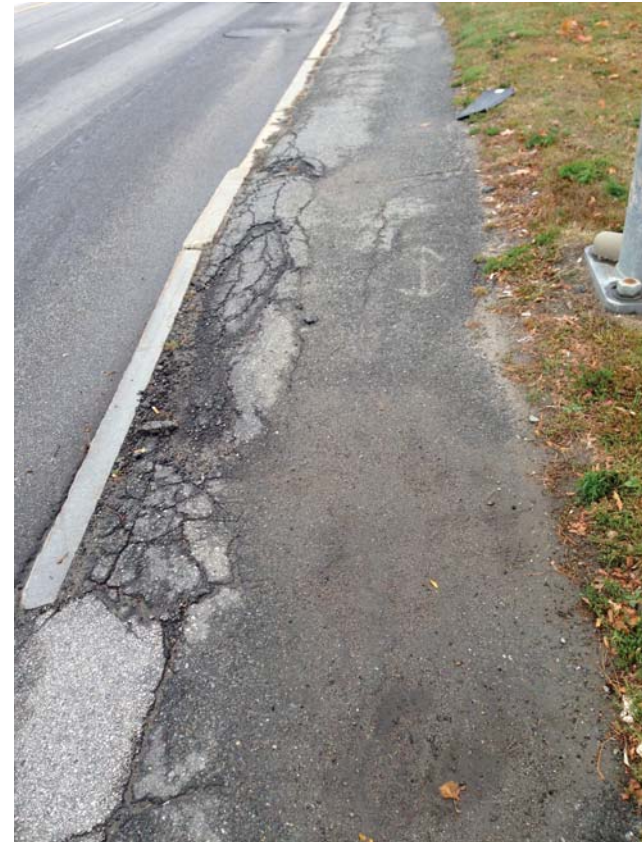
Figure: Poor sidewalk condition

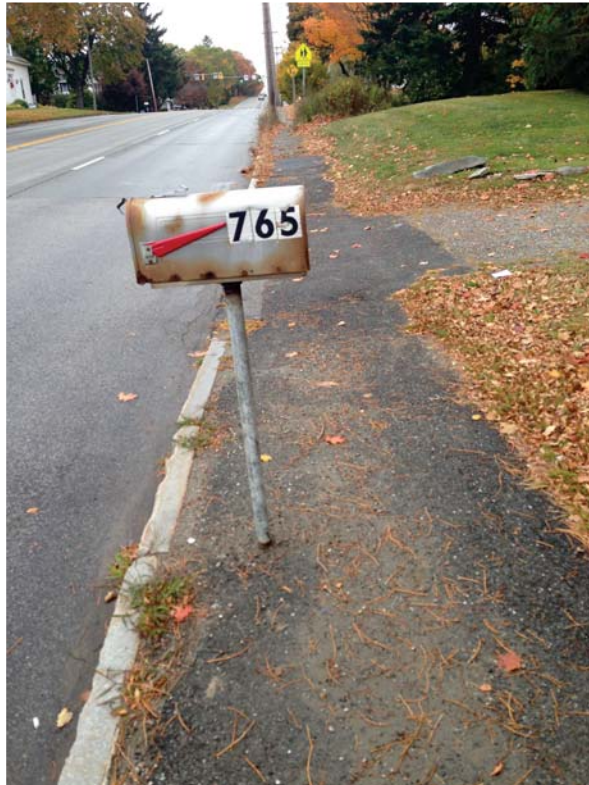
Figure: Sidewalk Obstruction

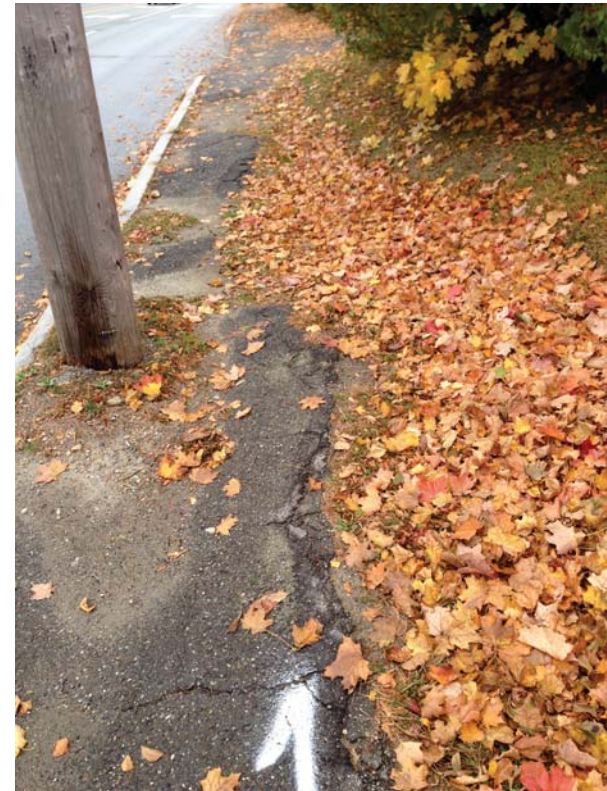
Figure: Sidewalk Obstruction
