Birch Stream Watershed Management Plan

Stakeholders' Presentation

October 29, 2009

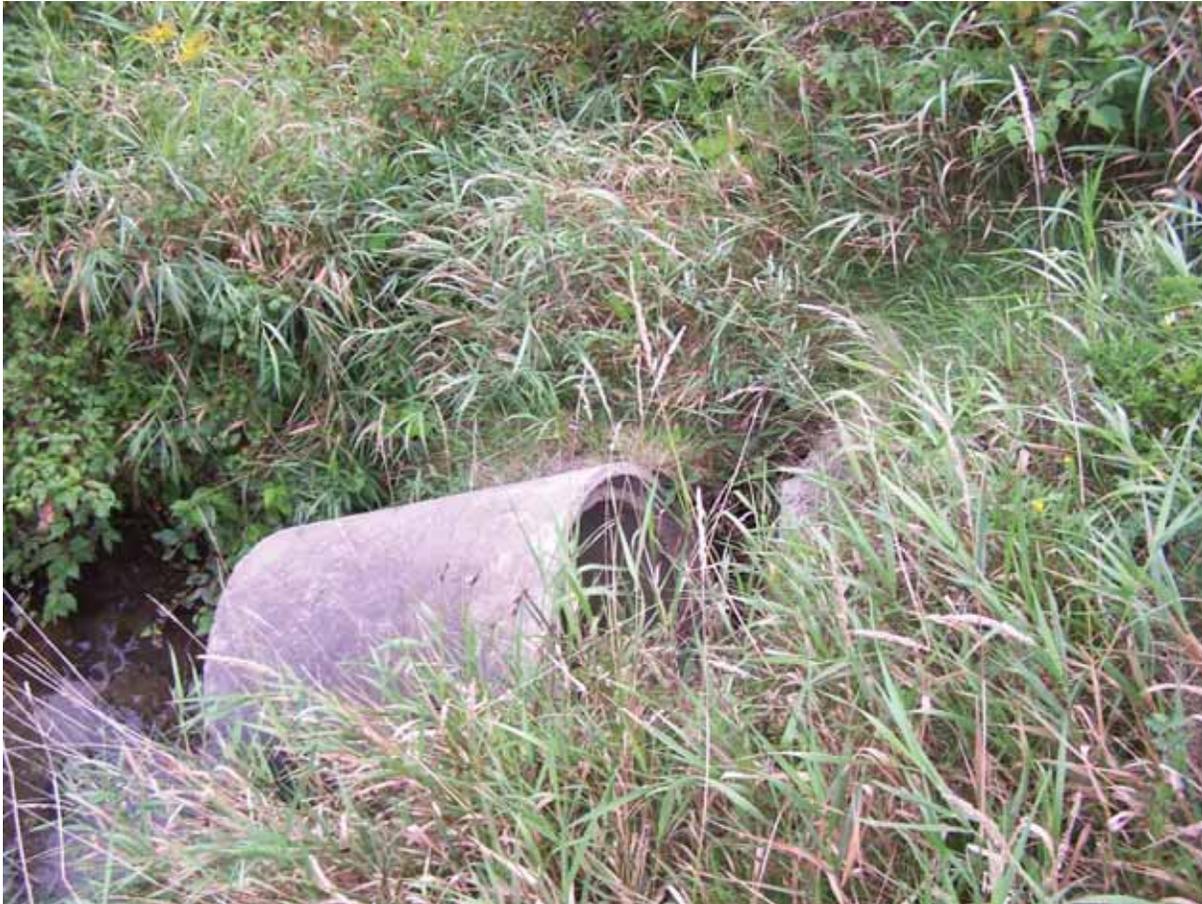
Broken Storm Drain and Undermining, Enters stream at right angle

- **Repair Storm Drain Outlet at Ohio Street Culvert – reduce angle to be in line with stream channel**
- **Repair undercutting to Box culvert**
- **Remove Trash and Channel Debris**
- **Harden Erodible Banks downstream of Ohio Street (Gabion baskets, rip rap)**
- **Realign Channel if necessary**

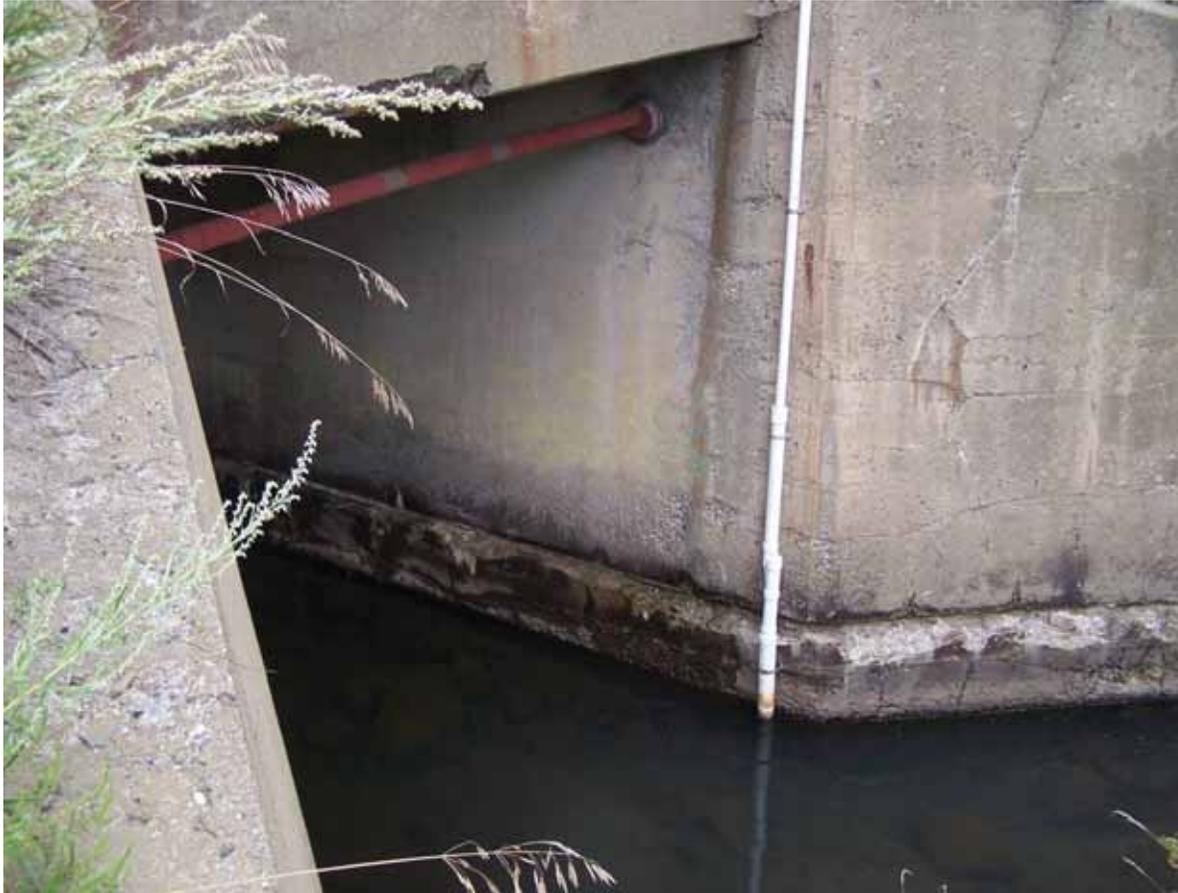
Undermining of Box Culvert from storm pipe at right angle

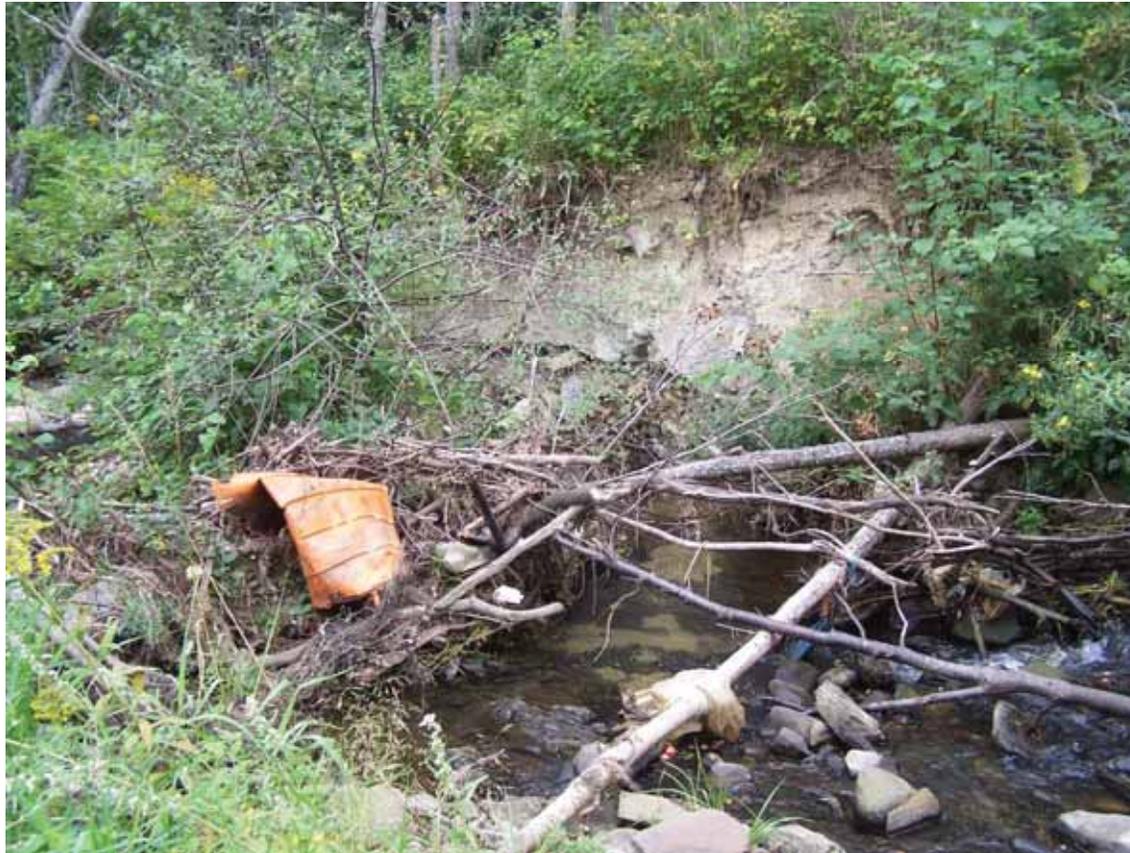
Debris Dams, Trash and Bank Erosion

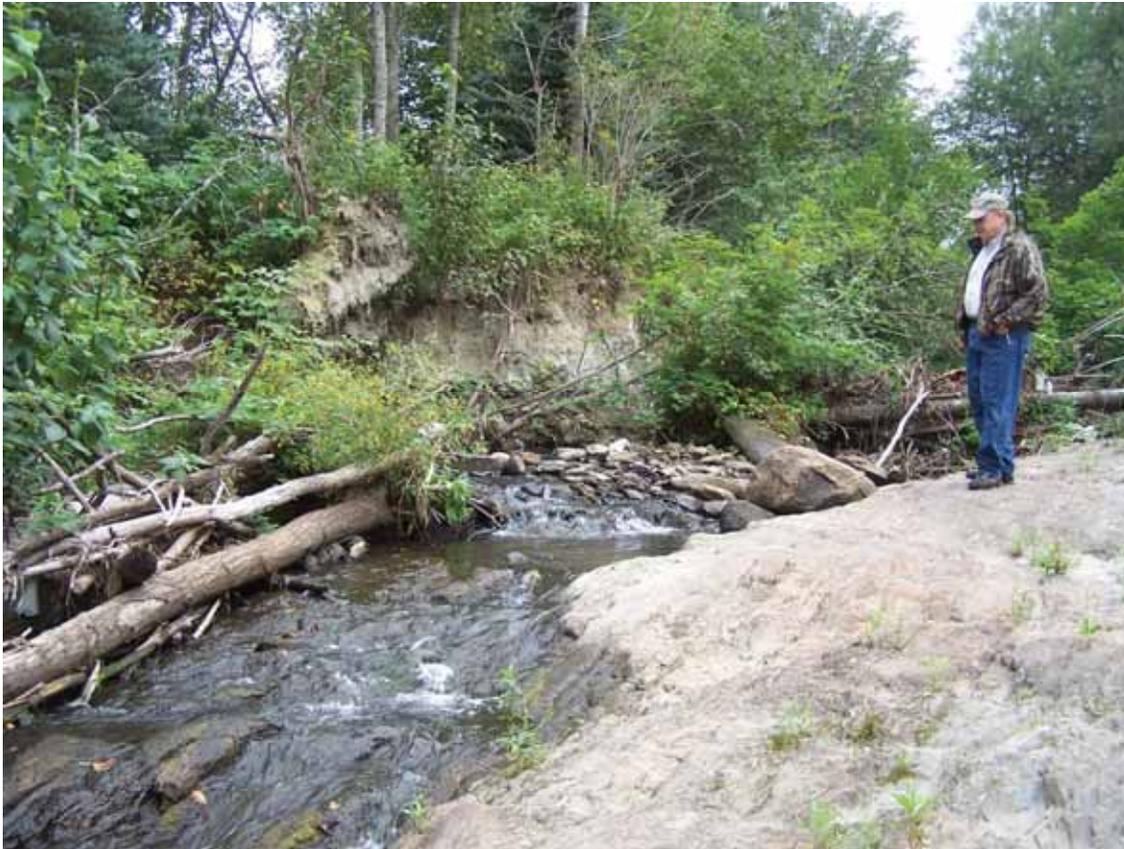
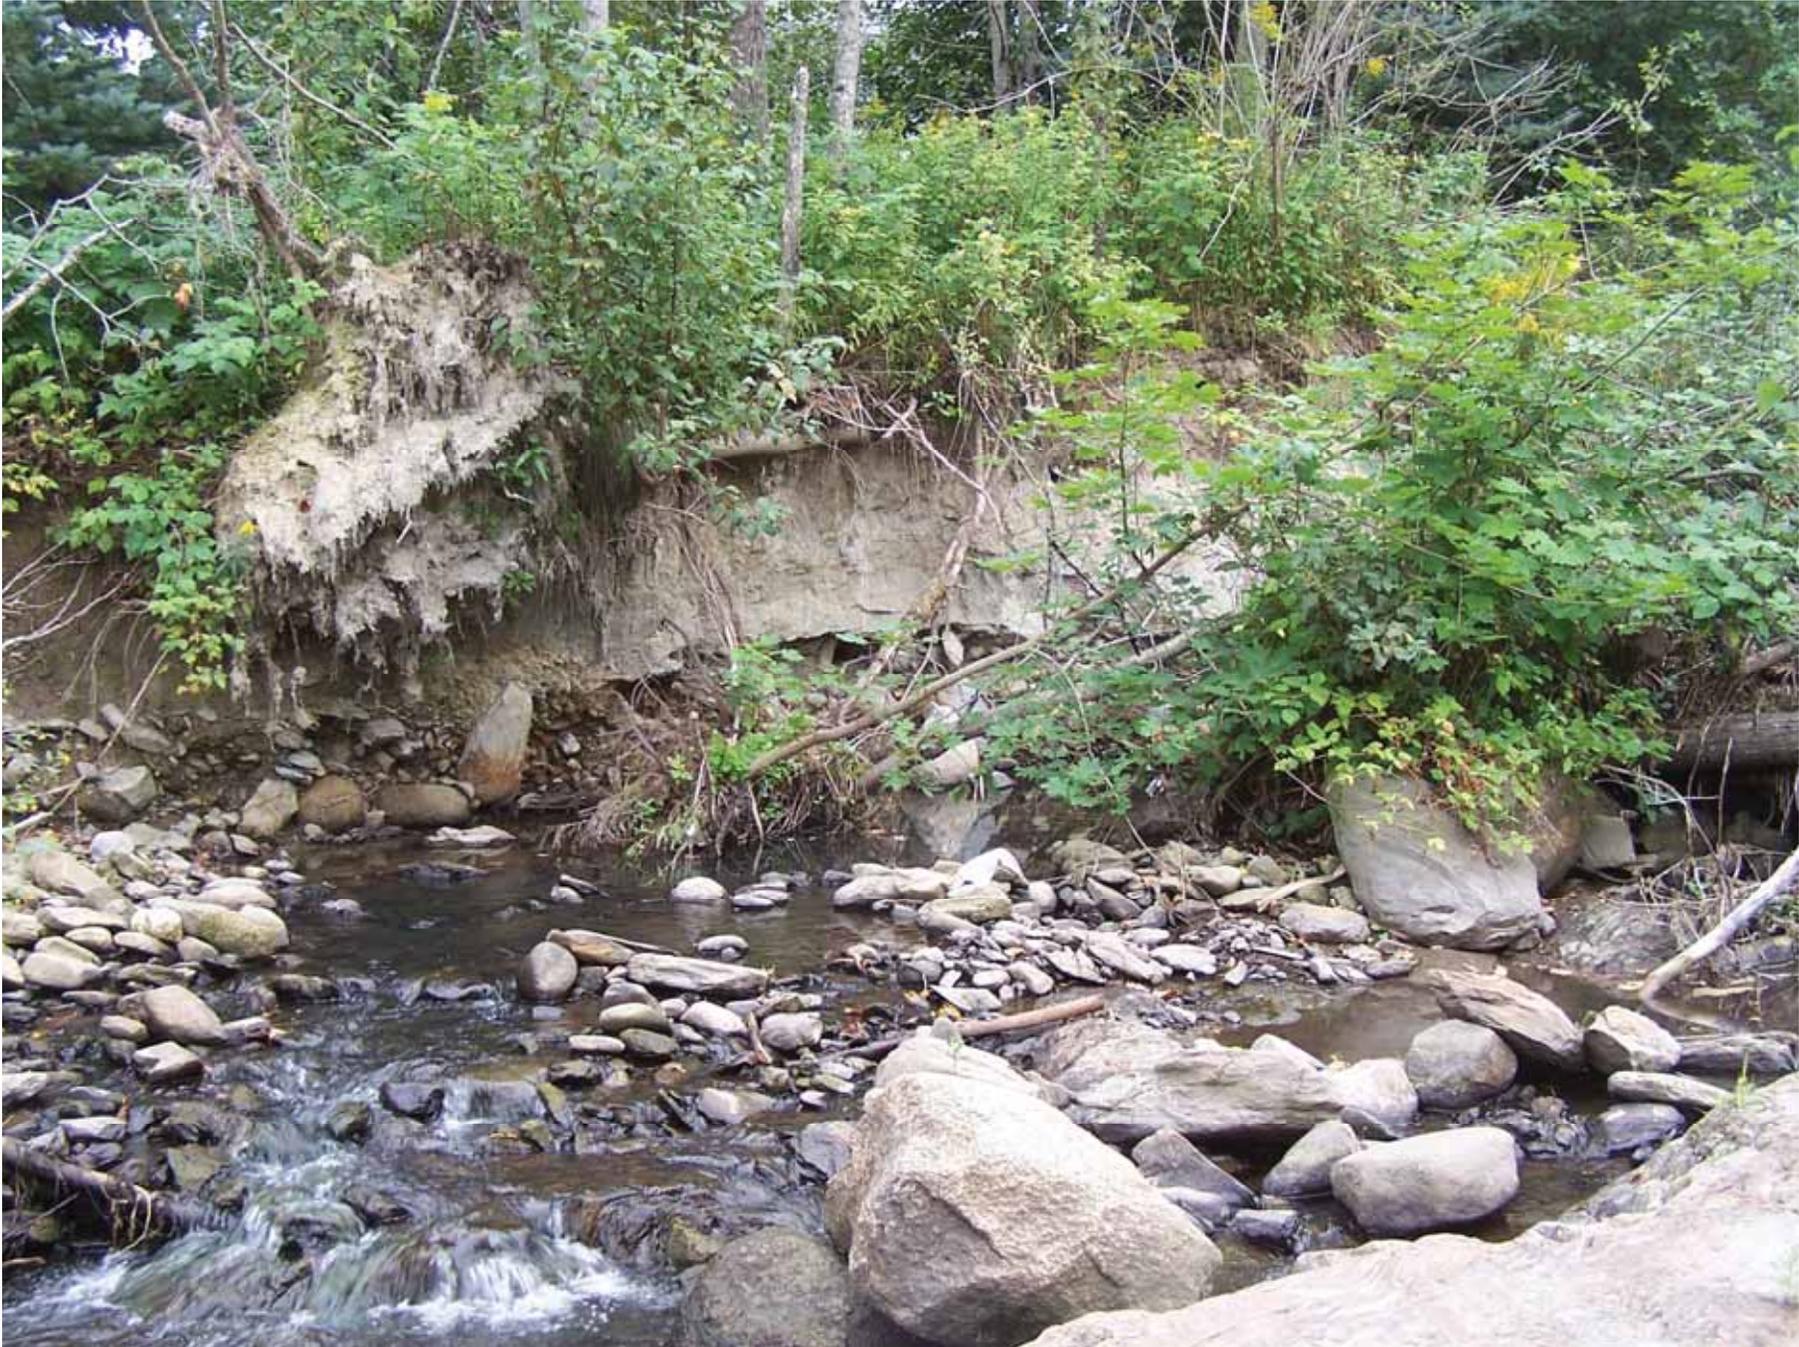
Severe Bank Erosion and Tree fall

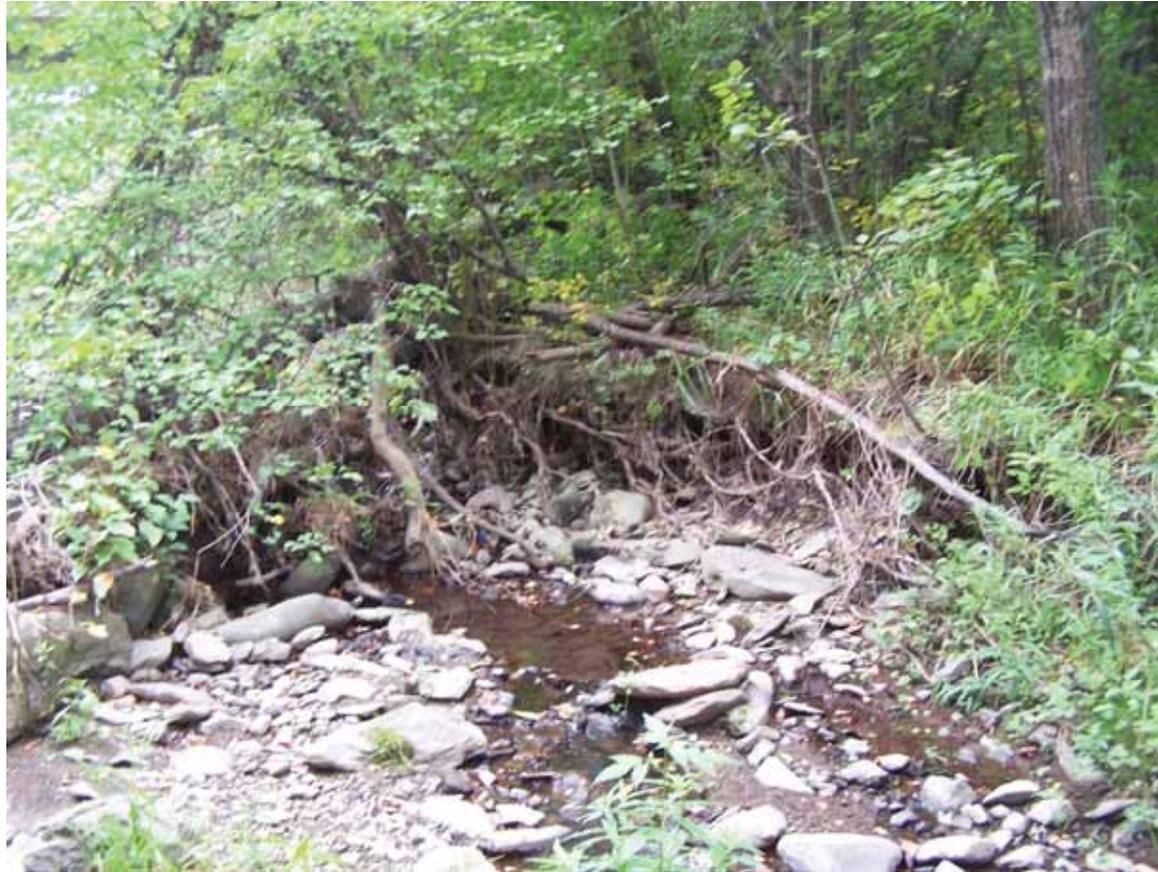
Channel Scour and Bank Erosion

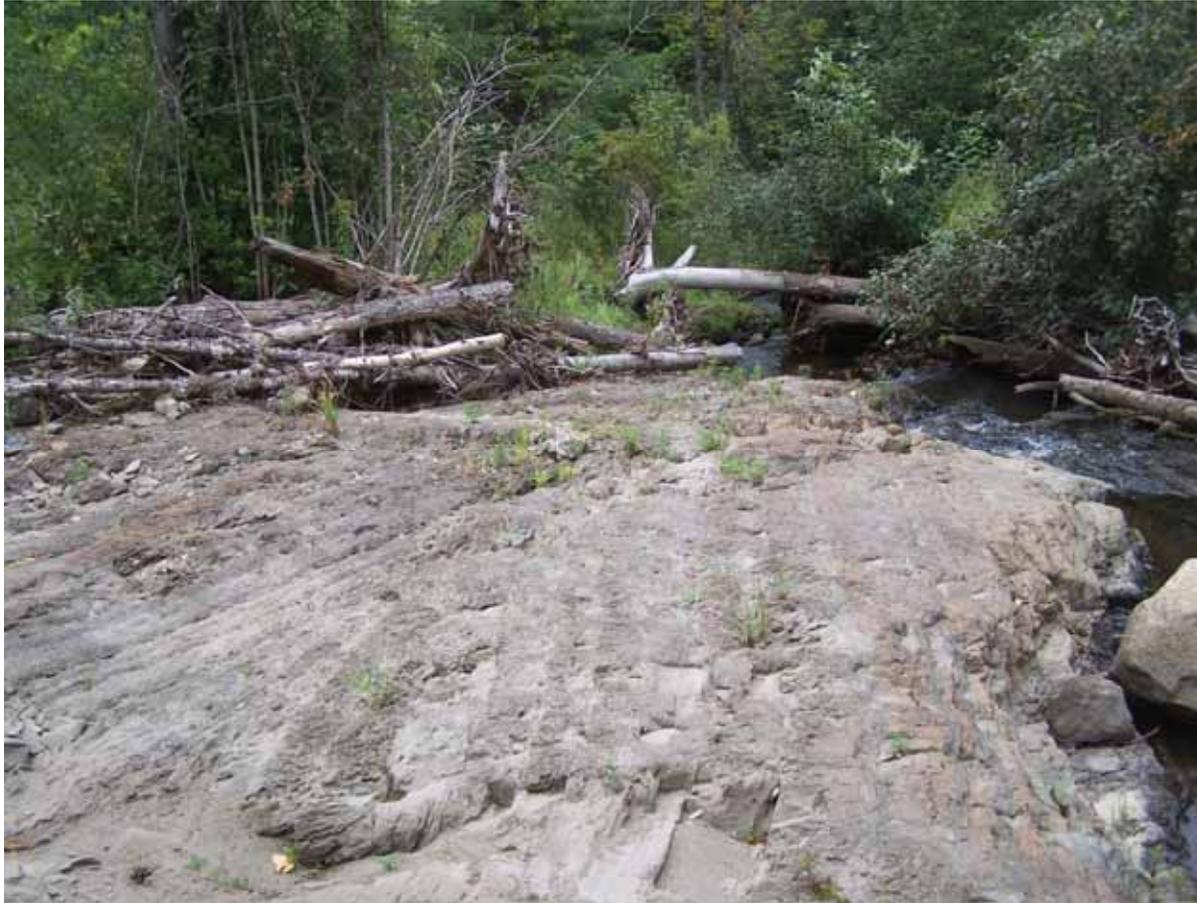
Downed Tree Debris and Ledge Deflection into Erodible Bank
