PENJAJAWOC STREAM ANALYSIS AND INTERPRETATION REPORT
ADDENDUM I

PENJAJAWOC STREAM – PRIORITIZED AREAS FOR RESTORATION

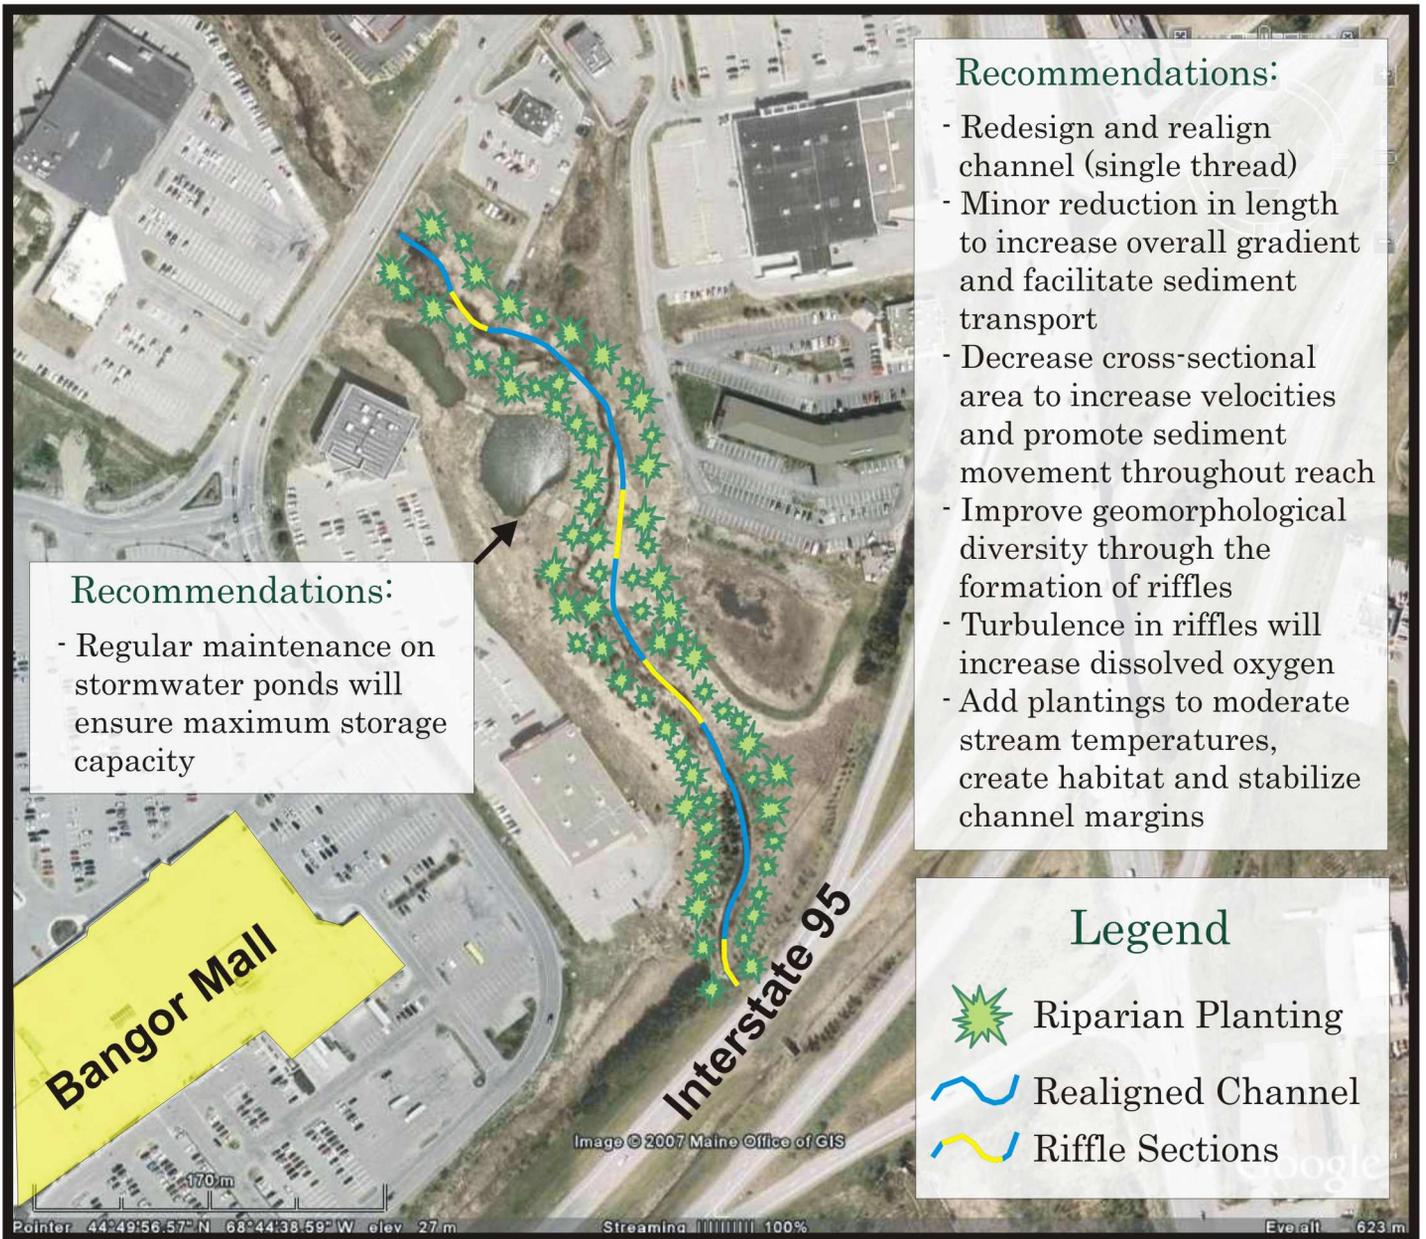
Figure 1

Restoration Site	Priority Level	Summary of Existing Concerns	Recommended Treatment
Mall Reach (Figure 1)	1	<ul style="list-style-type: none"> - A backwater effect dominates the reach, creating channel dimensions that are overly wide and a low gradient - Aggradation dominates the reach - Sedimentation of fines, low gradient and lack of coarse substrate have contributed to an overall lack of geomorphic diversity and aquatic habitat - Vegetated channel further slows flow and exacerbates deposition of fine materials - Lack of riparian cover and overwide dimensions contribute to warm water temperatures which can impact water quality and aquatic habitat - High organic content and warm water temperatures during the summer months may lead to anoxic conditions along the channel margins 	<ul style="list-style-type: none"> - Need to determine cause of backwater effect (likely culvert associated with Interstate 95) - Redesign and realign channel (single-thread) - Minor reduction in length to increase overall gradient and facilitate sediment transport - Decrease cross-sectional area to increase velocities and promote sediment movement throughout reach - Improve geomorphological diversity through the formation of riffles - Turbulence in riffles will increase dissolved oxygen - Add plantings to moderate stream temperatures, create habitat and stabilize channel margins - Regular maintenance on storm water management ponds will ensure maximum storage capacity for the system - Investigate storm water Best Management Practices (BMPs)

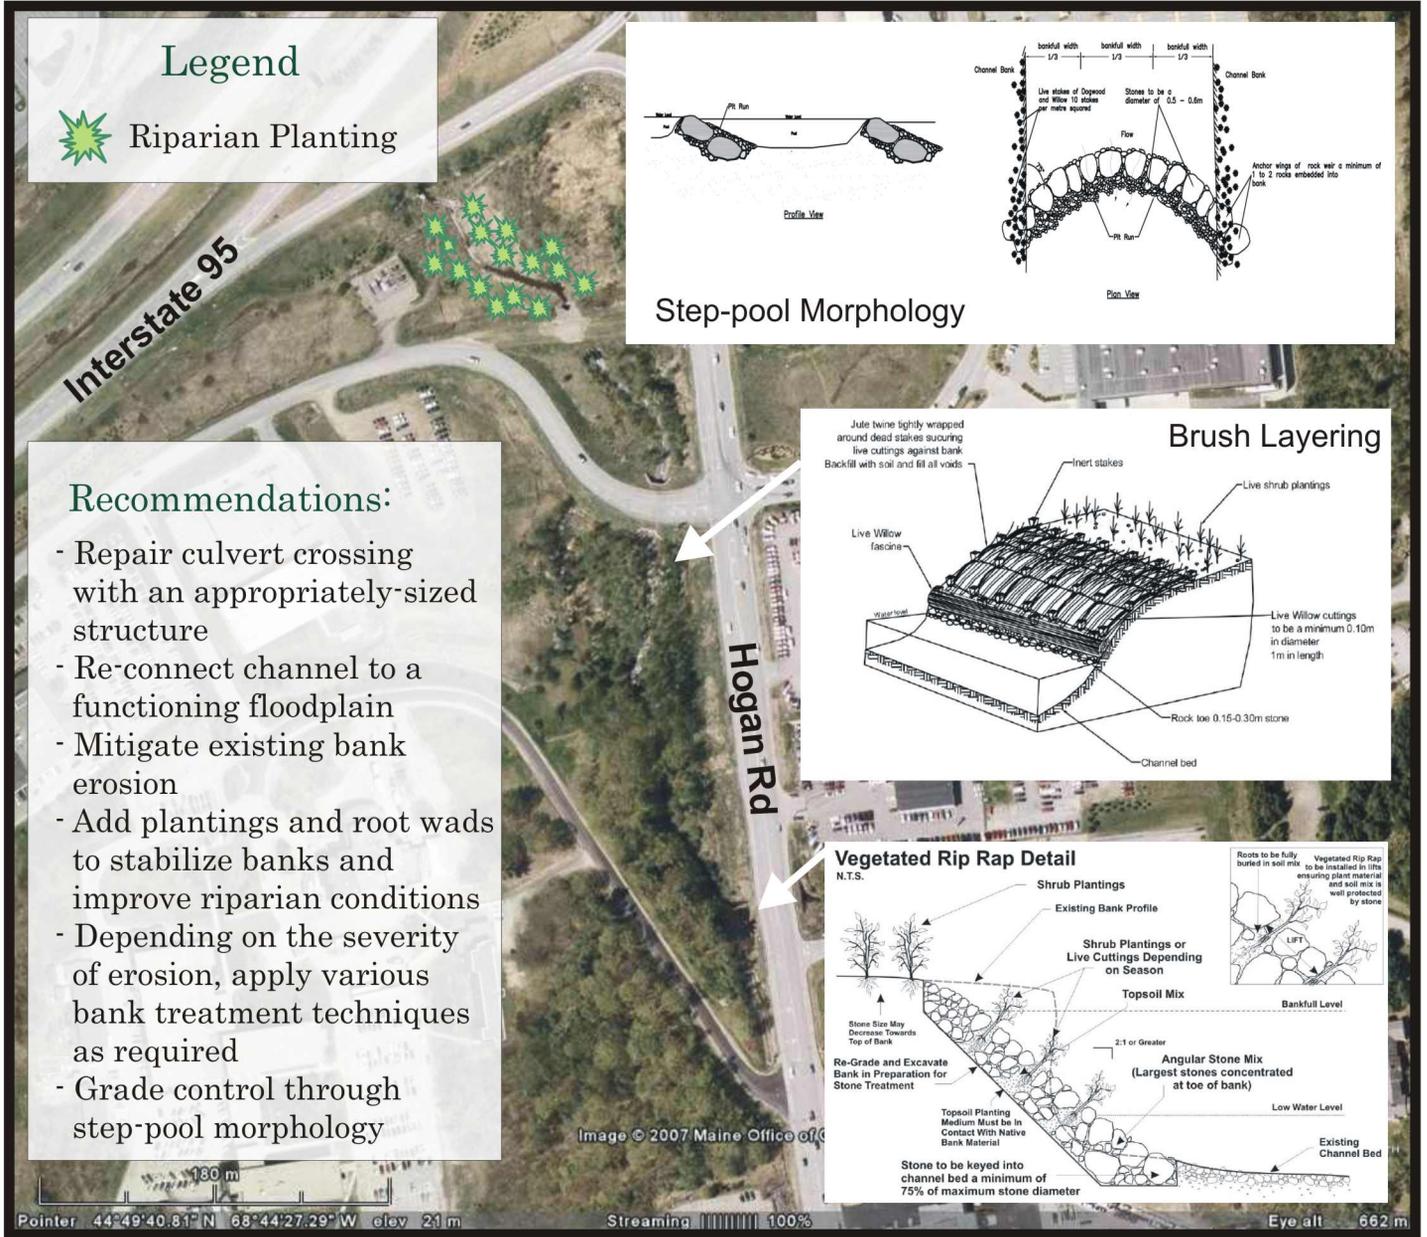
Figure 2

Downstream of Interstate to Hogan Rd (Figure 2)	2	<ul style="list-style-type: none"> - Due to the aggradation that is happening upstream of Interstate 95, this site is sediment-starved and actively adjusting - In an attempt to supplement its sediment supply, the channel is actively eroding the bed (incision) and banks (widening) - As a result of this incision, the upstream culvert has become perched and the channel itself has 	<ul style="list-style-type: none"> - Repair perched culvert crossing with an appropriately-sized structure - Re-connect channel to a functioning floodplain by lowering top of banks and terracing margins - Utilize plantings, live stakes and root wads to stabilize banks and improve riparian conditions - Depending on the severity of erosion, apply various bank treatment techniques (including

<ul style="list-style-type: none"> become entrenched - The inability of high flow events to spill out onto a connected and functioning floodplain acts to confine high energy flows within the main channel - This energy is dissipated through further erosion 	<ul style="list-style-type: none"> brush layering, wattles and vegetated rip rap) to stabilize banks, as required - Enact grade control along section through the utilization of step-pool morphology
Meadow Brook (Figure 3)	3	<ul style="list-style-type: none"> - Meadow Brook exhibits the geomorphic instabilities characteristic of a typical urban stream - The system is actively adjusting (degradation and widening) in response to the altered urban flow regime - As a result, the channel is incised and the system entrenched - The overall gradient is steep and bank erosion is prevalent - Due to the active erosion occurring within the system, fine materials are being transported downstream and being flushed into the main channel of Penjajawoc, holding major implications for aquatic habitat 	<ul style="list-style-type: none"> - Redesign and realign channel - Modification of channel to a more sinuous planform will increase channel length and decrease the gradient - Reduction in gradient will moderate stream flow energy available for erosion - Increase in cross-sectional area reduce velocities within the bankfull channel and mitigate erosion - Re-grade banks to address channel entrenchment - Apply various techniques to stabilize channel margins - Investigate storm water Best Management Practices (BMPs)

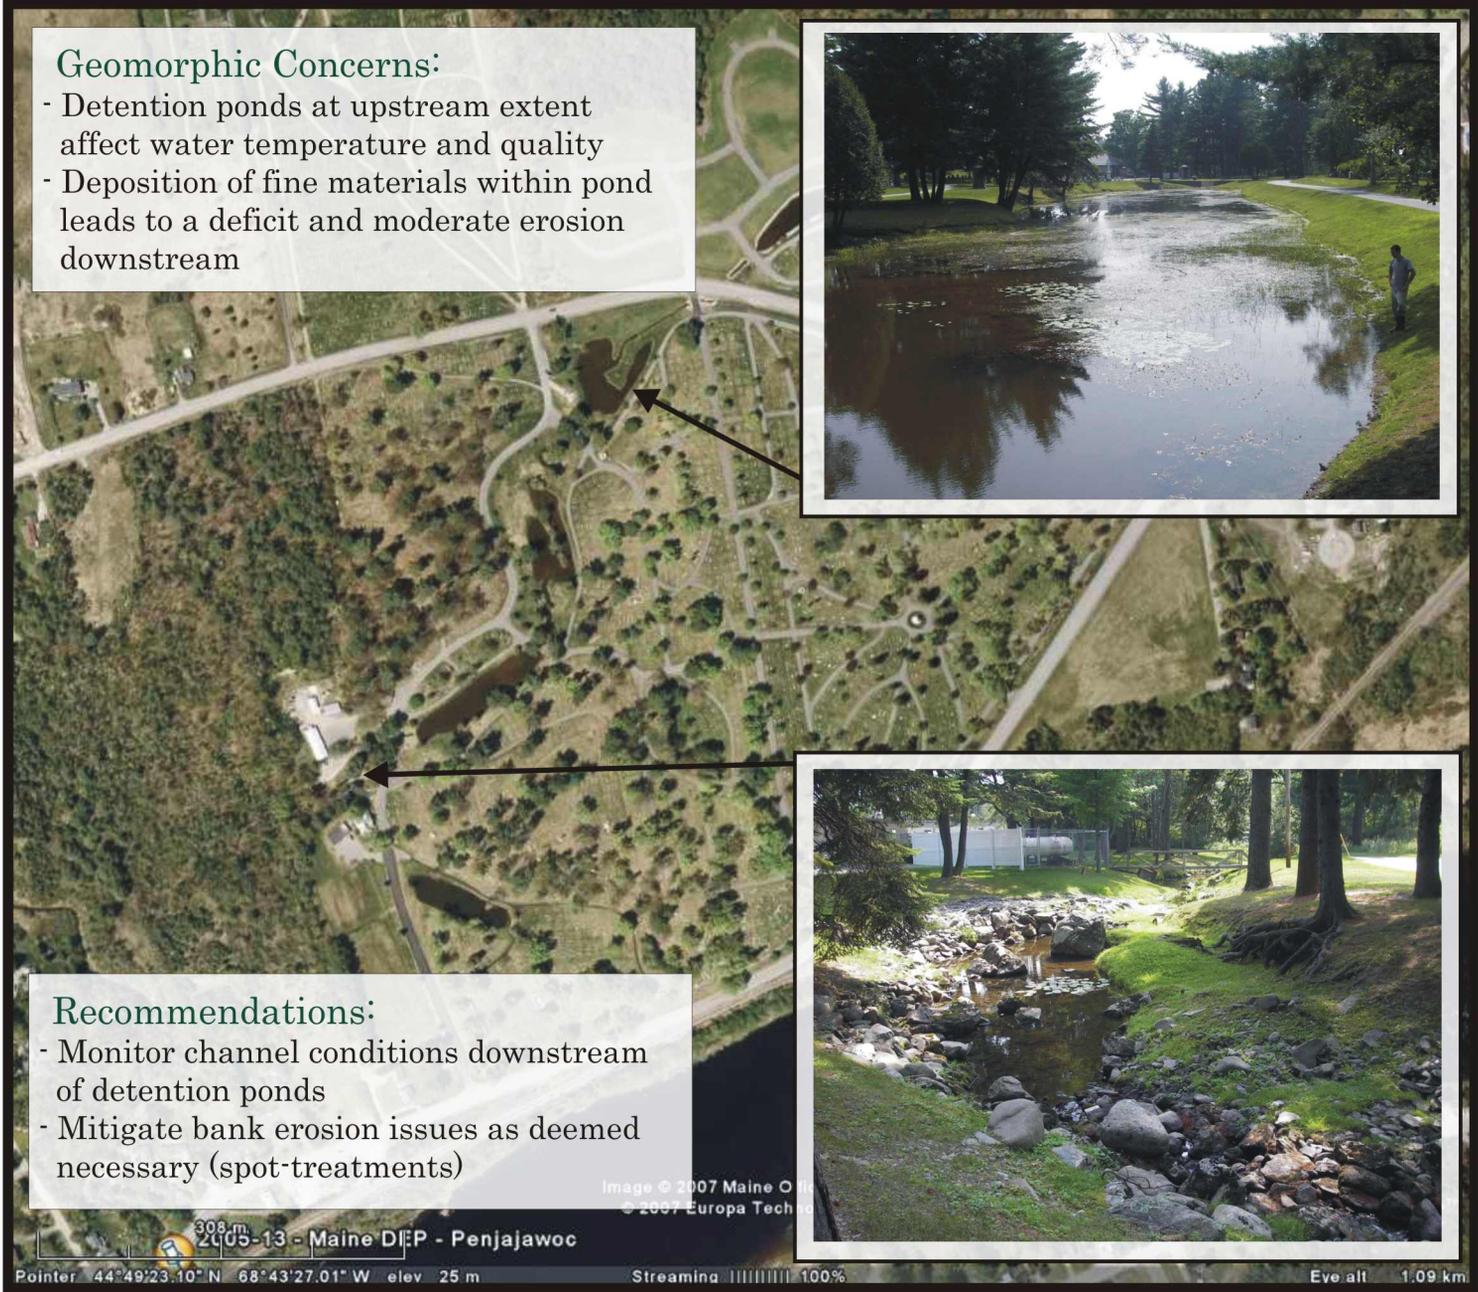
Figure 4

Cemetery (Figure 4)	4	<ul style="list-style-type: none"> - Detention ponds at upstream extent affect water temperature and quality - Deposition of fine materials within pond has lead to a deficit downstream and subsequent moderate levels of erosion 	<ul style="list-style-type: none"> - Monitor channel conditions downstream of detention ponds - Mitigate bank erosion issues as deemed necessary (spot-treatments)

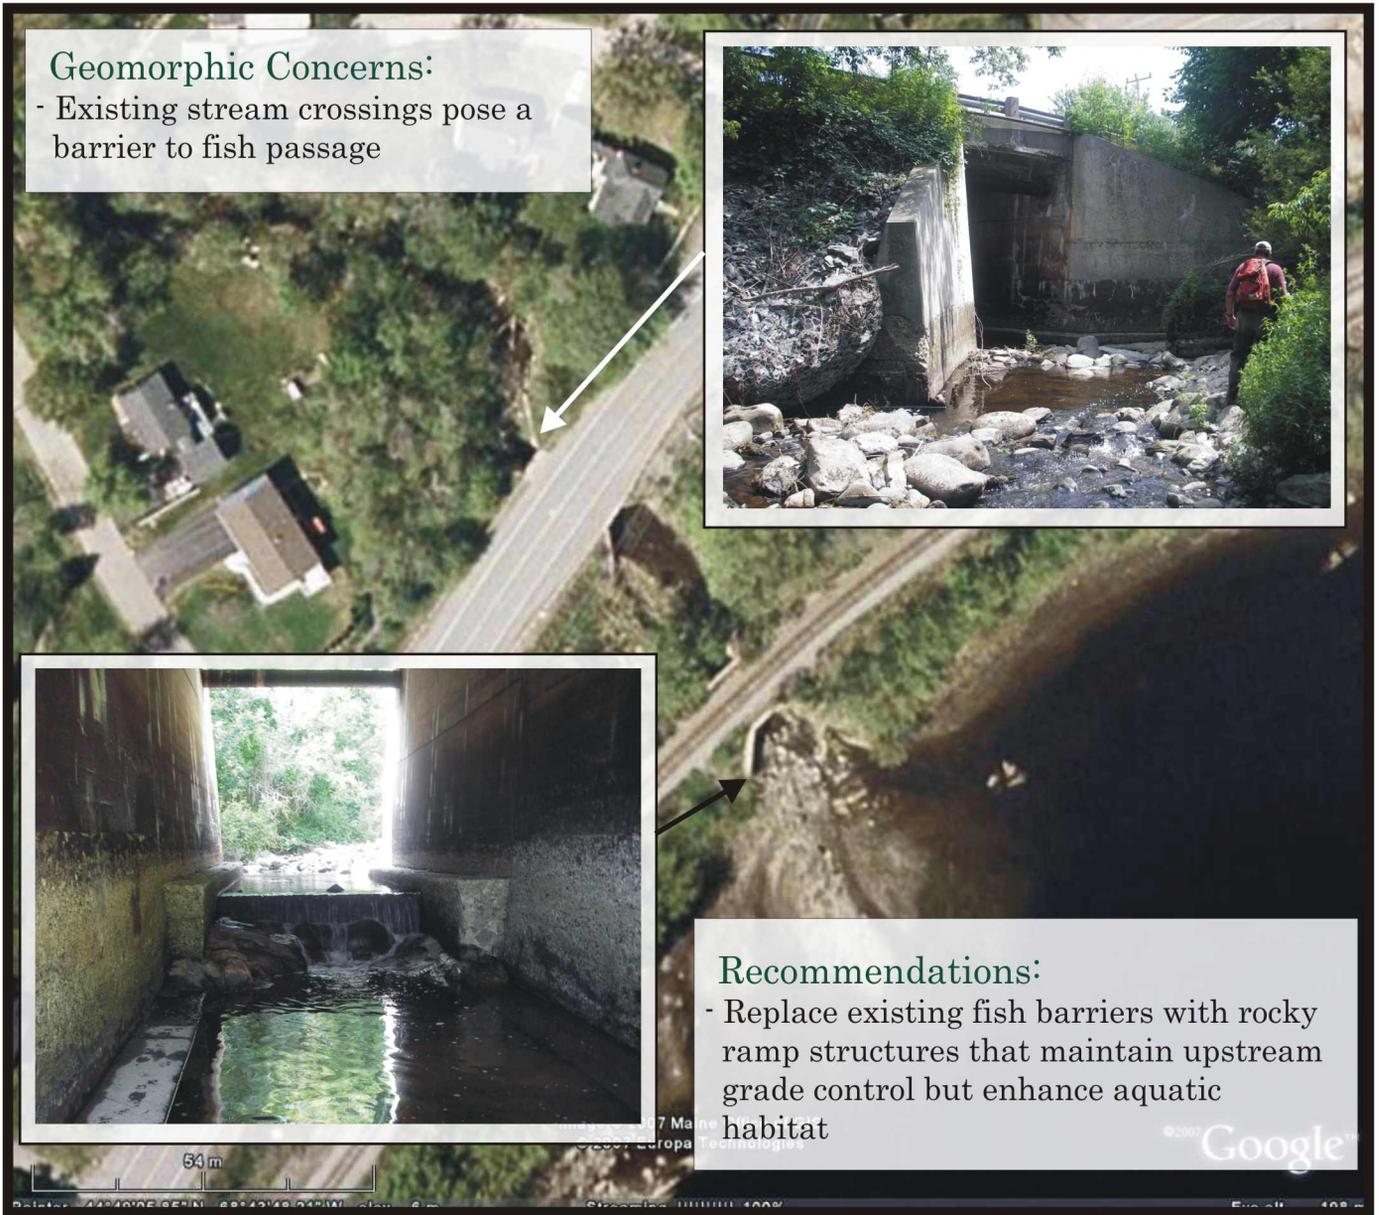
Figure 5

Ad-Hoc Spot Treatments		
Rail Trestle And Route 2 Crossings (Figure 5)	<ul style="list-style-type: none"> - Existing stream crossing structures pose a barrier to fish passage 	<ul style="list-style-type: none"> - Replace existing fish barriers with rocky ramp structures that maintain upstream grade control but enhance aquatic habitat
Beaver Dams (Figure 6)	<ul style="list-style-type: none"> - Beaver ponds can cause deposition of fine materials and increase water temperatures - Concerns exist regarding fish passage 	<ul style="list-style-type: none"> - Do nothing - Dam removal is rarely effective since dam is often rebuilt immediately - Area is too large for exclusion fencing - Beaver ponds create over-wintering refugia - Most salmonid species can travel both upstream and downstream through dams under most flow conditions
Stillwater Ave (Figure 7)	<ul style="list-style-type: none"> - Aggradation dominates the reach 	<ul style="list-style-type: none"> - Decrease cross-sectional area to increase velocities and promote sediment movement throughout reach - Add plantings to moderate stream temperatures, create habitat and stabilize channel margins
