CAPEHART BROOK

Capehart Brook Watershed-Based Management Plan

Bangor, Maine

June 2015

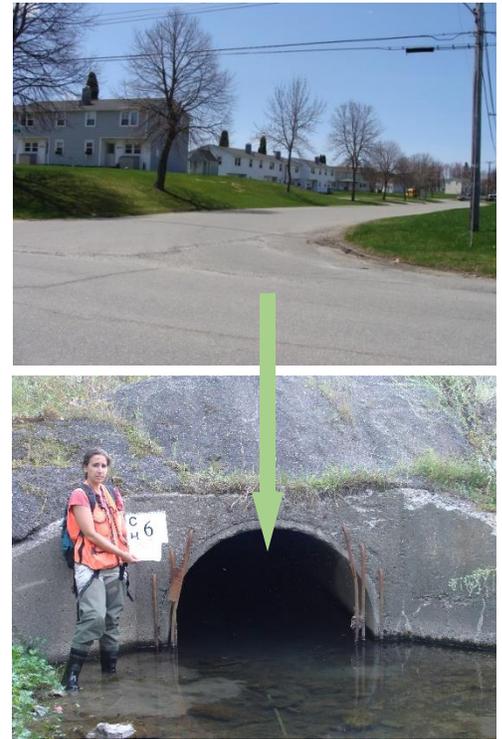
Stormwater runoff from the Capehart Brook neighborhood flows directly into Capehart Brook.

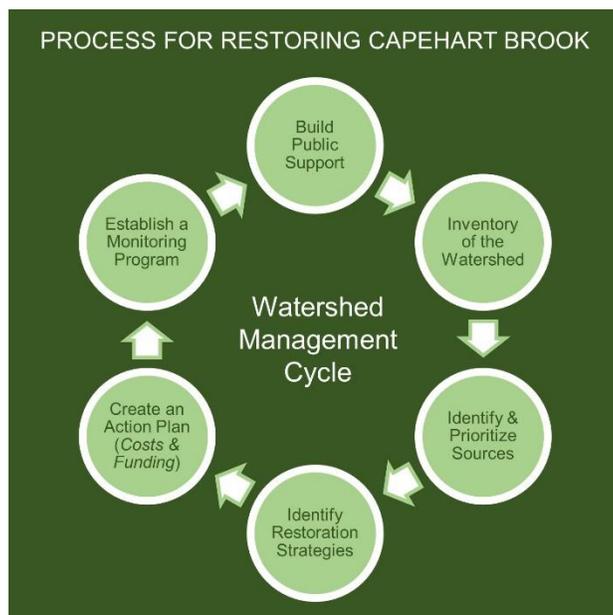
Figure 1. Watershed Management Cycle. The City of Bangor has embraced the watershed management cycle and should ensure that this Plan is a “living document.”

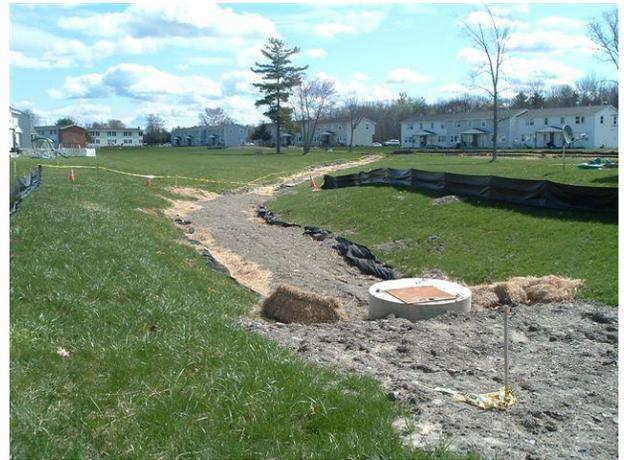
Bio-retention cell retrofit at Rangeley South. Photo credit: City of Bangor.

Bio-retention Cells at Rangeley Place South and the Downeast Elementary School: The network of drainage ditches in the open space areas throughout the residential neighborhoods of the Capehart Brook watershed were targeted for bio-retention cell retrofits. The goal of the biocells is to reduce flow volume and filter pollutants by replacing portions of the existing open ditch network. These two bio-retention cell systems treat stormwater from 6.29 acres of lawn and 1.34 acres of IC (including a parking lot, rooftops, driveways, and two streets)¹. The bio-retention cell at the Downeast Elementary School was installed in the lawn area adjacent to a ditch and serves as an educational example of low-impact development. An estimated 5.7 tons of sediment, 6.6 lbs. of phosphorus, and 9.1 lbs. of nitrogen are kept from entering Capehart Brook annually as a result of the improvements.

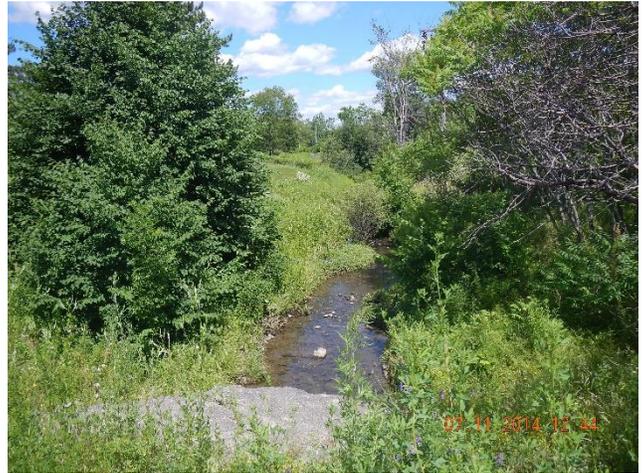
Willow and dogwood stake plantings at the Finson Road crossing. Photo credit: City of Bangor.

Willow Stake Plantings – In the spring of 2014, willow wattles, willow stakes, and dogwood stakes were planted along Capehart Brook just downstream of the Finson Road crossing. The City of Bangor purchased the wattles and stakes from Norpine Landscaping in Kingfield, ME. Willows and dogwoods are fast-growing species that can quickly and effectively stabilize and revegetate stream banks.

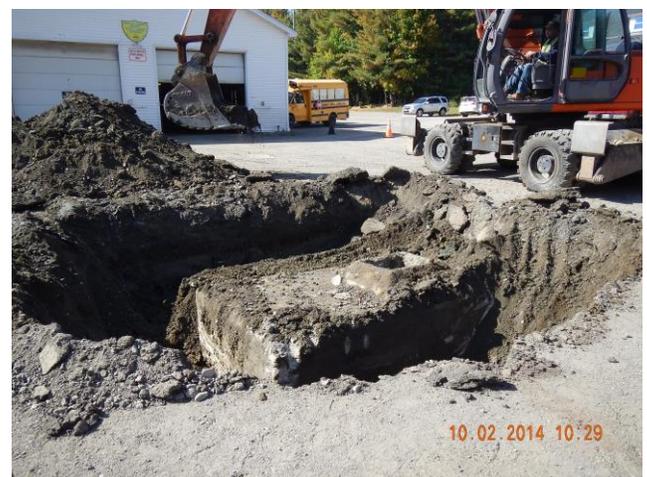
Cesspool removal. Photo credit: City of Bangor.

Oil Loading Decrease along Ohio Street – In October 2014, an underground drainage system/cesspool was discovered by City staff on a property within the Capehart Brook watershed. This system carried illicit connections from the various buildings to the City's Municipal Separate Storm Sewer System (MS4). The property managers, City Staff, the Maine DEP, and Clean Harbors worked in cooperation to fully disconnect the illicit discharge and prevent oils, greases, sink discharge, and parts washer discharge from reaching Capehart Brook. FBE staff noted oily and milky sheens on the surface water of Capehart Brook during the 2014 Stream Corridor Survey in August; removal of this

illicit discharge may help to alleviate these observed contaminations.

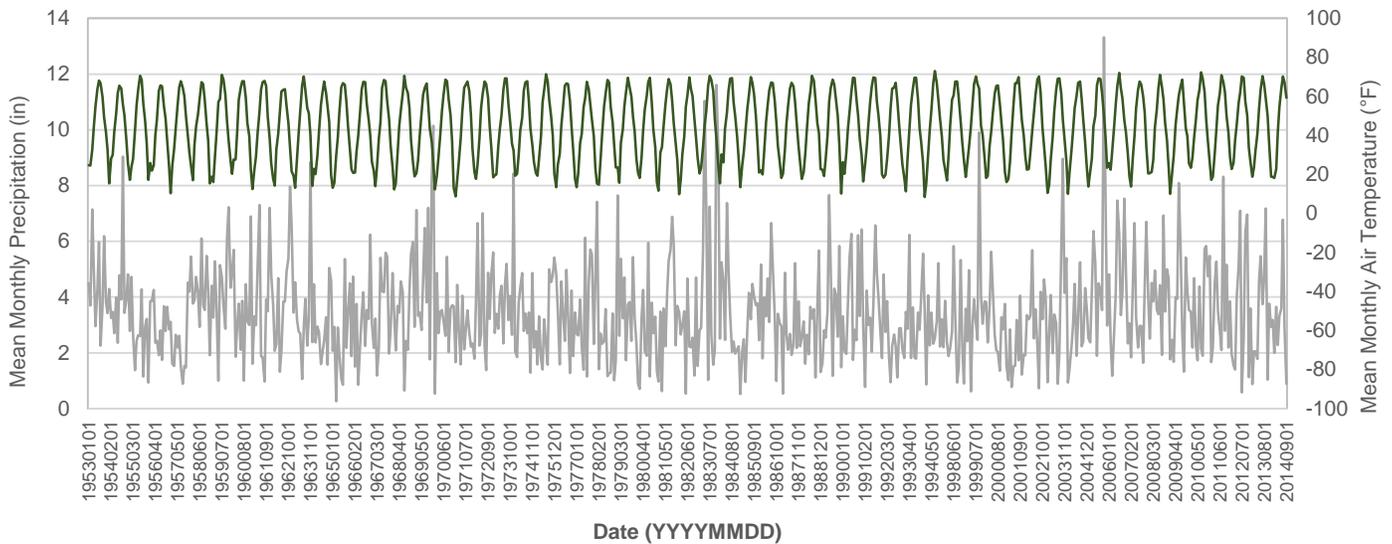
Figure 3. Mean monthly air temperature (dark green) and precipitation (gray) from 1953 to 2014. Data were obtained from the NOAA National Climatic Data Center (NCDC) from the Bangor International Airport station (GHCND:USW00014606).

Over the last three decades (1981-2010), climate in the Bangor region has seen normal annual temperatures of 66.3 °F in summer, 20.8 °F in winter, and 44.3 °F overall, as well as a mean annual precipitation of 41.93 inches (NCDC 2014). Mean monthly air temperature and precipitation data have remained relatively consistent from 1953-2014 (Figure 3).

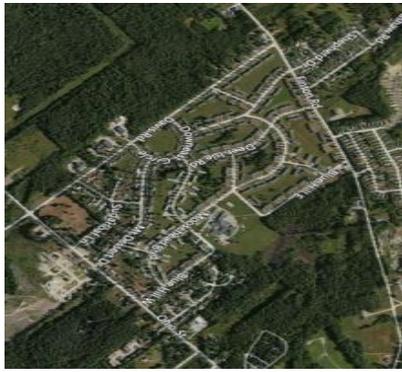
Capehart Neighborhood: The Capehart neighborhood is a prominent feature in the watershed covering approximately 145 acres of land area that drains directly to Capehart Brook via the storm drain system. This area has been targeted for BMP implementation for both Phase I and II restoration efforts. Phase I included installation of bioretention cells at the Downeast Elementary School and Rangely Place South.

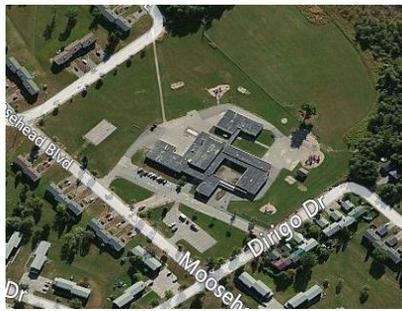
Downeast Elementary School: Within the Capehart neighborhood system and covering approximately 10 acres of land off Moosehead Boulevard, Downeast Elementary School has a considerable amount of IC that directs stormwater to the storm drain system. A bioretention cell was installed in the lawn area adjacent to one of the open ditches to help slow down flow and filter pollutants before reaching Capehart Brook.

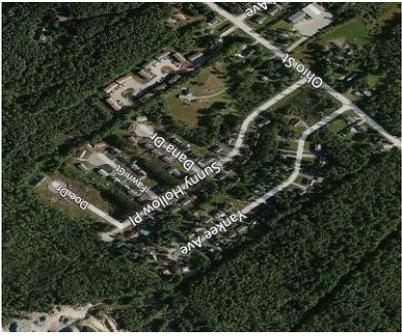
<p>Sunny Hollow Place and Yankee Avenue: Located on the outer edge of the Capehart Brook watershed, these neighborhoods are also serviced by Bangor’s storm drain and sewer network, and include 90 lots covering an area of approximately 40 acres. This detention pond was identified as failing and prioritized for retrofit as part of Phase II implementation work by the City of Bangor.</p>

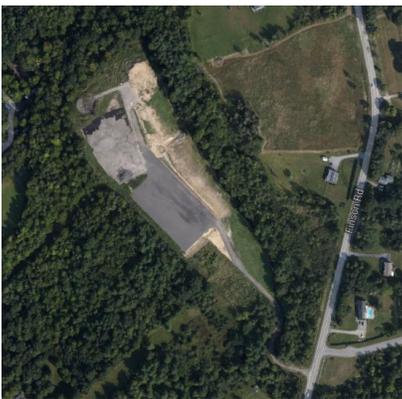
<p>Municipal Composting Facility: The City of Bangor Leaf Compost Site is located on Finson Road approximately 1,300 ft from its intersection with Ohio Street. This 17-acre site consists of 2.99 acres of IC. The facility is set up to process about 7,000 cubic yards of Type 1A Solid Waste consisting of leaf and yard waste, such as lawn/grass clippings. The site is adjacent to several small tributaries that flow to Capehart Brook. Stormwater controls are in place at the site, including two gravel compost pads underlain by GeoTech Fabric, a level lip spreader, two DHP culverts, a sediment trap, outlet, stone check dams, bark filter berming, and riprap outlet protection. The natural vegetated buffer also captures additional runoff and sediment from sheet flow excess. The City of Bangor has a Compost Operation & Maintenance Plan for PERMIT # S-022380-CB-A-E.</p>

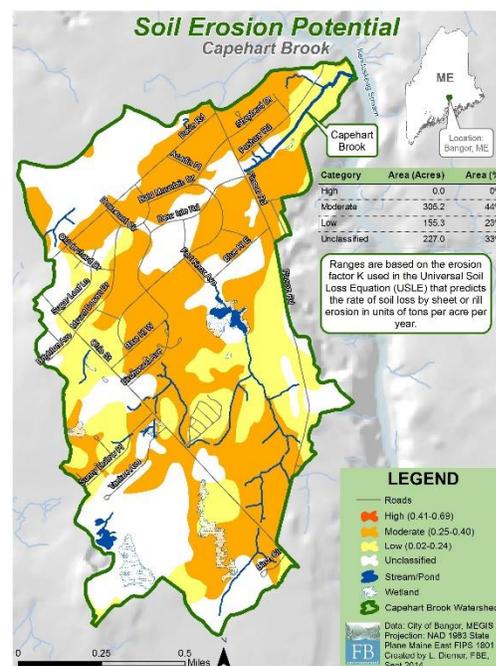
Most of the soils in the Capehart Brook watershed are categorized as having moderate soil erosion potential. Appendix A, Map 8.

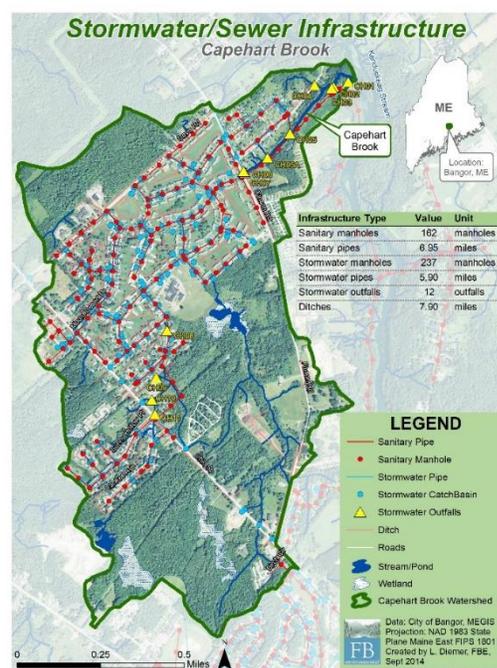
The Capehart Brook watershed hosts a large network of stormwater and sewer lines for the Capehart Neighborhood. Appendix A, Map 10.

The majority of the Capehart Brook watershed, particularly in the residential complex between Finson Road and Ohio Street, is serviced by City sewer as a means of human waste disposal. There are currently 162 manholes and 6.95 miles of sanitary pipes in the watershed. An old sewer treatment facility, known as the Dow Air Force Base Wastewater Treatment Plant, was built in the 1950's at the downstream terminus of Capehart Brook, specifically for collecting waste from the military housing. Only primary treatment (settling) was done to the waste before it was dumped directly into the Kenduskeag Stream. In an effort to clean up the Kenduskeag, the City reconnected the facility's sewer to the rest of the City by 1973. The treatment plant was sold in 1980, and many of the structures still remain.

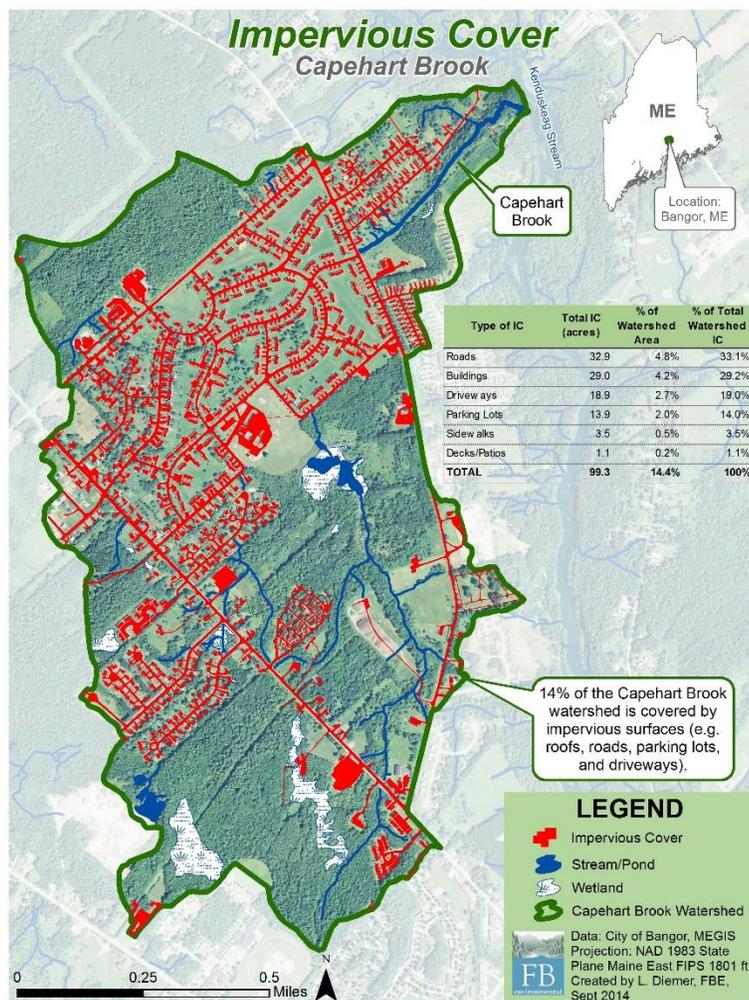
Figure 6. Impervious cover in the Capehart Brook watershed. Appendix A, Map 11.

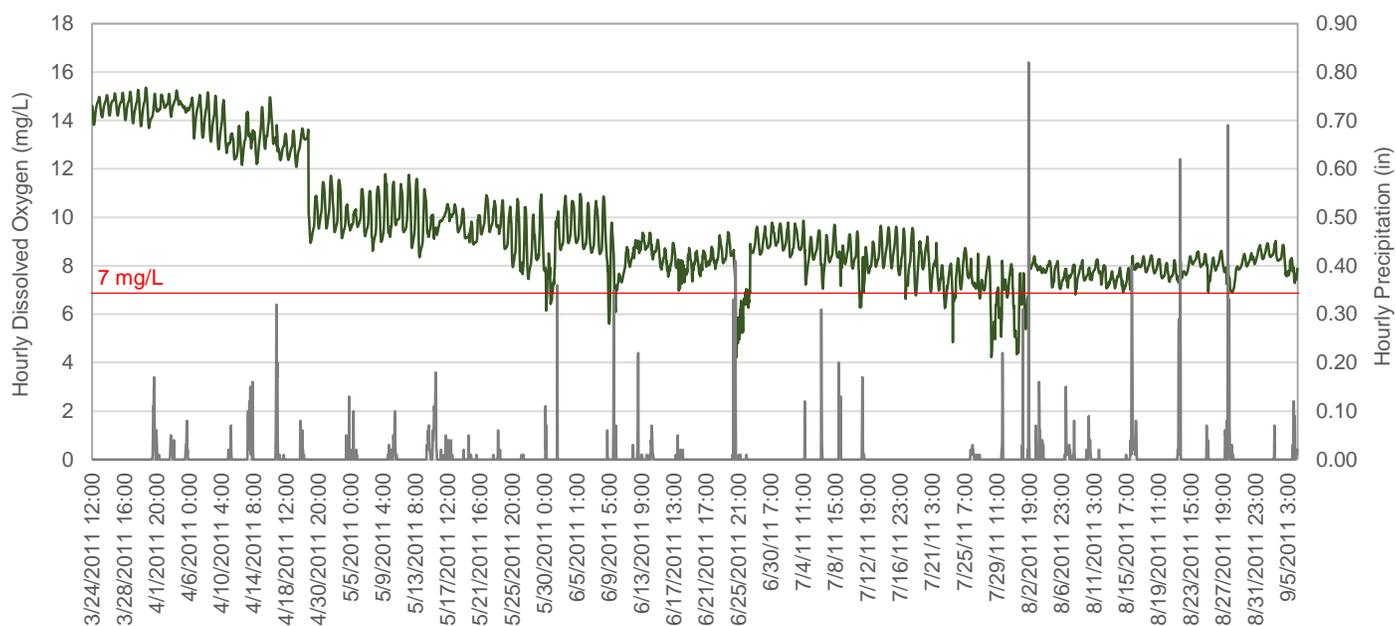
Figure 7. Hourly dissolved oxygen concentration (dark green) for Capehart Brook from March to September 2011. Data were collected as part of the Bangor Stream Monitoring Project with assistance from the Maine DEP. Daily precipitation (gray) values were obtained from the NOAA National Climatic Data Center (NCDC) from the Bangor International Airport station (GHCND:USW00014606). Red line indicates a dissolved oxygen threshold of 7 mg/L, below which is considered hypoxic and detrimental to aquatic life.

DO was collected monthly using a YSI 85 multi-meter probe by the James W. Sewall Company and the City of Bangor from 2009 to 2013 (Table 6). DO readings conducted during the Maine DEP macroinvertebrate surveys in 2001 and 2013 were also included (Appendix B). These instantaneous DO readings ranged from 7.2 to 15.4 mg/L and 75 to 109% saturation with means of 10.7 mg/L and 93% saturation, respectively. These data show acceptable ranges for DO (mg/L and percent saturation) with the lowest DO occurring in summer. In the early spring and fall sampling months, Capehart Brook tended to be supersaturated with oxygen when respiration processes were slower and water temperatures cooler.

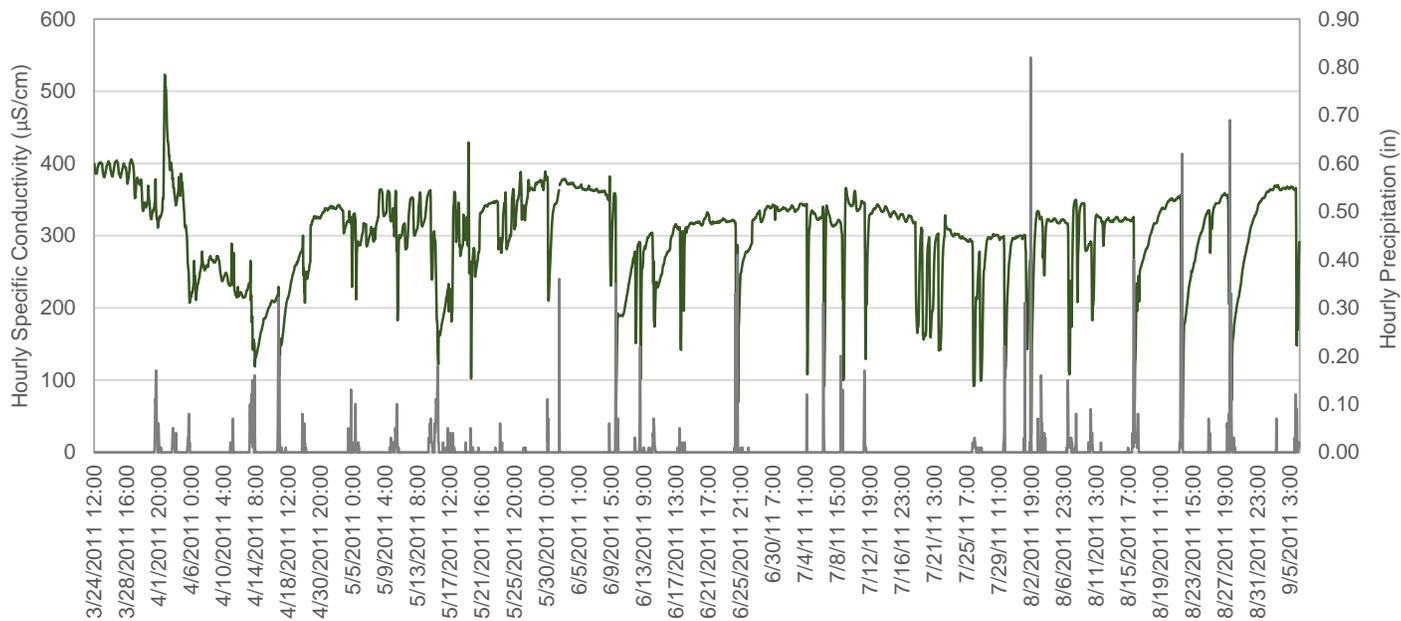
Figure 8. Hourly specific conductivity (dark green) for Capehart Brook from March to September 2011. Data were collected as part of the Bangor Stream Monitoring Project with assistance from the Maine DEP. Daily precipitation (gray) values were obtained from the NOAA National Climatic Data Center (NCDC) from the Bangor International Airport station (GHCND:USW00014606).

sand were flushed to streams. Rain events later in the summer resulted in dilution. The final conclusion by the Maine DEP was that conductivity levels stayed below chronic levels and are likely not inhibiting aquatic life.

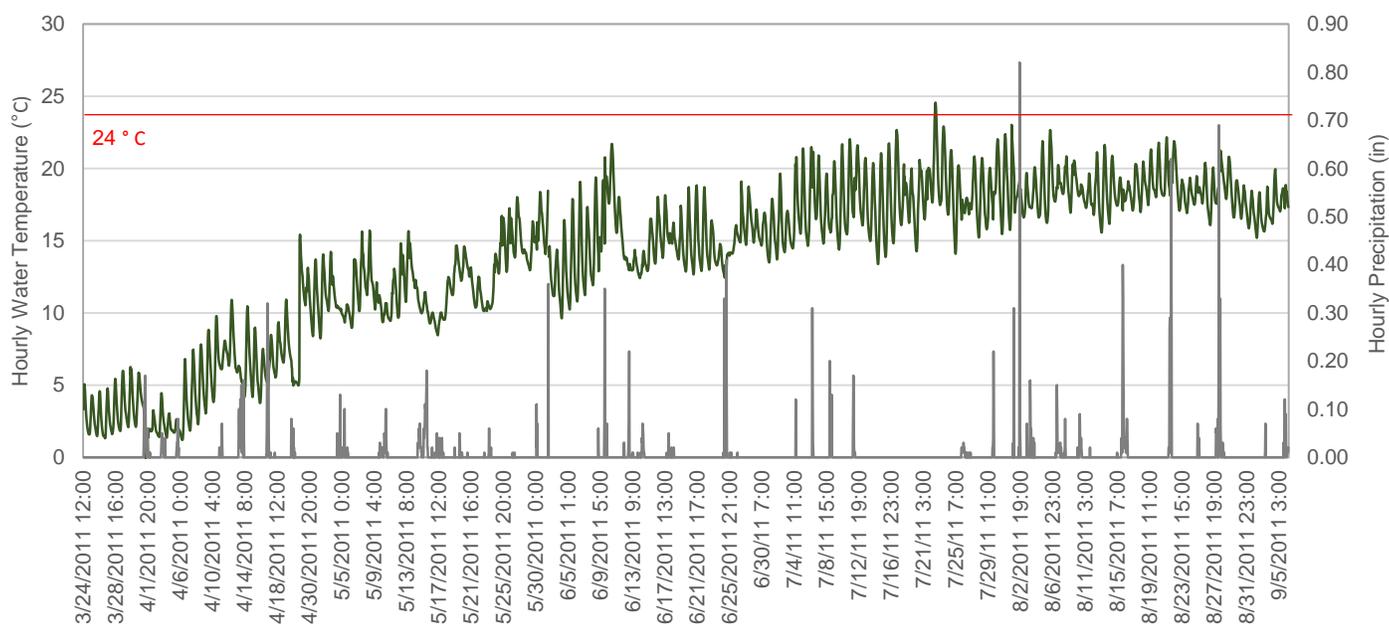
Figure 9. Hourly water temperature (dark green) for Capehart Brook from March to September 2011. Data were collected as part of the Bangor Stream Monitoring Project with assistance from the Maine DEP. Daily precipitation (gray) values were obtained from the NOAA National Climatic Data Center (NCDC) from the Bangor International Airport station (GHCND:USW00014606). Red line indicates an instantaneous water temperature threshold of 24 °C, above which is considered detrimental to aquatic life.

Continuous water quality logging by the Maine DEP in summer 2011 showed mean temperatures ranging from 16-18 °C (60.8-64.4 °F) in late summer (July and August) (Figure 9). Only one day reached 25 °C (77 °F) for a few hours during peak daylight hours. The conclusion by the Maine DEP was that temperature was not adversely affecting aquatic life in Capehart Brook.

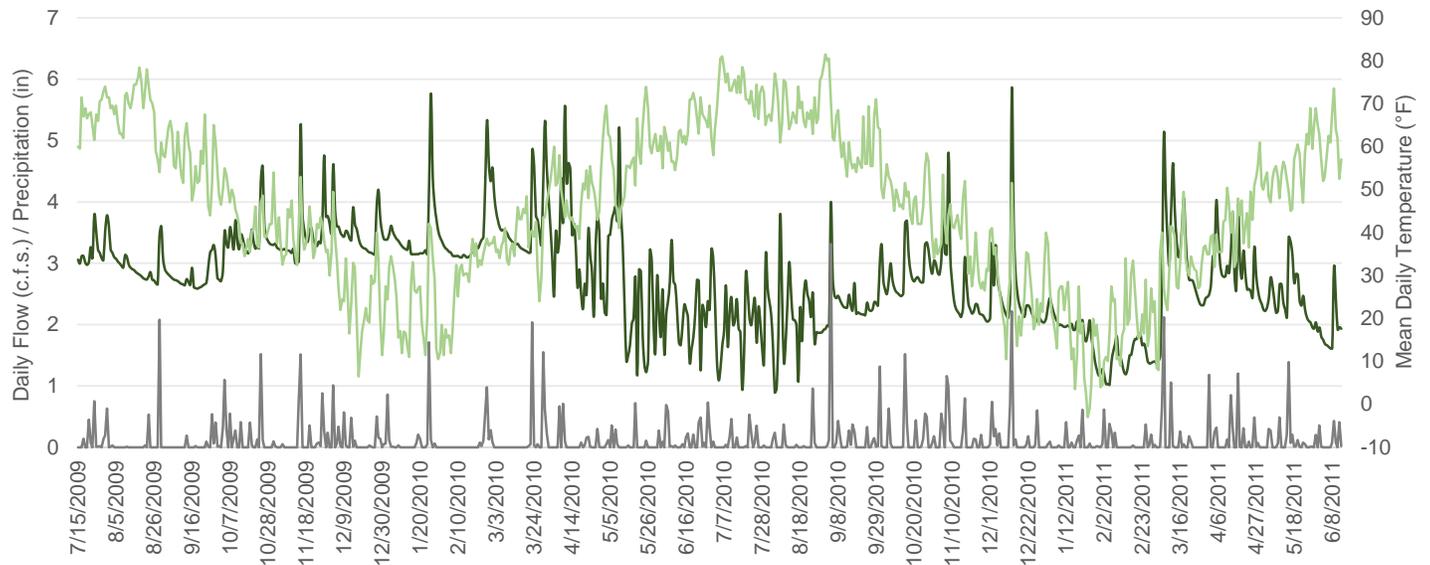
Figure 10. Daily average flow (dark green) for Capehart Brook from July 2009 to June 2011. Data were collected as part of the Bangor Stream Monitoring Project with assistance from the James W. Sewall Company. Daily precipitation (gray) and temperature (light green) values were obtained from the NOAA National Climatic Data Center (NCDC) from the Bangor International Airport station (GHCND:USW00014606).

There are a number of ways to measure discharge with varying levels of accuracy. For Capehart Brook, the James W. Sewall Company deployed a data logger (Global Logger™) to measure water depth (or stage height) continuously every 15 minutes from 2009-2011. Four flow measurements at varying discharges (low to high) were conducted in the field using a current meter. From this, a flow rating curve was developed between direct flow measurements and corresponding stage height. The regression equation was applied to the continuous stage height data, and the subsequent mean daily flow results are presented in Figure 10. Flows ranged from 0.7 to 8.6 cfs with a mean of 2.0 cfs. Capehart Brook experienced lowest flows in summer when precipitation was low. Flow tends to increase rapidly in response to rainfall and recede quickly, indicating that Capehart Brook experiences sudden surges in water level immediately following storm events and recedes quickly in a similar manner. This high disturbance environment may not be conducive for most biological communities and tends to scour out banks and deposit sediment downstream where the stream cannot accommodate the enhanced flow volume.

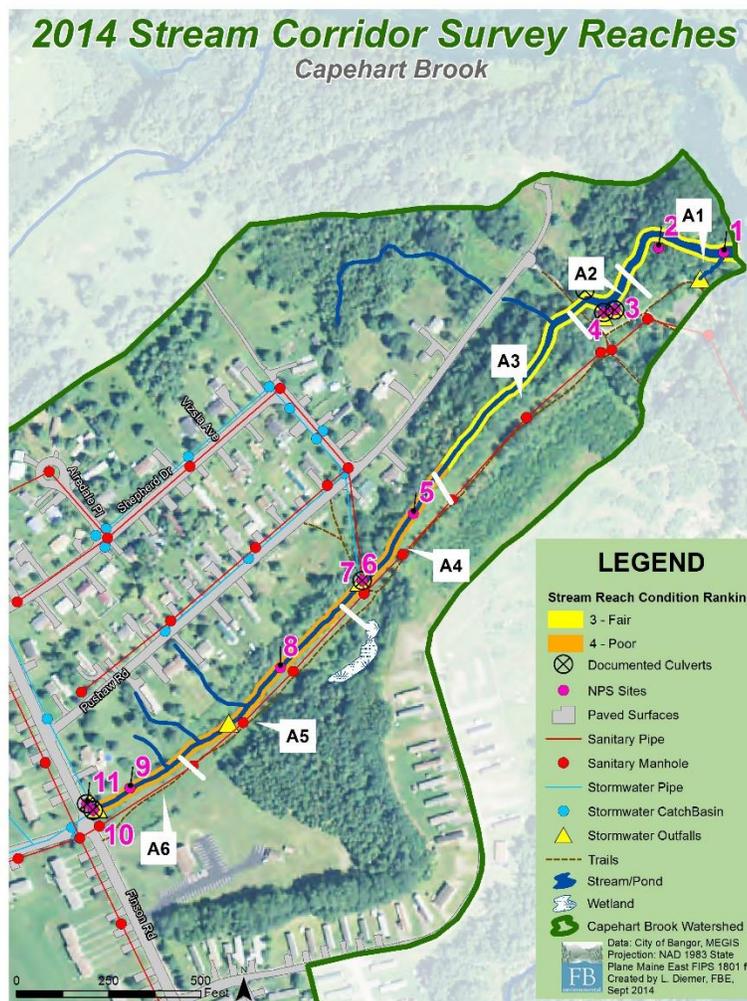
Figure 11. Survey reaches for the Level 1 Stream Corridor Survey conducted by FBE staff in 2014. Appendix A, Map 12.

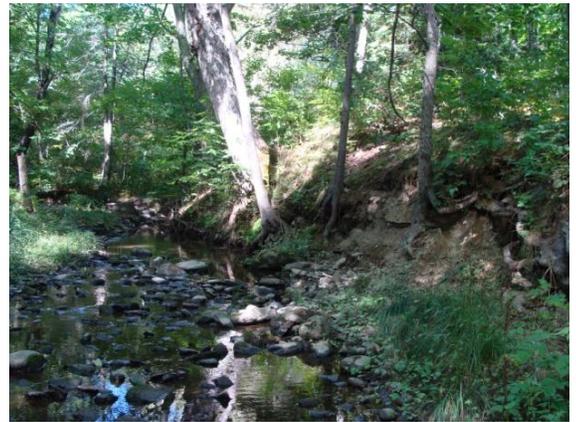
Example of stream bank erosion (Reach A1).

Overall, Capehart Brook is a somewhat narrow (average wetted width of 7.5 ft.) and relatively shallow stream with the exception of one small pool greater than two feet deep. Three of the six reaches have at least one bank with steep, eroding slopes, and all reaches exhibit undercut banks at varying degrees of severity. Degradation of natural streamside plant cover and collapsed banks is common. Discharging pipes (including storm drain outfalls) and/or ditches are present in a majority of the reaches, carrying stormwater and attached sediment and pollutants, and causing erosion where the discharge meets the stream. Refer to Table 11 for more specifics.

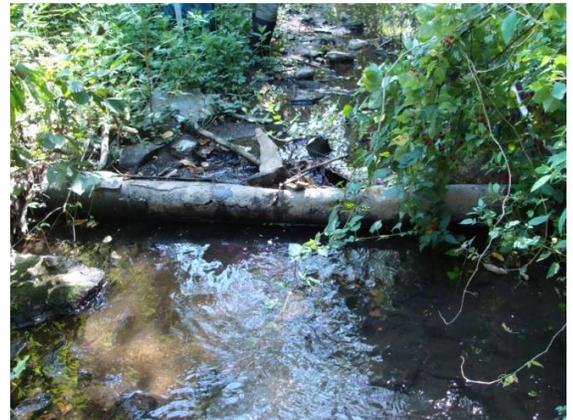
A broken pipe in Reach A4 may be part of the old sewer system.

Water quality and potential pollution sources are scored separately for each stream reach (Table 3, Appendix A). The most apparent problems stem from both known and unknown sources including eroding culverts, stormwater outfalls, ATV crossings, yard waste, trash, and undercut banks. Bank erosion is common, as well as trash and debris in most stream reaches. Despite a major volunteer trash clean-up in Capehart Brook in the spring of 2014, large quantities of trash were documented throughout the stream, indicating that more effort is needed to keep trash out of the stream (e.g. public education, installation of a trash guard(s) at outfalls, etc). The potential illicit discharge documented in Reach A4 has been addressed by the City. Water quality in Capehart Brook ranges from Fair (Reaches A1, A2, and A3) to Poor (Reaches A4, A5, and A6).
