Broadway Corridor Study

Bangor, Maine

Existing Transportation Conditions Technical Memorandum

Prepared by:
TYLININTERNATIONAL

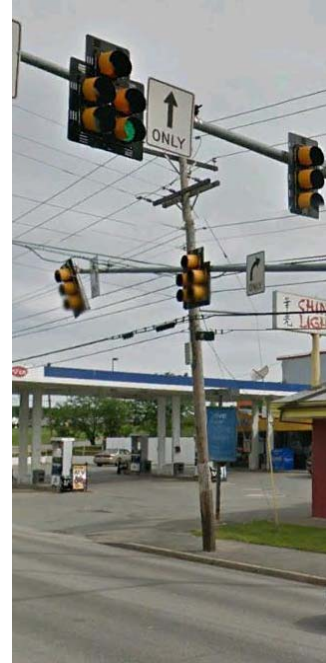
- **Falvey Street Intersection:** Sidewalks are on all approaches to the intersection. On Falvey Street, sidewalks line the residential street separated by esplanades that open into Broadway. There are sidewalks on both sides of Broadway. Ramps open to the two crosswalks that cross Broadway and Falvey Streets from the west but on the east, the sidewalk receives the Broadway crosswalks at the entrance to the Chinese restaurant. Ramps do not contain detectable warning tiles or updated pedestrian heads. Utility poles and signs continue to impede sidewalks.

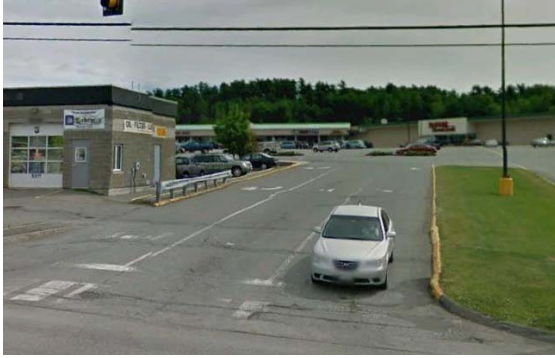
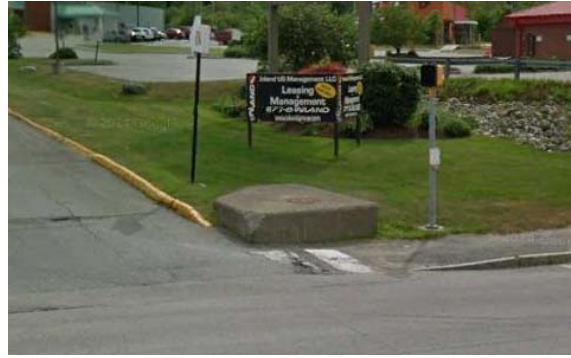
- **Shopping Center/McDonald's Exit Intersection:** There are sidewalks along Broadway with a gap at the shopping center island. There is also a stretch of sidewalk along the northerly side of the shopping center entrance. The sidewalk at the shopping center entrance has a stretch of guardrail blocking the full width. Detectable warning tiles and updated pedestrian signals are not present.

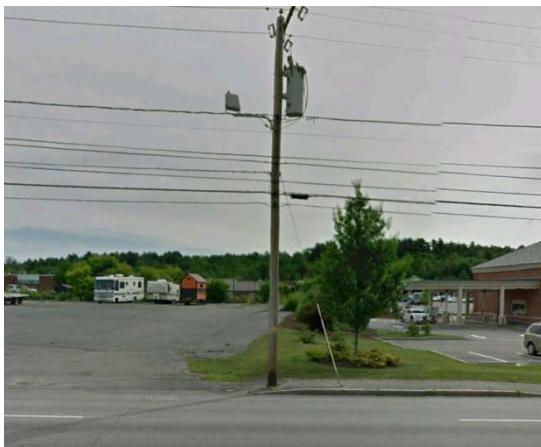
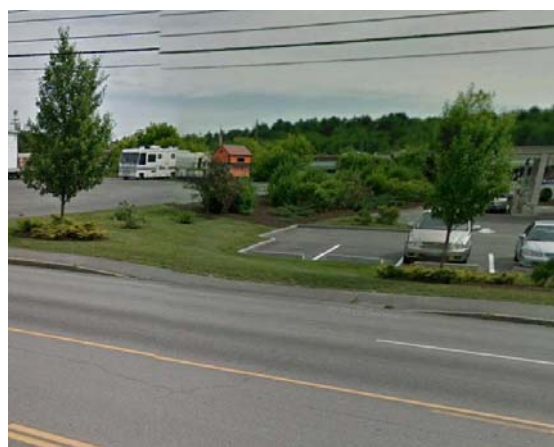
- **From Broadway Shopping Center to School Street/Walgreens:** Sidewalks line Broadway and continue to be impeded by utility poles. Ramps that have no crosswalk are present.

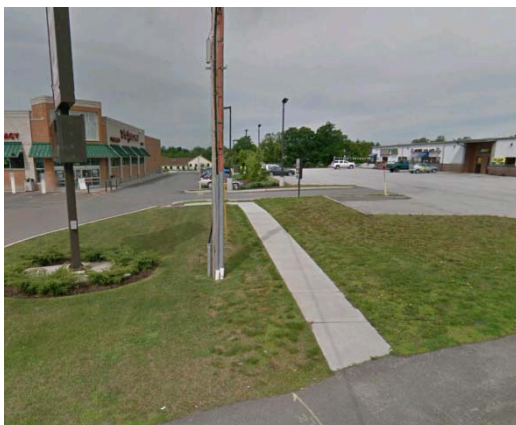
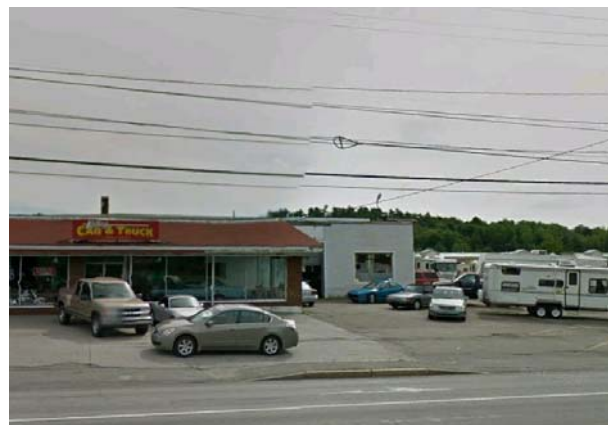
- **School Street/Walgreens Intersection:** There are sidewalks along Broadway and a concrete sidewalk separated from traffic by esplanade connects pedestrians to Broadway. There is no sidewalk along School Street beyond the intersection. Some sidewalks are level with parking lots. Detectable warning tiles and updated pedestrian signals are not present.

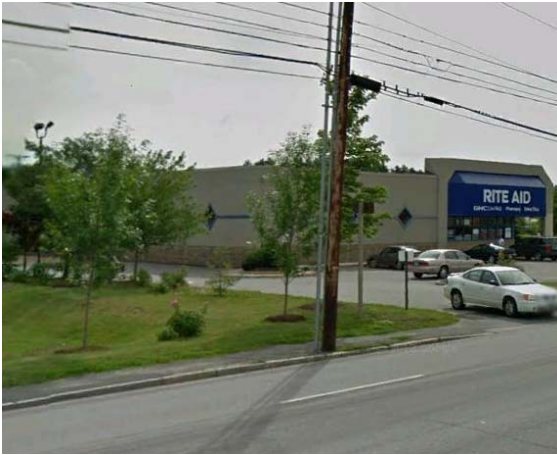
- **From School Street/Walgreens to Husson Avenue:** Sidewalks line Broadway and continue to be impeded by utility poles. Sidewalks crossing major drives with islands did not have pedestrian refuge.

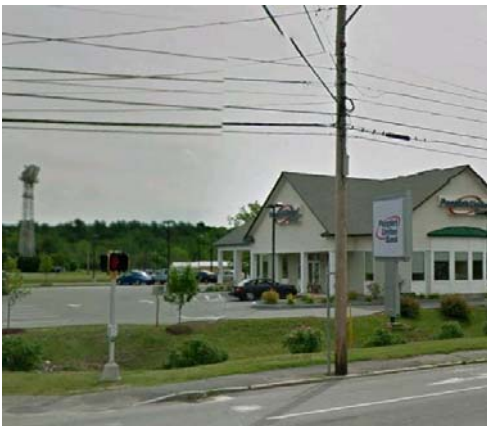
- **Husson Avenue Intersection:** There are sidewalks along Broadway and sidewalk along the southerly side Husson Avenue separated by an esplanade. There is no sidewalk along the entrance to the bank and dentist office. Detectable warning tiles and updated pedestrian signals are not present. Utility poles continue to be in the sidewalk.

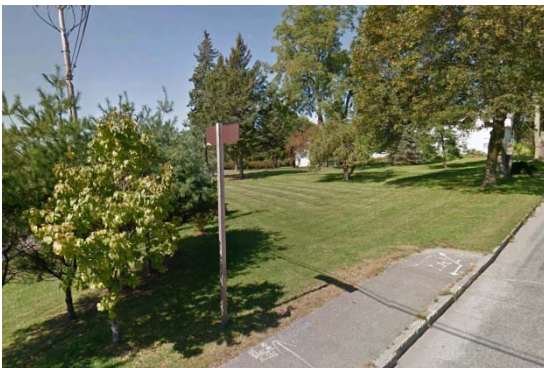
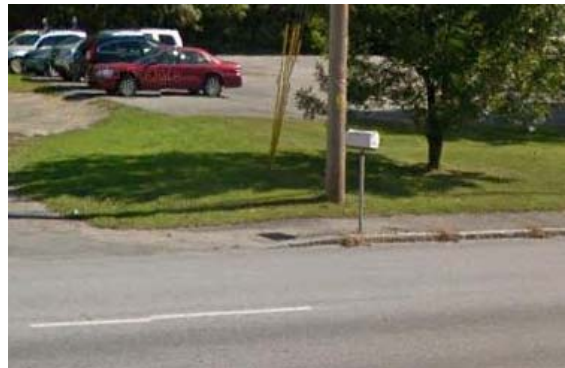
- **From Husson to Grandview Avenue:** There are sidewalks for part of the way on the westerly side of Broadway that end approximately 250 feet north of the Husson intersection. Sidewalks continue for the entire length of Broadway on the easterly side. There are conflicts on the easterly side from mailboxes and utility poles.

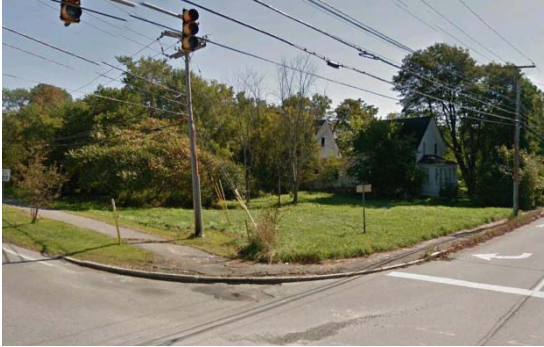
- **Grandview Avenue Intersection:** There are sidewalks at this intersection only at the southeast corner by Bangor High School

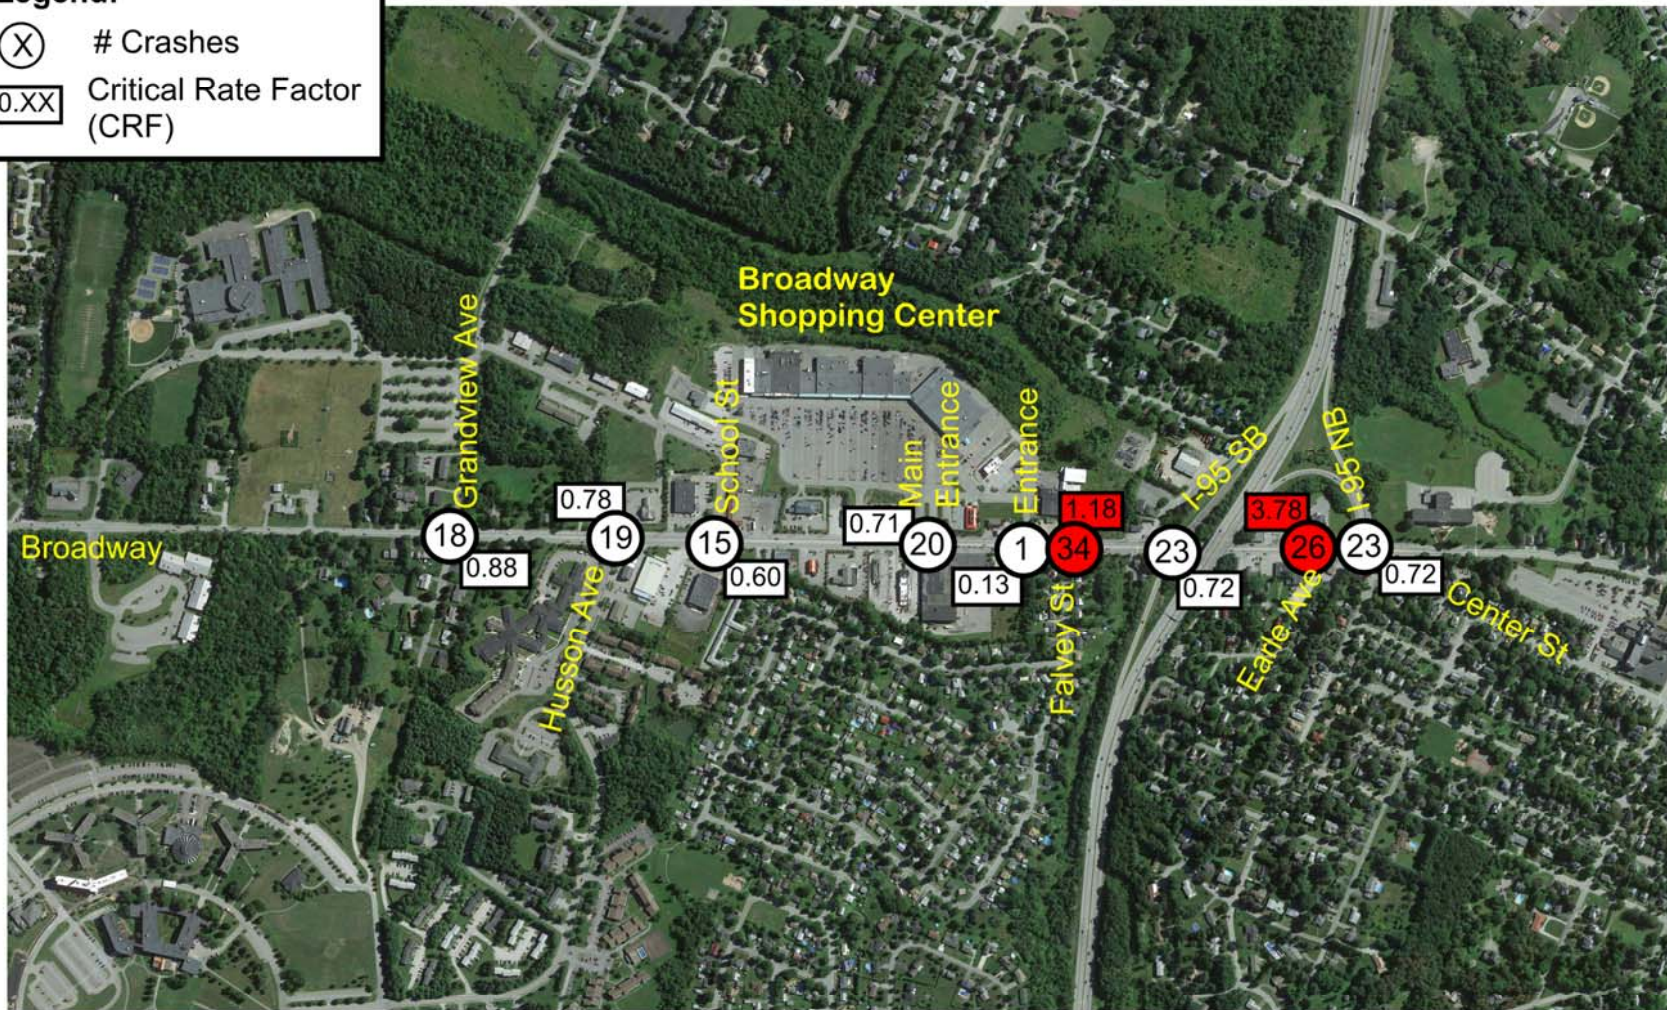
Figure 4:
Intersection Crash Data
 Source: MaineDOT
 2011 - 2013

Locations are highlighted. **Figures 4 and 5** graphically summarize this information separately for intersections and road segments.

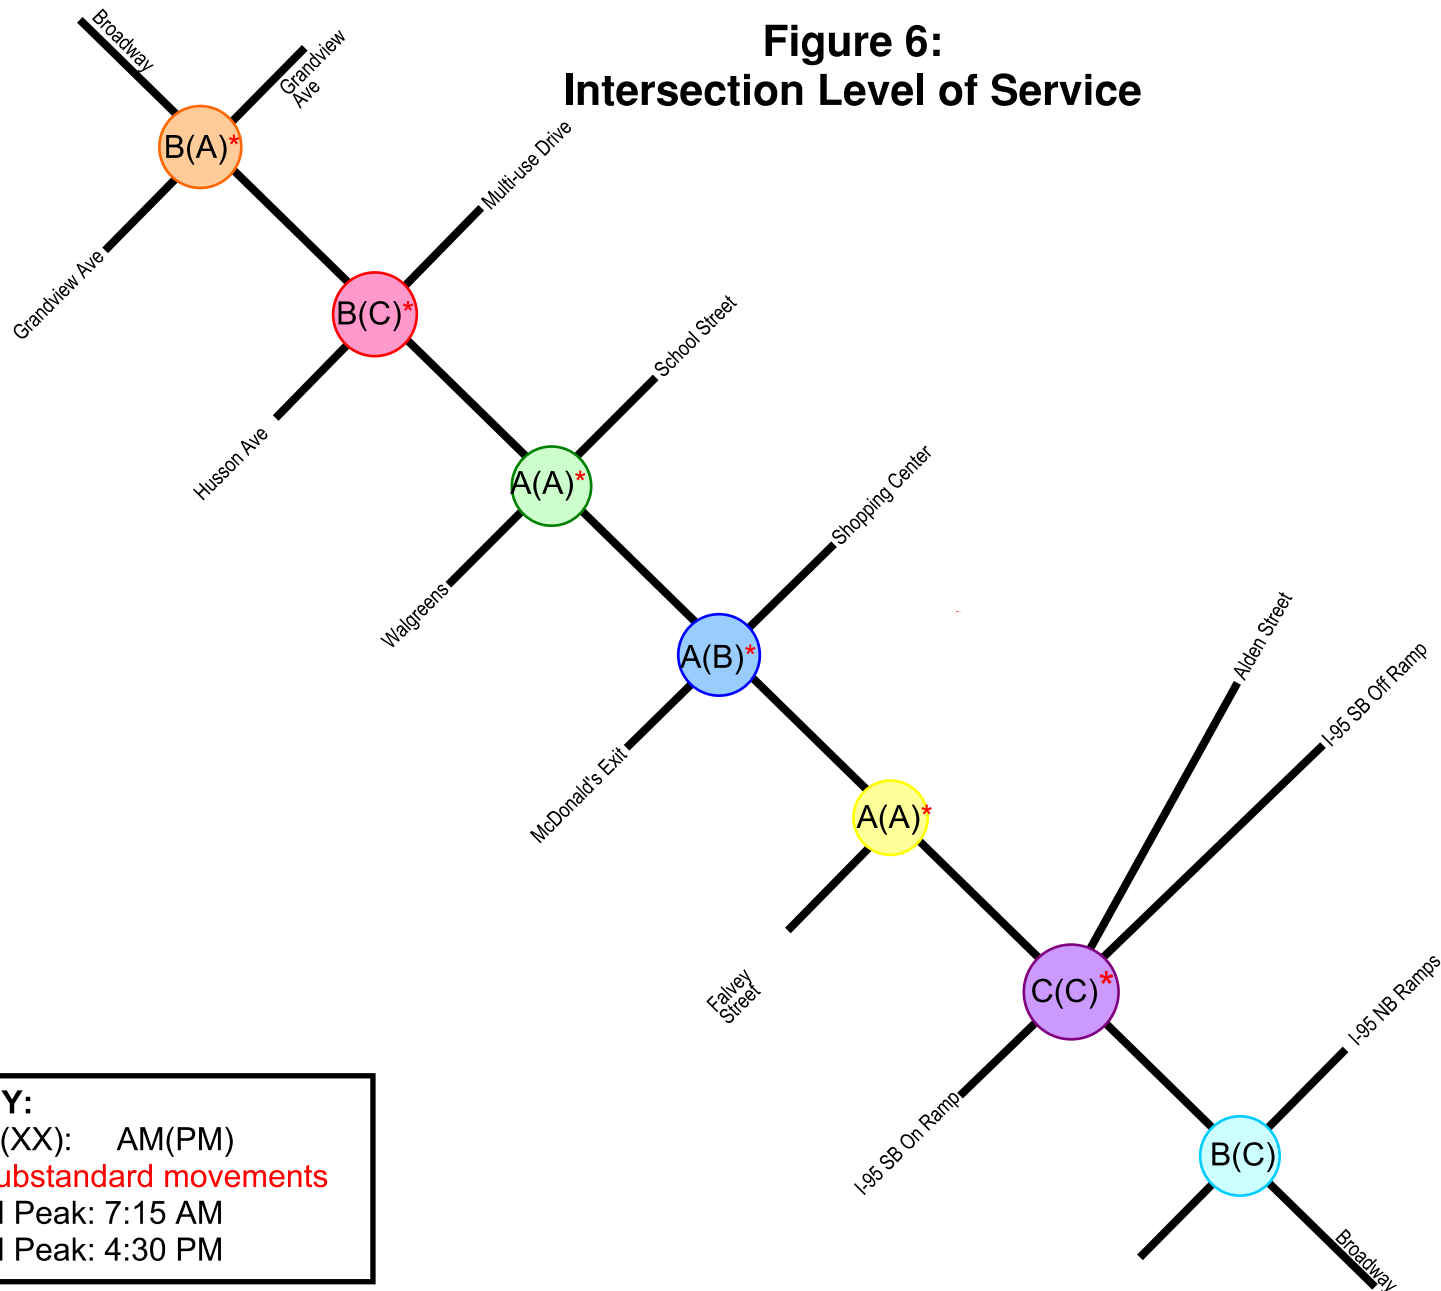
**Figure 6:
Intersection Level of Service**

Synchro and SimTraffic computer models were used to analyze the study intersections. For SimTraffic, the Trafficware standard output was used (based on 5 runs of 60 minutes of simulation). Results varied between Synchro and SimTraffic. Because SimTraffic more closely represented conditions observed in the field, it is represented in the following tables. All queues in the results tables represent 95th percentile queues, indicating that 95% of the time the queues will be less than this length. The report printouts can be found in **Appendix G** and **Figure 6** also depicts the results.

Table 8 summarizes the results at the signalized intersection of Broadway, I-95 NB, and Center Street. There are no failing movements at this intersection however there are several queues that exceed the space allotted.

Table 9 summarizes the results of the signalized intersection Broadway, I-95 SB, and Alden Street. Several failing movements are seen during the AM and PM Peak hours as highlighted in the following table. Queues exceed available storage during the AM Peak hour on all approaches except Alden Street.

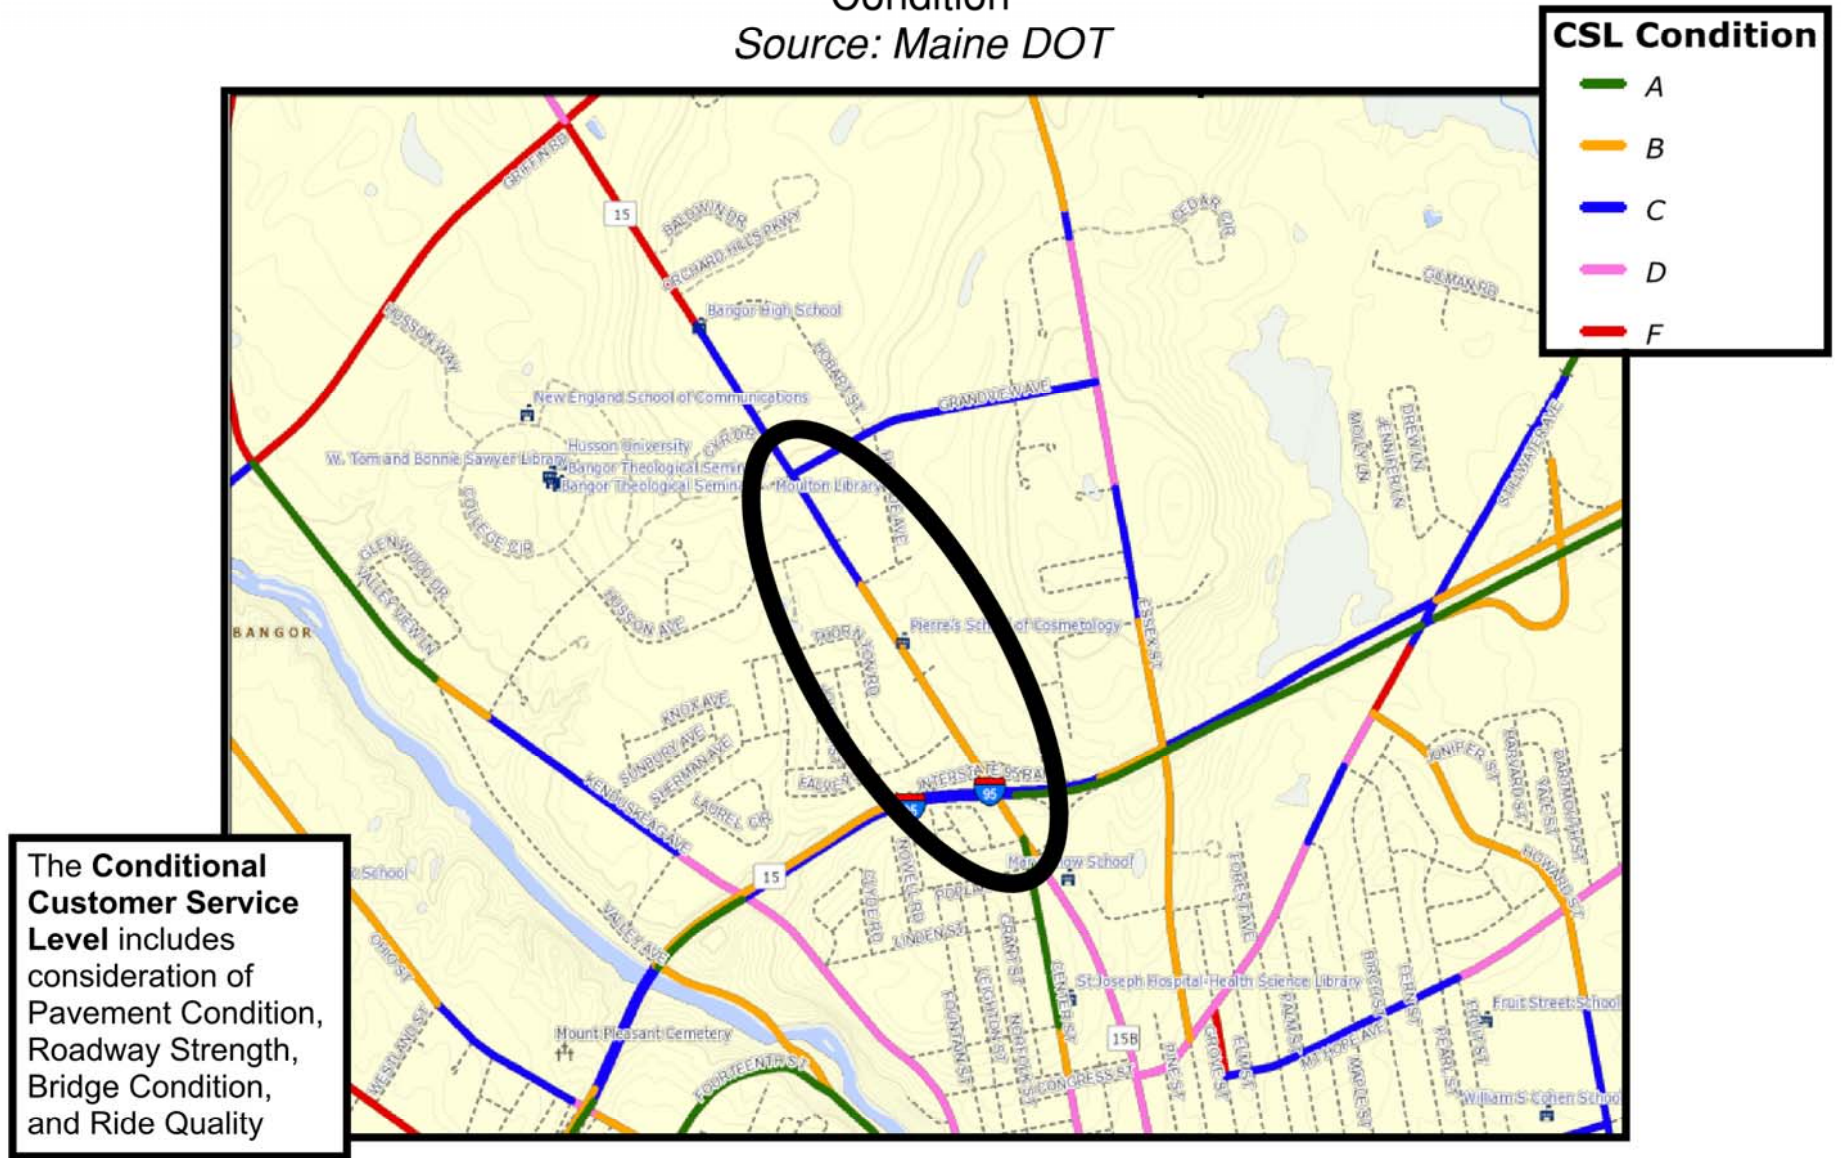
Figure 7: Customer Service Level:
Condition
Source: Maine DOT

CSL/Condition - The Condition CSL includes consideration of Pavement Condition, Roadway Strength, Bridge Condition, and Ride Quality. As shown on **Figure 7**, the corridor ranges from A to C for this

category. Center Street has a condition rating of A. The condition deteriorates to a level of service of B along Broadway due to ride quality and small shoulders from the I-95 NB ramps up to School Street. Broadway from School Street to Grandview experiences a level of service C with some lane markings and pavement conditions deteriorating.

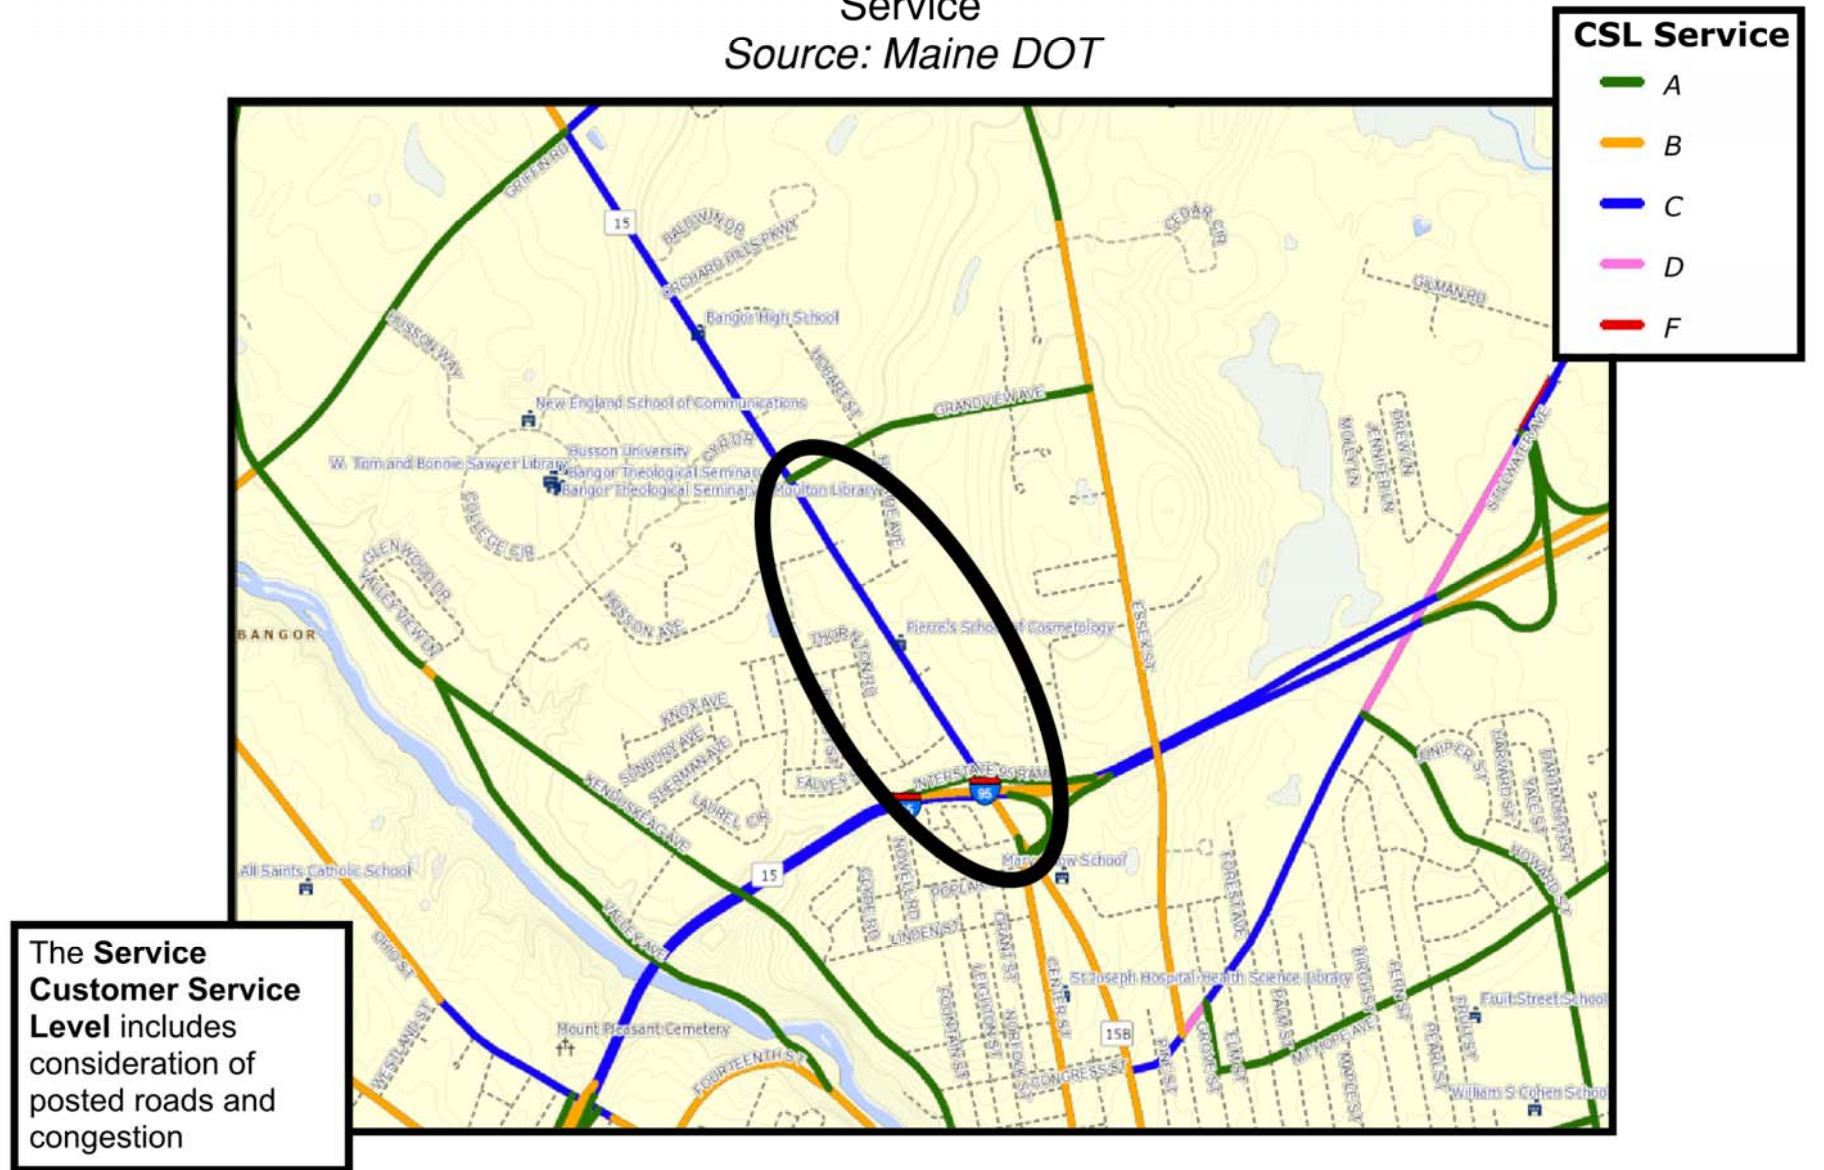
Figure 8: Customer Service Level:
Service
Source: Maine DOT

CSL/Service - The Service CSL includes consideration of posted roads and congestion. As shown in **Figure 8**, the corridor ranges from A to C for this category. The I-95 NB and SB Ramps along with Grandview Ave at the northerly portion of Center Street experience a service rating of A. The study portion of Broadway from I-95 NB to I-95 SB experiences a level of service B with some minor congestion and narrow shoulders seen. From I-95 SB to the north, Broadway experiences a service level of C due to the increased congestion.

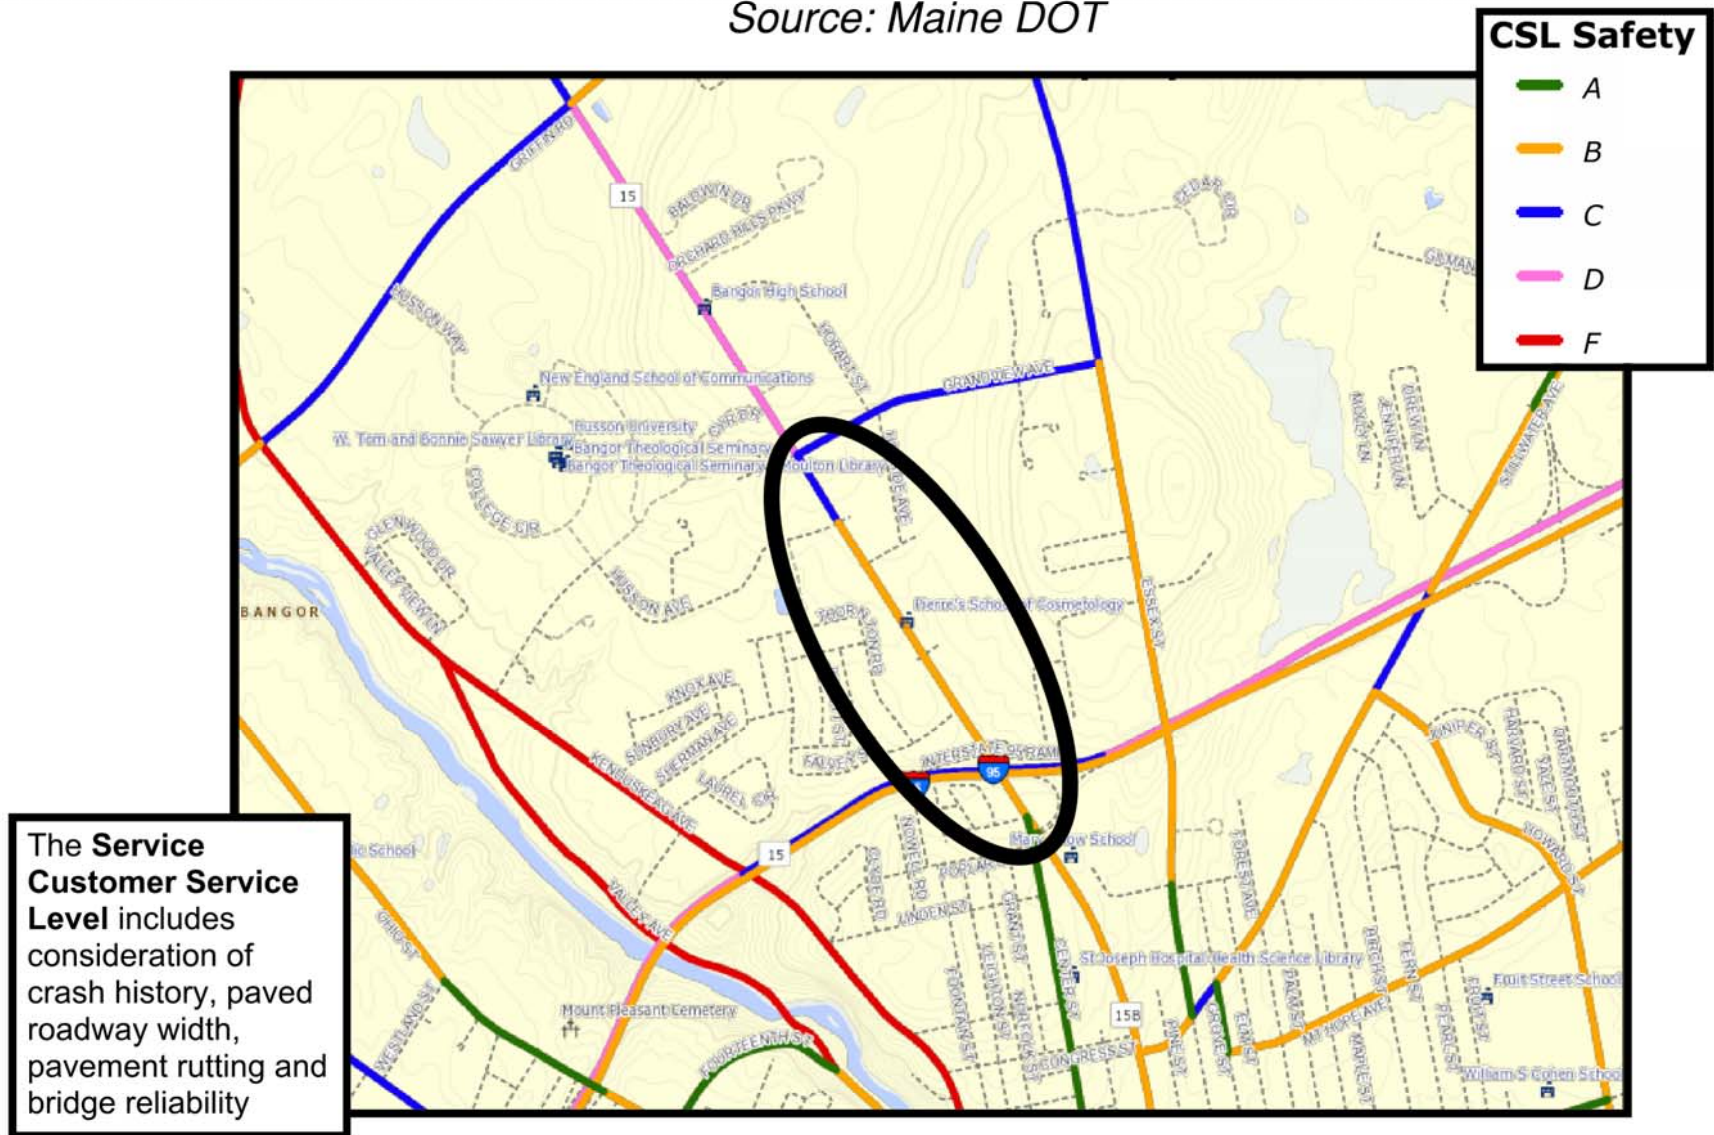
**Figure 9: Customer Service Level:
Safety**
Source: Maine DOT

CSL/Safety - The Safety CSL includes consideration of Crash History, Paved Roadway Width, Pavement Rutting, and Bridge Reliability. As shown in **Figure 9**, the corridor ranges from A-C for this category. Center Street experiences a safety rating of A. From the I-95 northbound ramps to Husson Avenue, Broadway experiences a safety rating of B. Grandview Ave and Broadway from Husson Avenue to Grandview Ave experience a safety rating C.

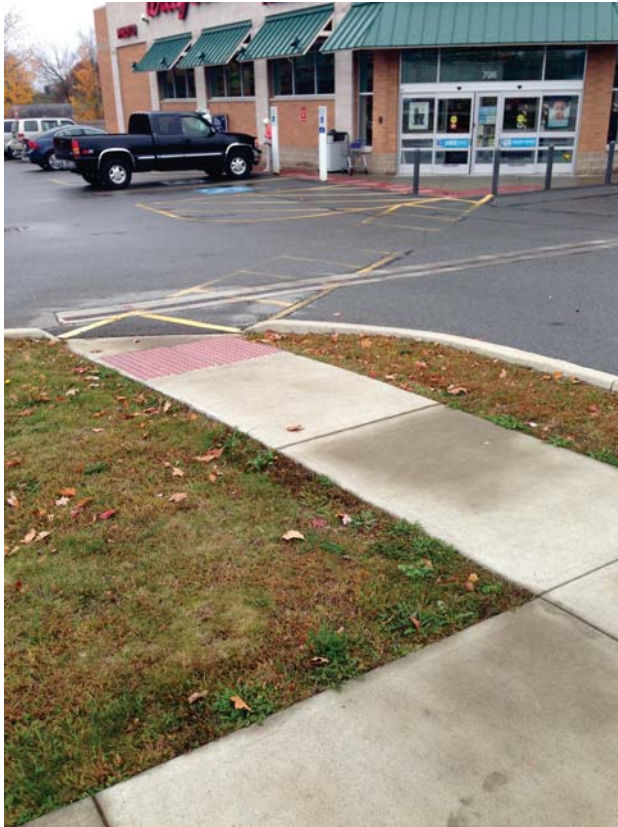
Figure: Field Notes
October 16, 2014 Site Visit
School Street

Figure: Detectable warning tile at Walgreens
