PENJAJAWOC STREAM ANALYSIS AND INTERPRETATION REPORT
ADDENDUM I

PENJAJAWOC STREAM – PRIORITIZED AREAS FOR RESTORATION

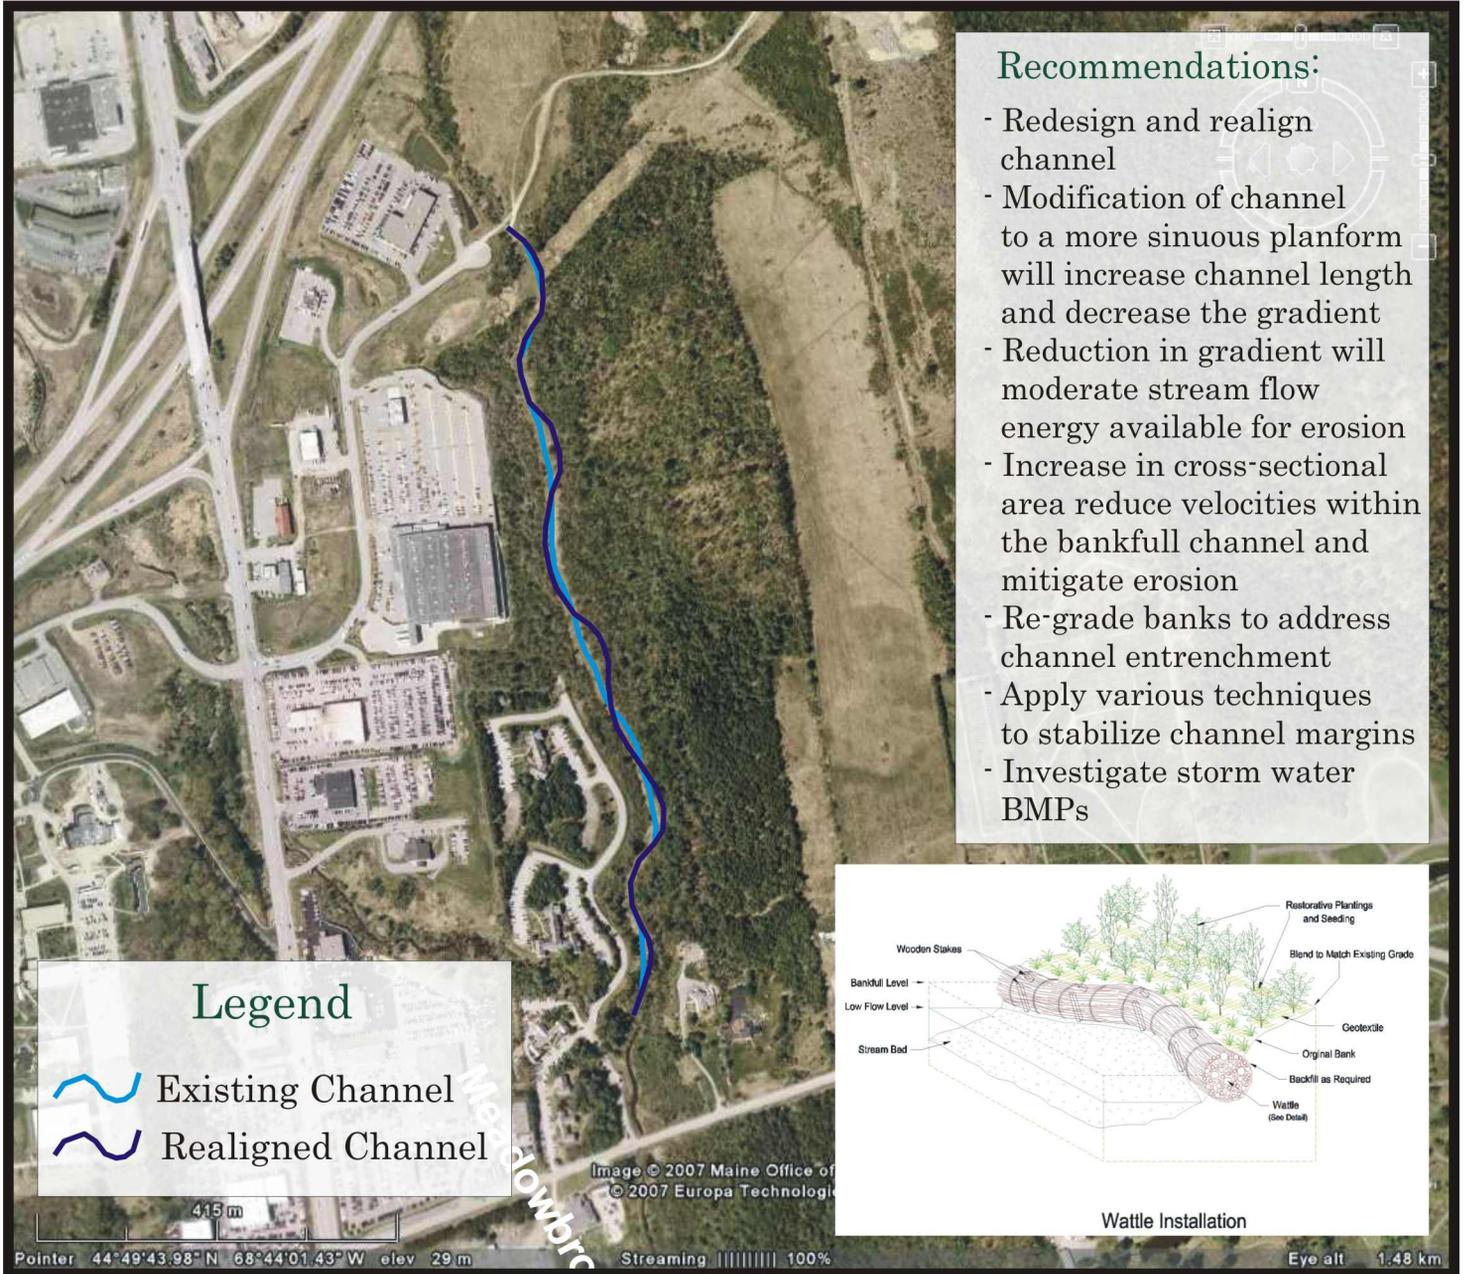
Figure 2

Downstream of Interstate to Hogan Rd (Figure 2)	2	<ul style="list-style-type: none"> - Due to the aggradation that is happening upstream of Interstate 95, this site is sediment-starved and actively adjusting - In an attempt to supplement its sediment supply, the channel is actively eroding the bed (incision) and banks (widening) - As a result of this incision, the upstream culvert has become perched and the channel itself has 	<ul style="list-style-type: none"> - Repair perched culvert crossing with an appropriately-sized structure - Re-connect channel to a functioning floodplain by lowering top of banks and terracing margins - Utilize plantings, live stakes and root wads to stabilize banks and improve riparian conditions - Depending on the severity of erosion, apply various bank treatment techniques (including
