RE: Annual Report on Compliance for Calendar Year 2020 (Consent Decree, Civil Action No. 1:15-cv-00350-NT)

# 2020 Annual Report on Compliance *City of Bangor, Maine*

January 31, 2021

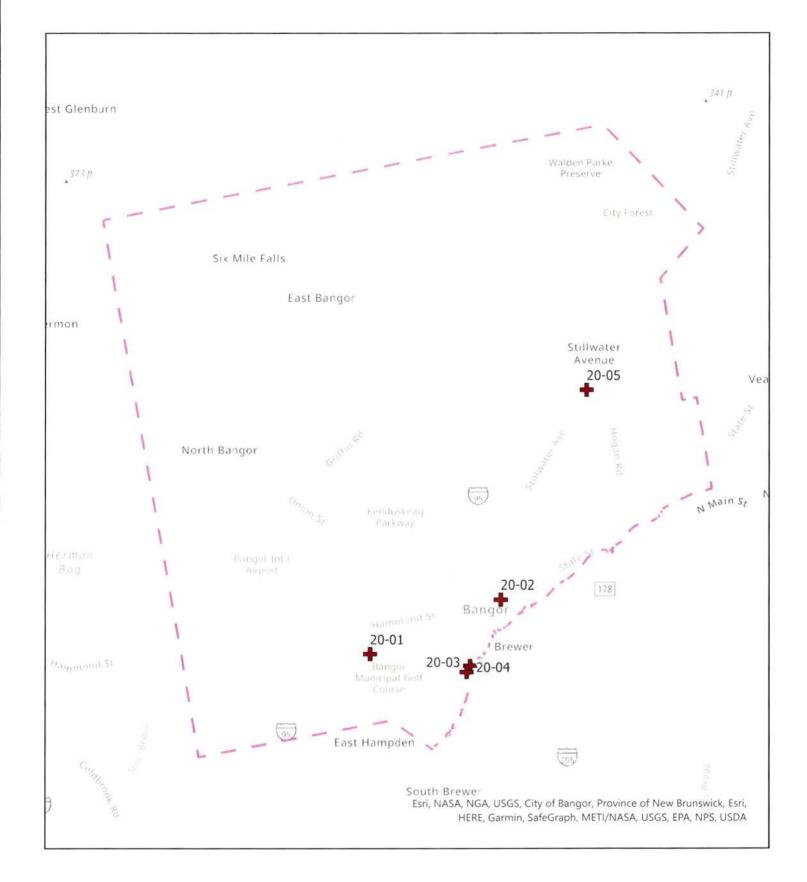
## Appendix F

## **Location Map of Sanitary Sewer Overflows**

Location of Sanitary Sewer Overflows 2020

- A. CCTV Inspection Log
- B. Manhole Inspection Log
- C. CCTV Repair, Replacement, and Upgrade Log
- D. Cleaning Log
- E. SSO Event Log
- F. Location Map of Sanitary Sewer Overflows
