# Sucker Brook

## Stream Corridor and Watershed Survey

*Bangor and Hampden, Maine*

*October 2014*

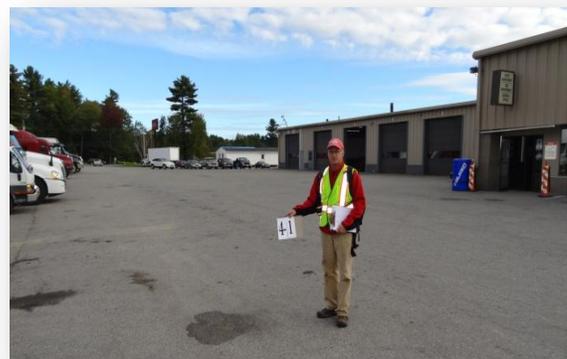
*Example of a large area of impervious cover in the Sucker Brook watershed south of I-395.*

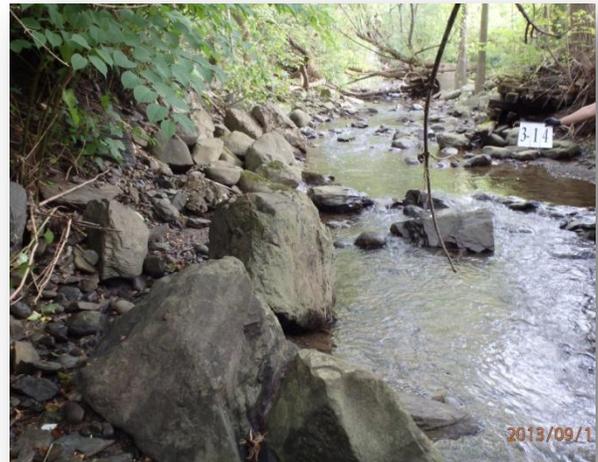
*Example of different habitat types in Reach 3.*

Examination of the in-stream characteristics of Sucker Brook indicates that the presence of habitat varies by stream reach. Reach 3 was found to have the most habitats present (pools, riffles, runs, cascades, and rapids), while Reach 1-1, a subreach of Sector 1, had the least (pools only). All other reaches (or subreaches as is the case for Reach 1 with four subreaches), had at least two or three habitats present. The most prevalent habitats include pools, riffles and runs. Average pool depth was between 1-2 ft. with the exception of reach subreach 1-3 and 3-2 with average pool depth greater than 2 ft. The most number of pools greater than 2 ft. were documented in Reach 3 (7 pools), and Reach 4 (12 pools). Deeper pools such as those documented in the lower reaches of Sucker Brook provide habitat for fish to spawn and rear their young. Reaches with low frequency of deep pools may be the result of aggradation (see RGA Results, Section 2.3).

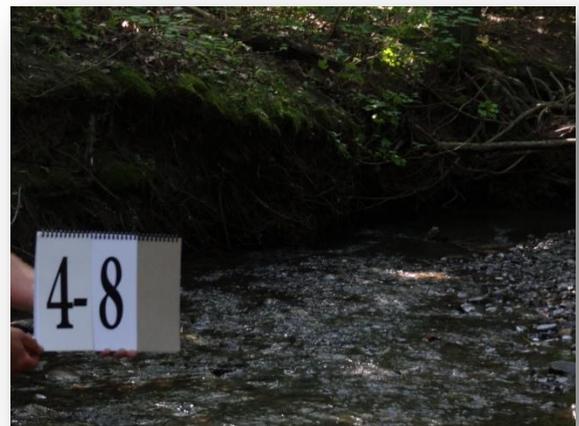
Example of gravel and cobble substrate in Reach 4.

sloping banks (>30%) and undercut banks in this section which has resulted in a wide, shallow channel. Stream bottom conditions ranged from Good (Reach 4), to Poor (Subreaches 1-1, 1-2, 2-3, 3-1, 3-2). The remaining reaches scored Fair (Table A1, Appendix A).

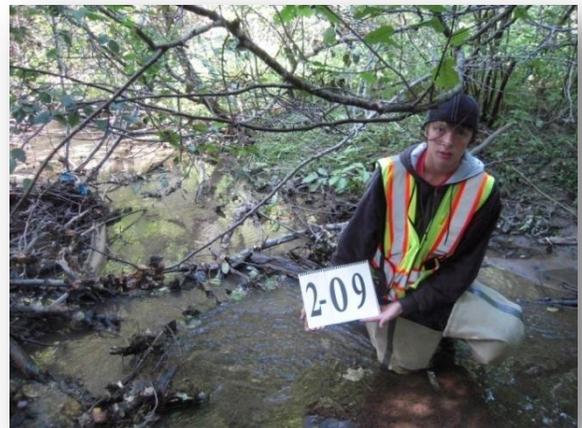
*Example of woody debris in Reach 2.*

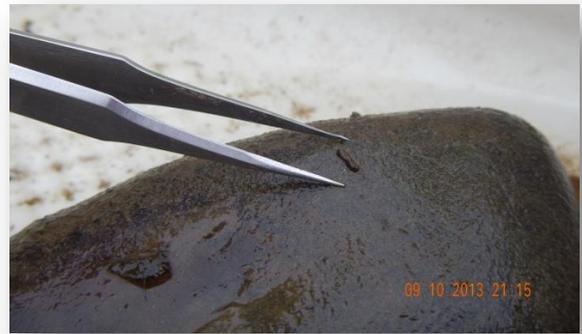
*Macroinvertebrates in Sucker Brook were present, but generally rare with the exception of one reach, in which no macroinvertebrates were found.*

Evidence of mammals (deer, muskrat, gopher) were documented at fewer than half of the reach survey sites (1-1, 1-3, 1-4, 2-3). Fish were documented at six of the ten reach survey sites (1-1, 1-4, 2-1, 3-1, 3-2, 4), and amphibians were documented at four of the ten reaches (2-2, 2-3, 3-1, 4). Macroinvertebrates were present, but generally rare, at all of the sites with the exception of Reach 2-2 where none were found at all. Water striders, aquatic worms, blackflies, beetle larvae, and snails were the common insects identified. A caddisfly was documented in Reach 4. With the exception of the caddisfly, the other insects found in the stream are typically less sensitive to environmental pollution, and are often dominant in polluted urban streams.

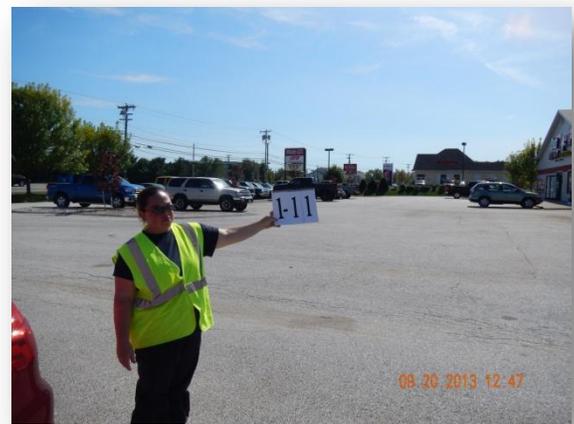
*Example of a large area IC within a commercial development near VIP in Sector 1.*

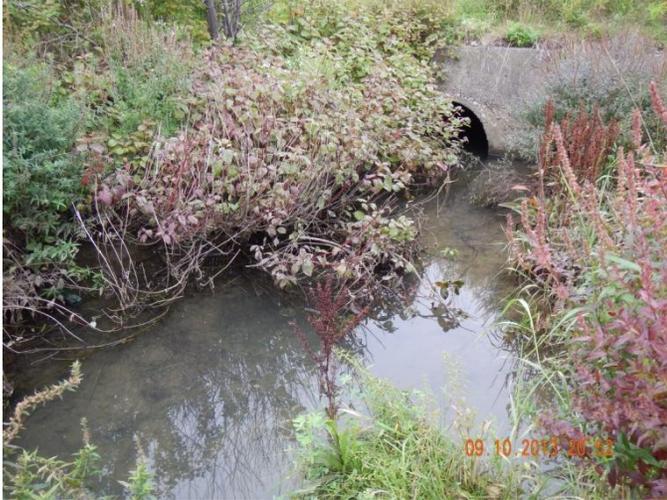
### Reach 1

Slow moving portion of Sucker Brook in Reach 1.

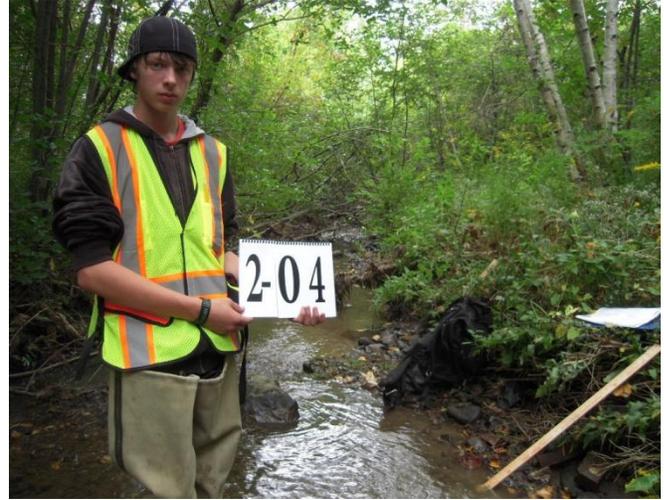
### Reach 2

Section of Sucker Brook flowing through a wooded area in Reach 2.

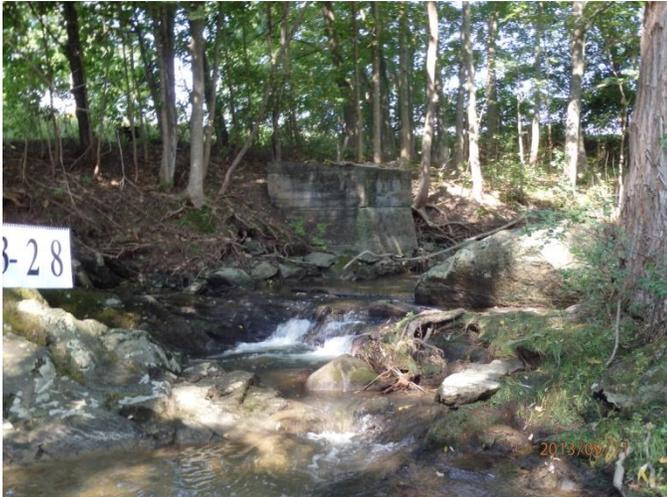
### Reach 3

Example of a pool documented in Sucker Brook in Reach 3.

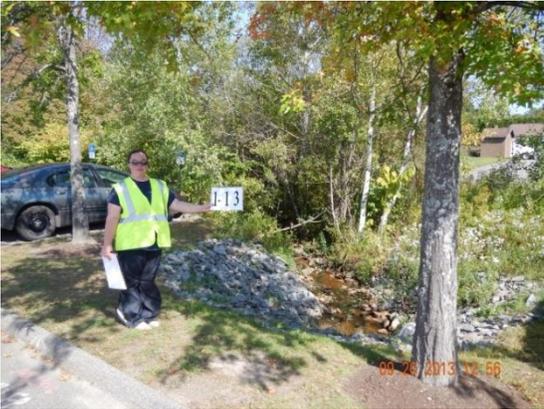
### Sector 1

A portion of Sucker Brook flowing near the Red Cross.

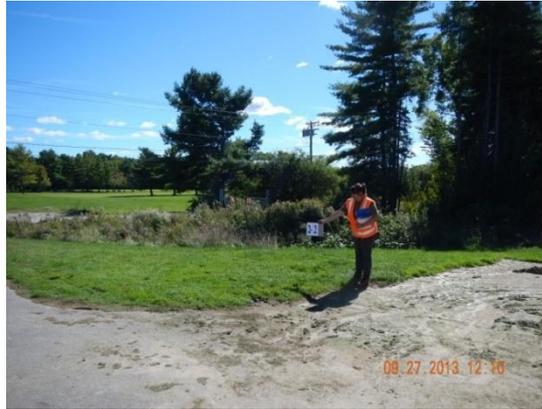
### Sector 2

Ponded area near the brook at the Bangor Municipal Golf Course.

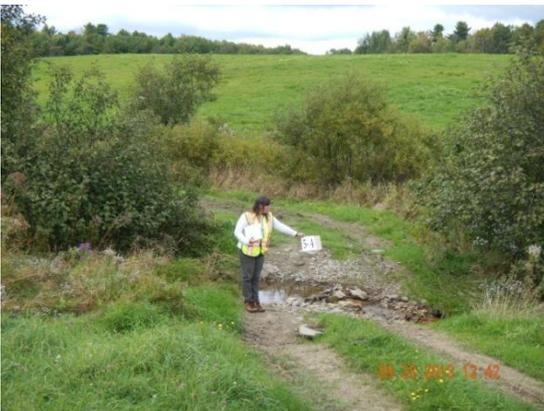
### Sector 5

An agricultural access road crosses Sucker Brook in Sector 5.
